## EXISTING CONDITIONS & RECOMMENDATIONS

**1835 Old Town Hall Community Center**Sterling, MA  
MTS Project No. 1140.00

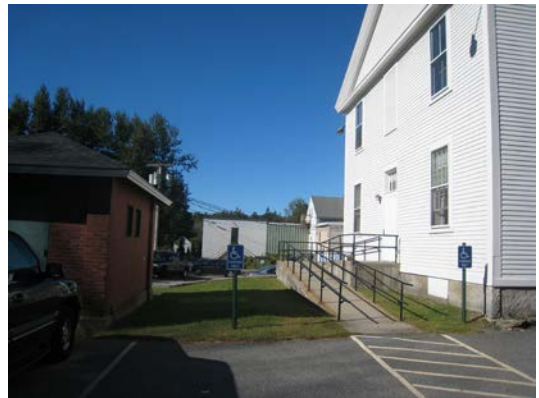
Brick fire proof storage building and concrete ramp at south side of building.

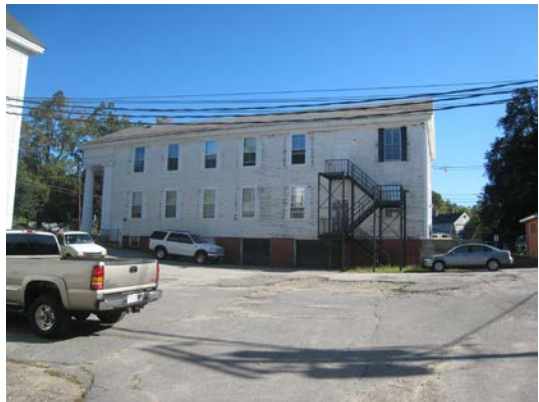
Parking lot on west side.

- Spot repair and patch paving as required.
- Stripe the parking when lines are faded.
- Monitor area around retaining wall for erosion.
- Coordinate with town on sidewalk maintenance.

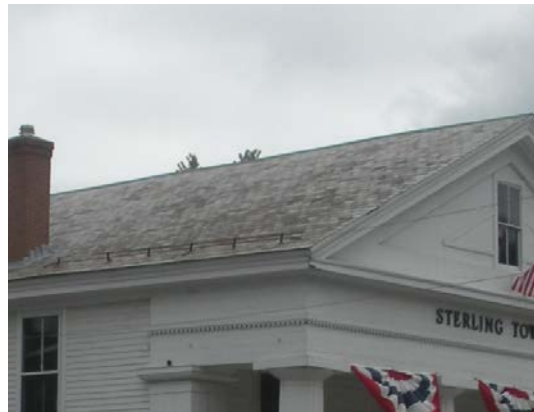
Snow rail and chimney flashing at slate roof.

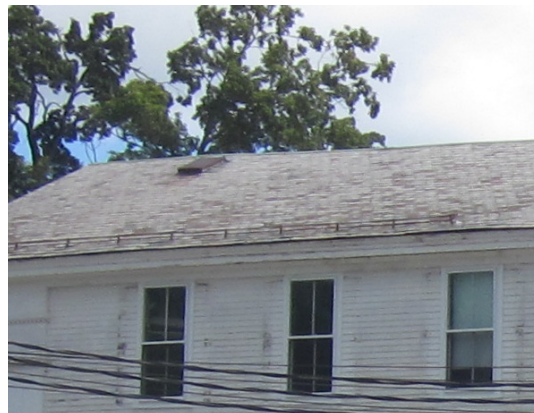
Snow rail and roof hatch on slate roof.

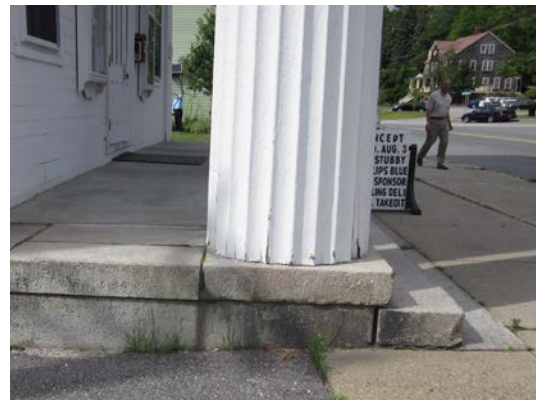
There are areas of separation between granite step components and several cracks in the concrete slab at the portico. The foundation walls have deteriorated at all four elevations.

Shifted, separated granite steps at the south elevation. Paint failure at the column base.

- Spot repair and repaint trim elements at the facade. Repaint the entire elevation on a cyclical schedule.
- Repair, reglaze and repaint all windows.
- Repair and reinstall the louvered vent at the pediment and the original double entry doors with sidelights. These actions will help restore the building's Greek Revival character.
- Repoint the granite steps and repair or replace cracks the concrete slab.
- Cut and repoint all foundation stones.

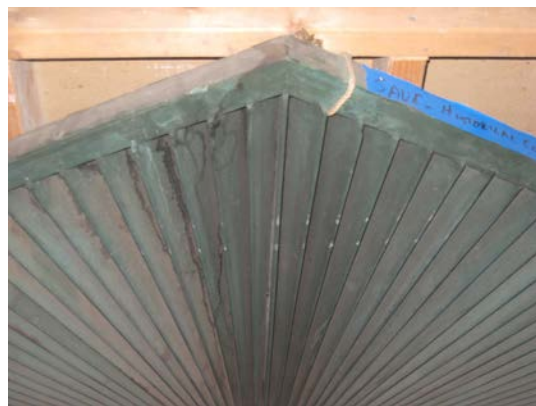
Original louvered vent stored in attic.

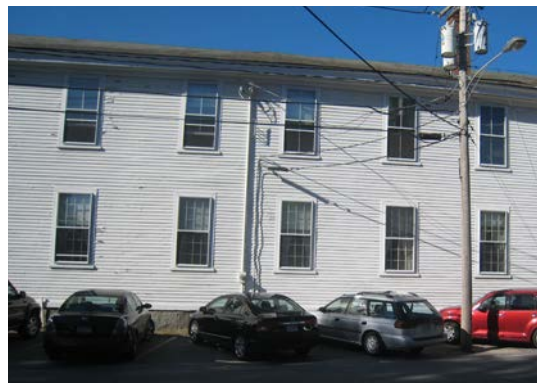
The paint on the east elevation is in fair condition, with areas of peeling seen primarily at the eastern half of the building around window openings.

Peeling paint on wood siding around windows at both floor levels.

- Spot repair and repaint wood clapboards. Repaint the entire elevation on a cyclical schedule.
- Repair, reglaze and repaint all windows on the first and second levels.
- **Restore the basement windows?**
- Repoint the granite foundation.

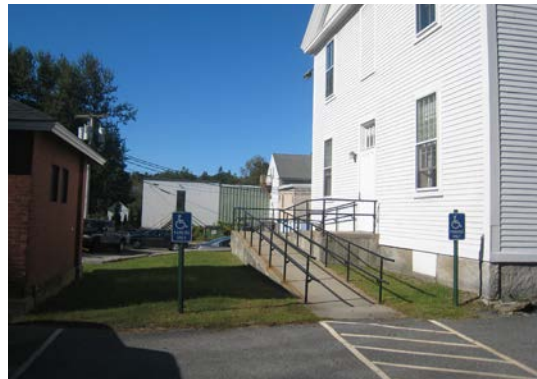
The concrete handicap access ramp is pitted, cracked and rust stained around and under the painted metal posts and railings. The metal posts and railings are exfoliating and causing expansion cracks in the concrete.

The concrete handicap ramp is in poor condition.

- Repaint the entire elevation on a cyclical schedule.
- Repair, reglaze and repaint all windows on the first and second levels.
- Restore the basement windows?
- The proposed schematic design calls for the concrete ramp to be removed. If it remains, it should be repaired and the railings refinished.

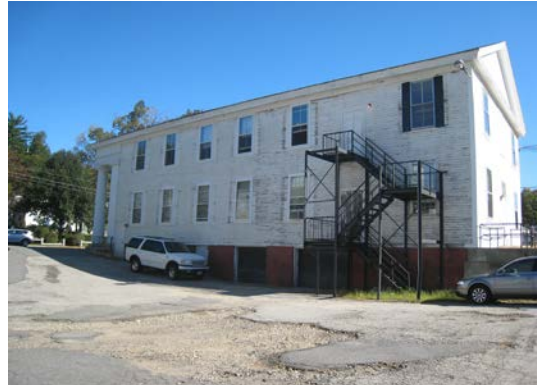
The paint on the west elevation is in poor condition. Painting this elevation was postponed in anticipation of proposed alterations and construction of a handicap access addition.

Poor paint conditions at the west elevation.

- Repaint the entire elevation on a cyclical schedule.
- Repair, reglaze and repaint all windows.
- Repoint the masonry foundation.
- Repair the concrete entry platform at the northwest corner.

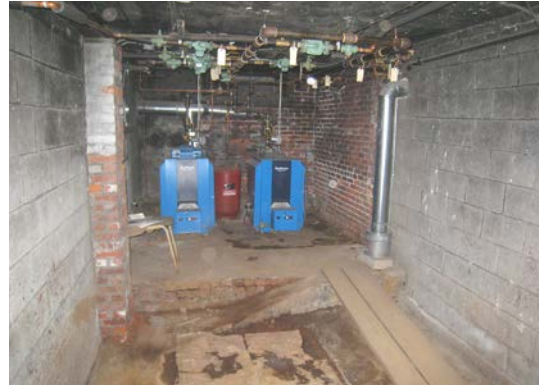
The unfinished basement, which has been subdivided by brick and concrete block walls into areas for storage and mechanicals, is damp and shows evidence of water infiltration at the north and east walls where mortar joints have deteriorated. Two vertical piers supporting the first floor framing beams are damaged, particularly at their bases. Several first floor framing beams have insufficient capacity for the load required.

New boilers installed in the basement. Areas of moisture seen on the floor.

- Replace damaged piers with hollow steel columns.
- Reinforce framing beams as required.
- Repoint foundation walls
- Upgrade the electrical service to support air conditioning and an elevator.
- Upgrade the fire alarm system and install a sprinkler system.
- Install a permanent dehumidifier.

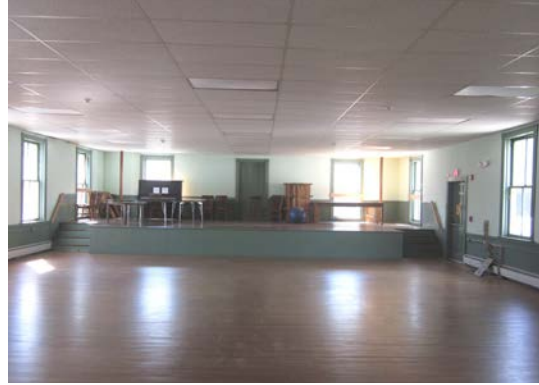
The dropped ceiling is unattractive, historically inappropriate and creates a cramped feeling in the space. The acoustic ceiling tile shows water damage in several areas from roof leaks. The finish on the wood floor is worn. Paint finishes are in fair to good condition.

Dropped ceiling detracts from the aesthetics of the assembly room.

- Remove dropped ceiling to create “cathedral” space.
- Refinish wood floor.
- Refresh paint finishes as required.

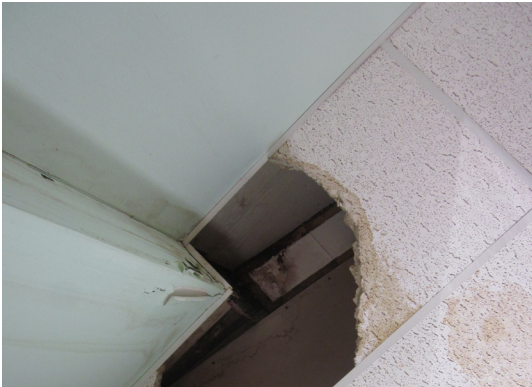
Water damage to acoustic tile ceiling.

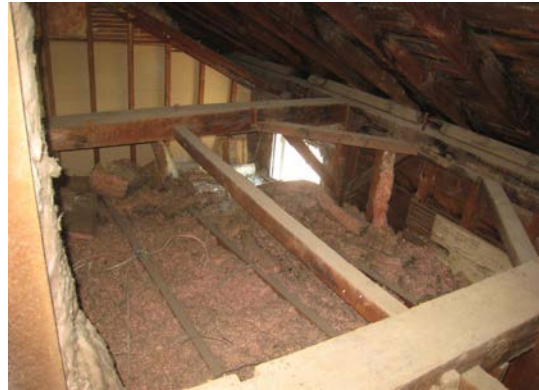
Wood framing supporting the roof consists of rafters, purlins and trusses. The purlins are overstressed and the top chord of one truss has failed. There are no trusses at the westernmost bays of the building. Past concerns about the trusses resulted in the installation of tie rods.

Attic and roof framing over the assembly room.

- Reroof with slate or wood shingle as the preferred historic materials. Asphalt shingle or metal roofing would have no historic integrity but would be less costly.
- Install rail type snow retention system along eaves above entries.
- Install new supplemental truss framing and purlins below existing to strengthen roof framing. These would be visible in the Meeting Hall but would allow removal of the acoustical tile flat ceiling and revealing the historic ceiling height. The trusses would be encased to create architectural elements. The tie rods would remain, but new sag bars would be installed that would be more architectural.

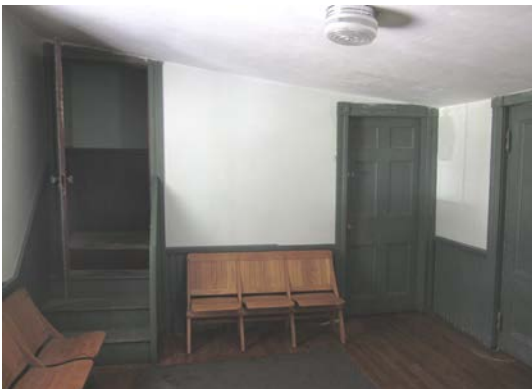
Stairs to the assembly room balcony, which has been covered by the drop ceiling. Wood doors, trim and wainscot are among the remaining original Greek Revival details at the building interior.

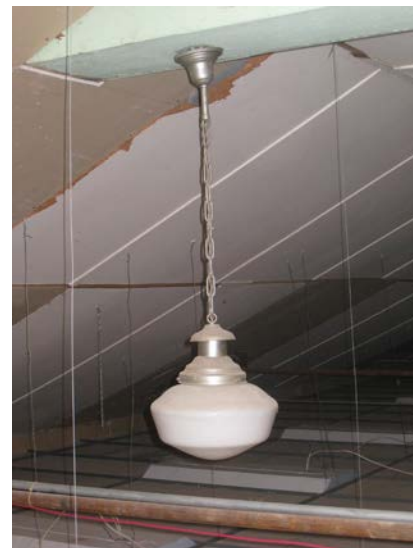
Pendant lamp obscured by drop ceiling.
