## STRUCTURAL SURVEY & RECOMMENDATIONS

Reference: Sterling Town Hall  
Sterling, Massachusetts

Re: Limited Hazardous Building Materials Inspection  
1835 Town Hall, Sterling, Massachusetts  
Fuss & O'Neill EnviroScience, LLC No. 20111236.A1E

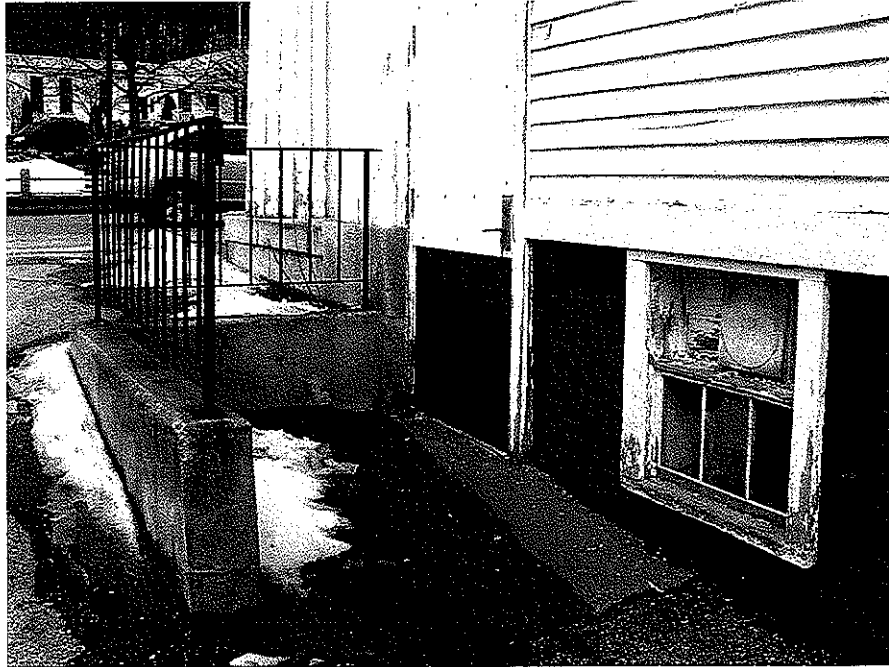
**STAIR EXIT DOOR AND AREAWAY**

- Door Boarded Up and Steel Plate Added
- Cracked Concrete Wall
- Rusting Metal Railing
- Broken Basement Window Boarded Up
- Brick Missing Upper Right of window Opening

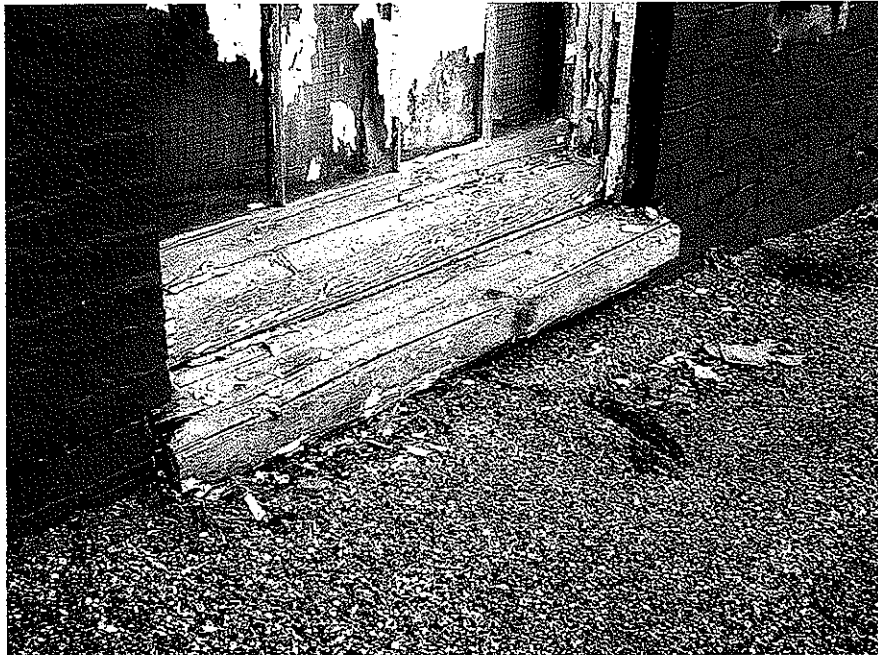
**BASEMENT WINDOW SOUTH ELEVATION**

- Rotted Wood Window Sill
- Paint Failure at Window
- Broken / Missing Glazing Putty

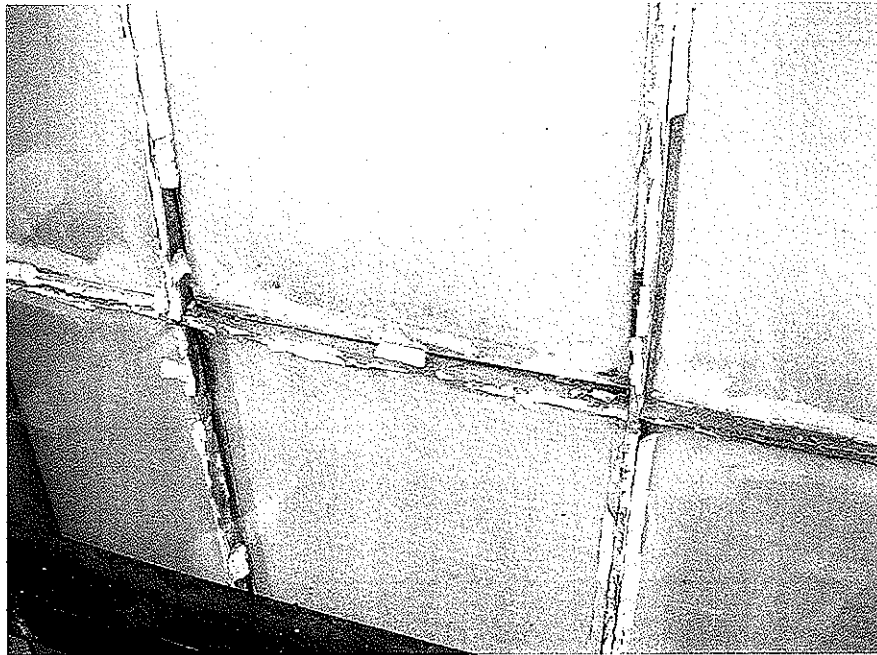
**FIRST FLOOR WINDOW SOUTH ELEVATION**  
• Broken / Missing Glazing Putty

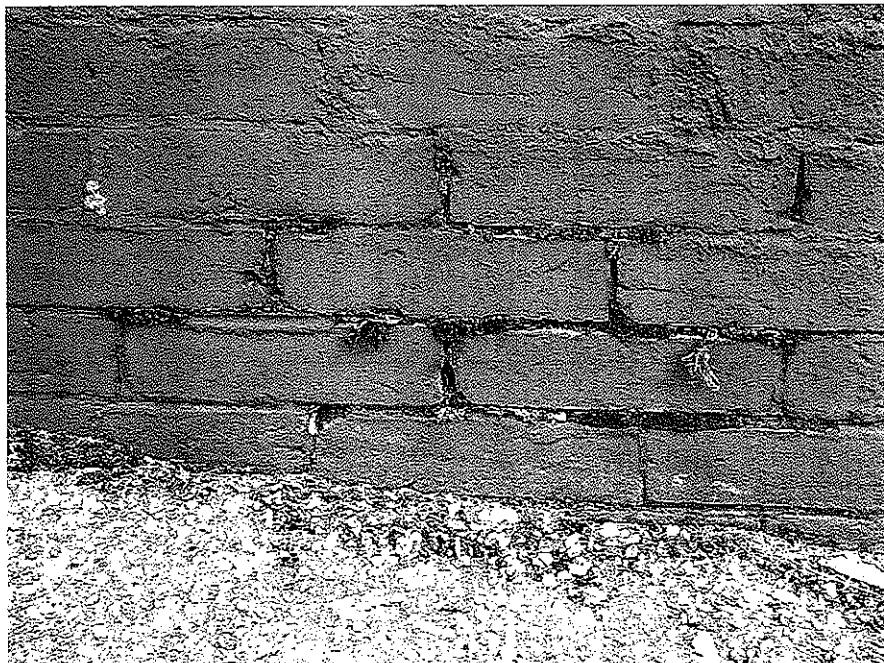
**FIRST FLOOR WINDOW SOUTH ELEVATION**  
• Moss Growing in Mortar Joints

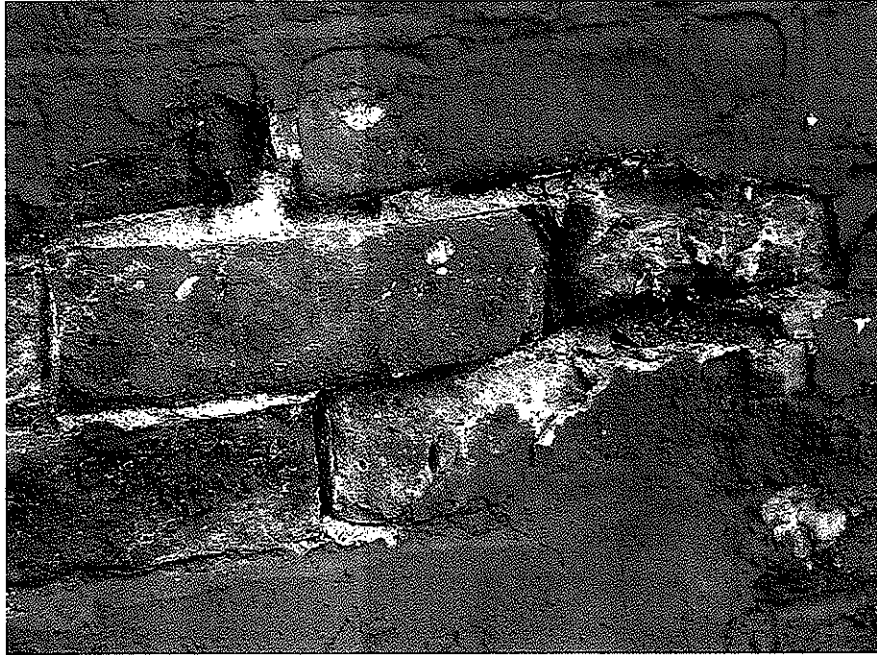
**BRICK FOUNDATION SOUTH ELEVATION**

- Spalled Deteriorated Brick
- Deteriorated / Missing Mortar

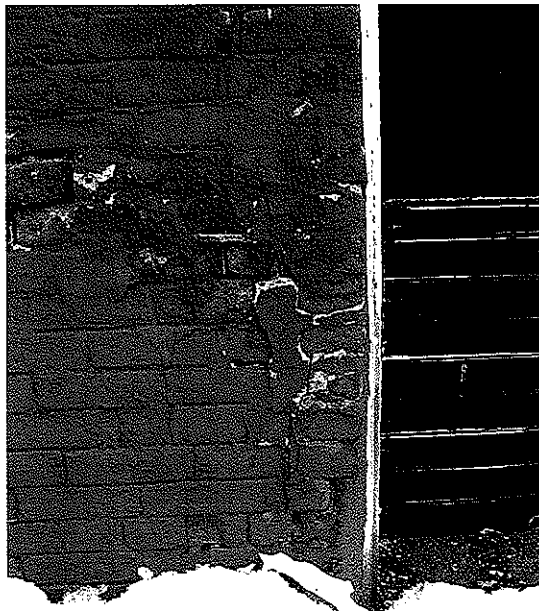
**BRICK FOUNDATION SOUTH ELEVATION**

- Broken Previously Repaired Masonry Jamb
- Cracked Broken Masonry
- Deteriorated / Missing Mortar
- Typical of (2) Doors

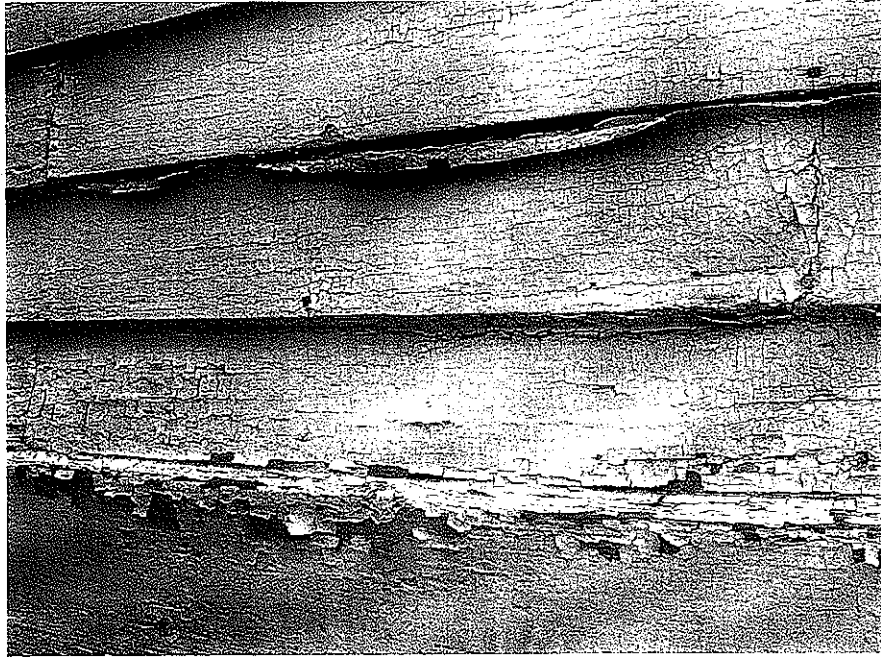
**WOOD SIDING SOUTH ELEVATION**

- Cracked, Crazed, Peeling, Curling Paint Failure

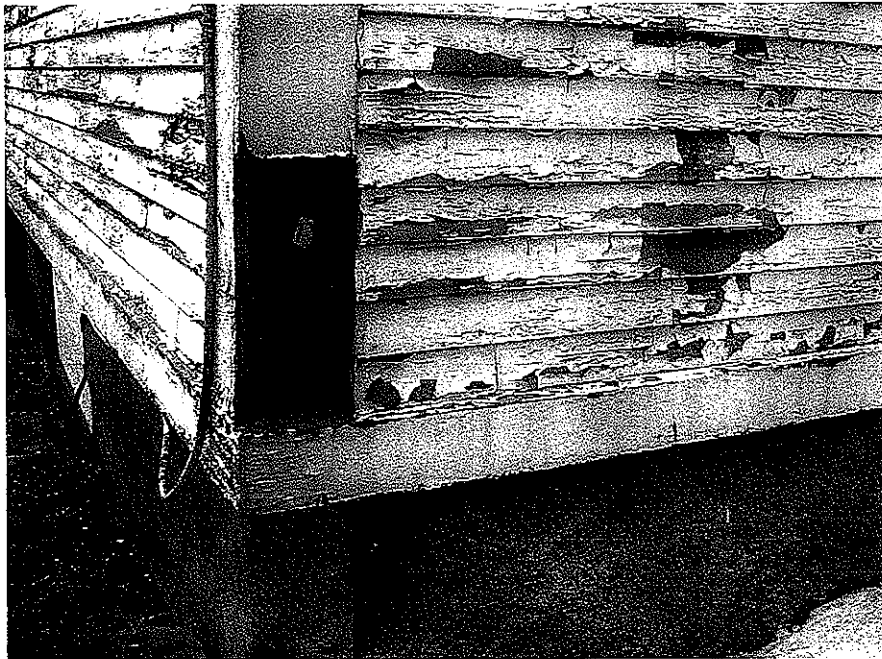
**WOOD CORNERBOARD / SIDING NORTHEAST BUILDING CORNER**

- Paint Failure at Clapboard Siding
- Missing Cornerboard Trim

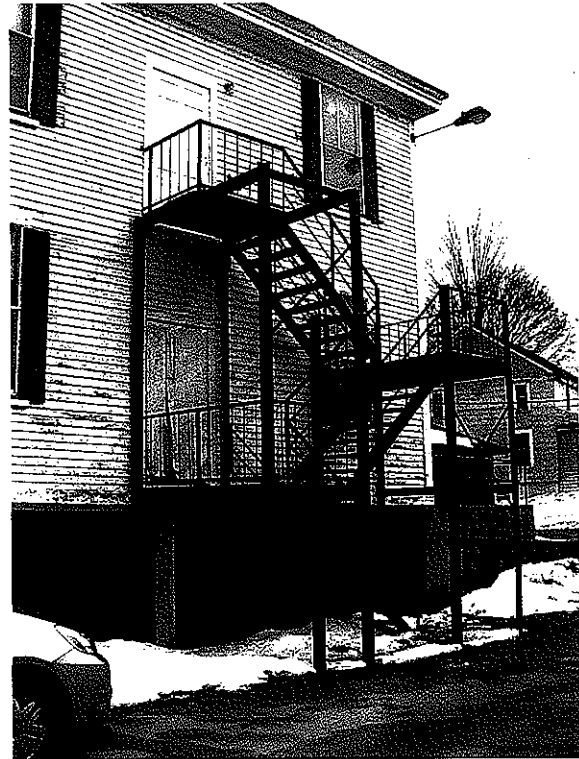
**STEEL FIRE ESCAPE**

- Steel Supports in Contact with Ground
- First Floor Door Boarded Up
- Non-Historical Light Fixtures

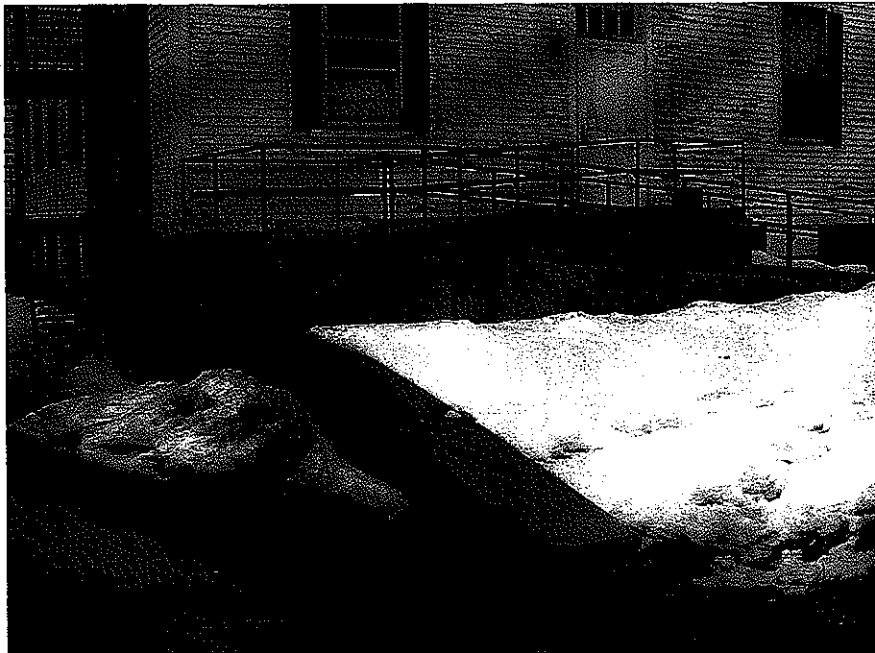
**STONE / CONCRETE RETAINING WALL**

- Broken Concrete
- Exposed Reinforcing Bar
- Loose / Broken Stone Mortar Joints

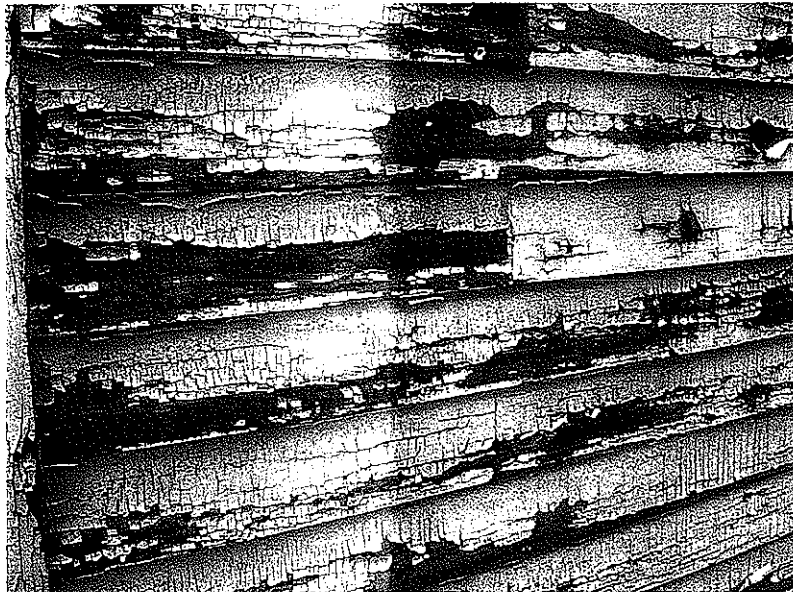
**WOOD SIDING NORTH ELEVATION**

- Cracked, Crazed, Peeling, Curling Paint Failure

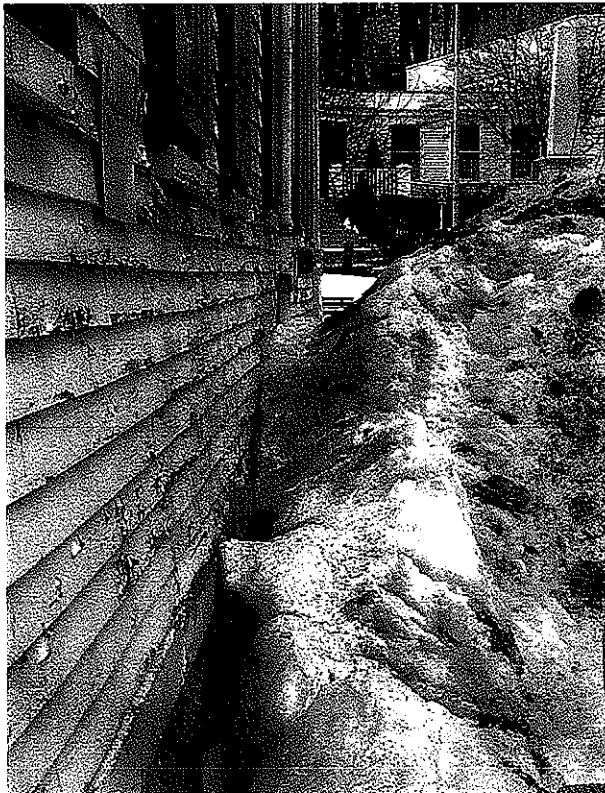
**NORTH ELEVATION SNOW PILE**

- Snow Pile Obstructing Electric Meter
- Snow Pile Obstructing Boiler Air Intake

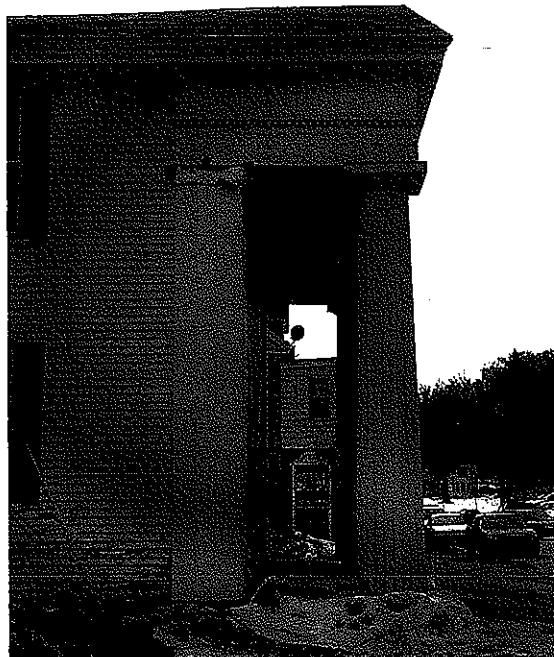
**NORTH PORTICO ELEVATION**

- On-Going Corner Capital Repairs

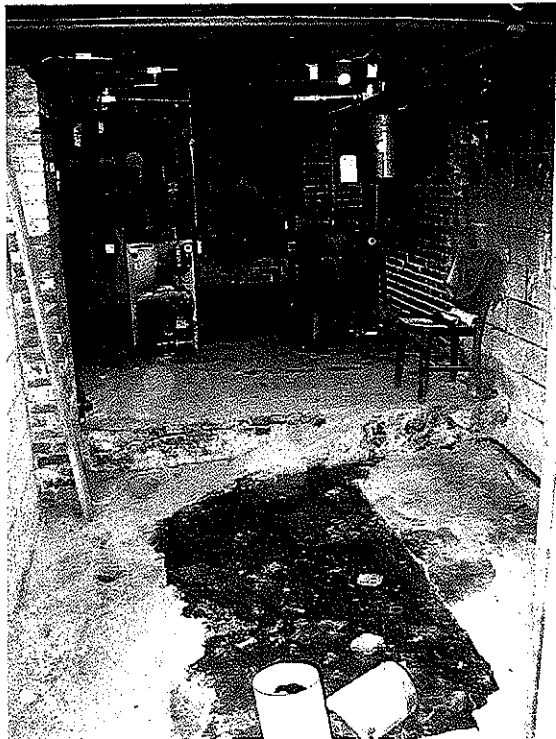
**BASEMENT BOILER ROOM**

- Open Concrete Floor Slab

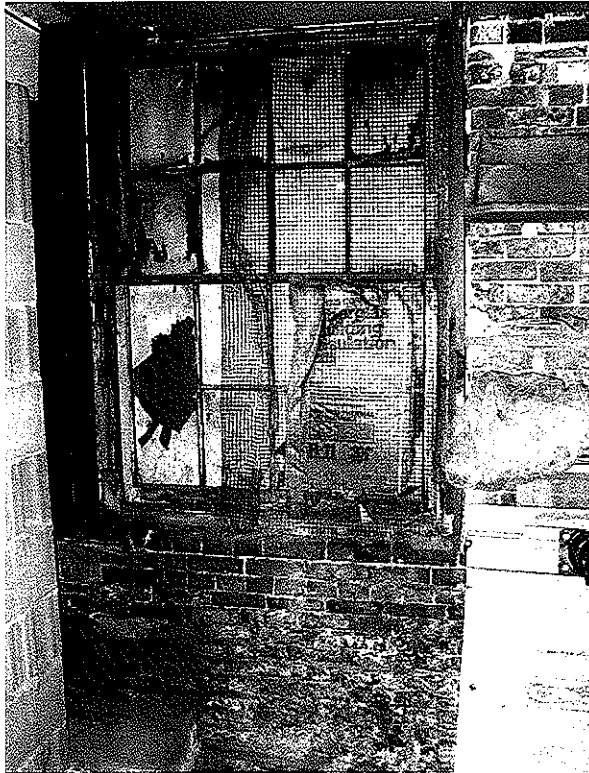
**BASEMENT WINDOW**

- Broken, Deteriorated Wood Window
- Moisture Damage at Masonry below Window

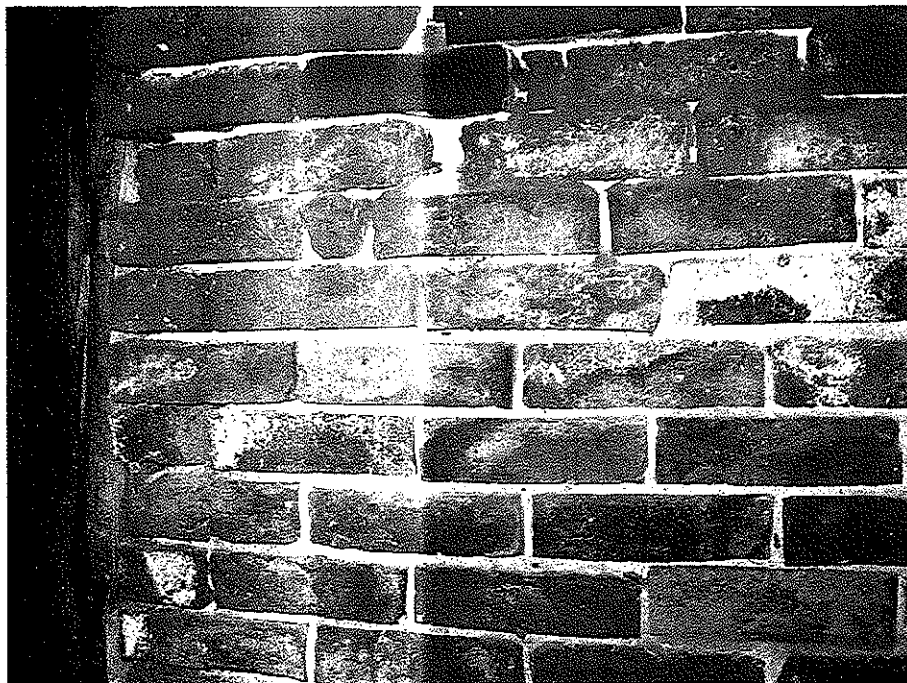
**BASEMENT BRICK INTERIOR BEARING WALL**

- Deteriorated and Missing Mortar

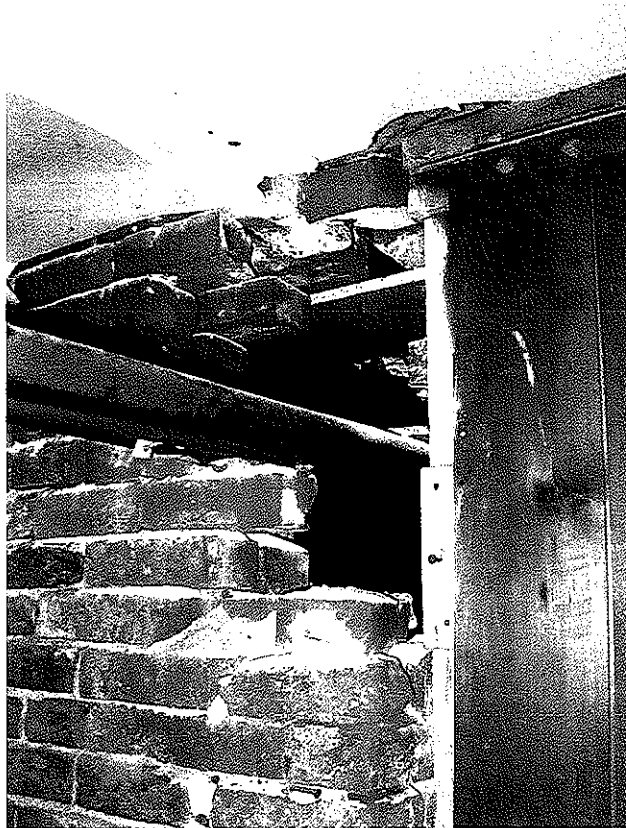
**BASEMENT BEARING WALL**

- Brick Removed for Pipe Installation
- Missing / Deteriorated Mortar

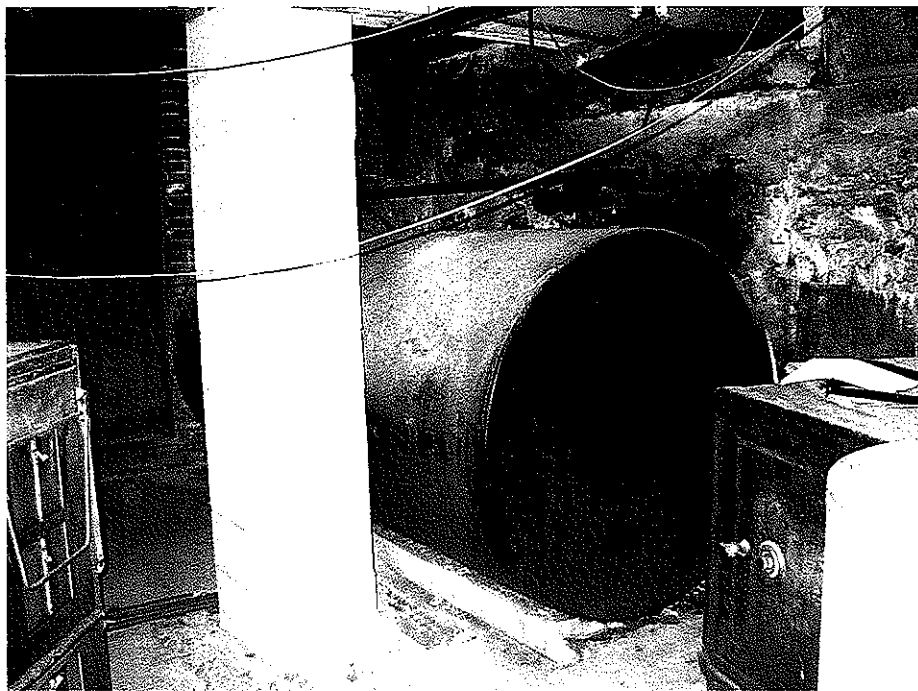
**BASEMENT ABANDONED FUEL OIL TANK**

- CMU Supplemental Pier
- Rubble Stone Foundation Intact

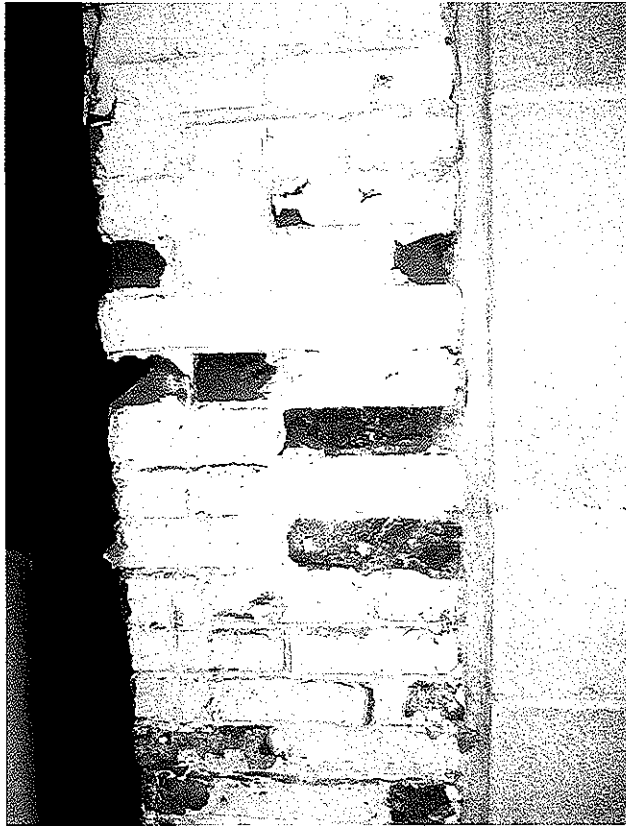
**BASEMENT COLUMN REPAIR**

- Deteriorated Brick Pier
- Supplemental CMU Pier

*These damaged piers should be removed and replaced with hollow steel columns. During the column replacement, footing conditions should be verified and insufficient footings replaced as required.*

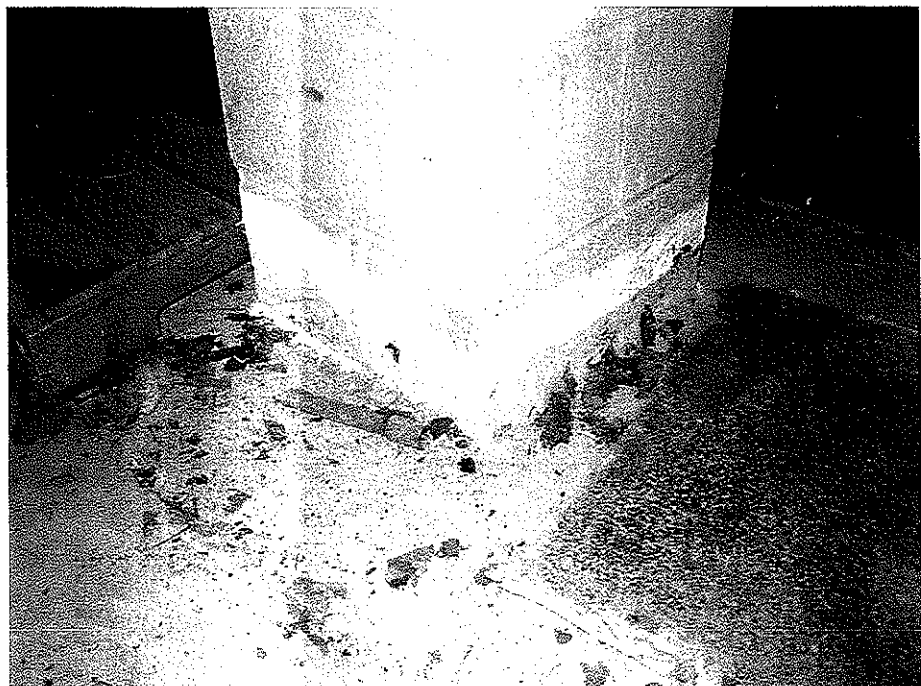
**BASEMENT COLUMN REPAIR**

- Supplemental CMU Pier
- Efflorescent Staining from Previous High Water

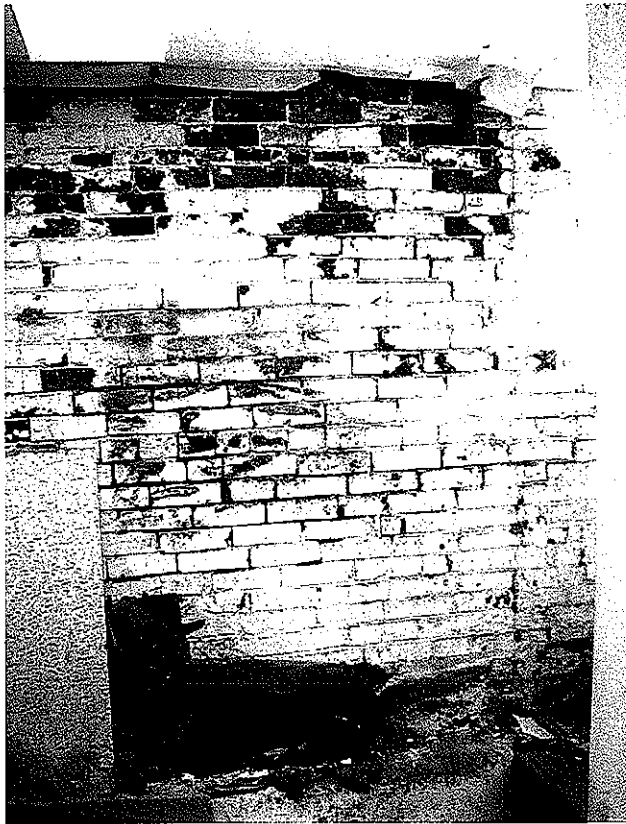
**FOUNDATION WALL AT BASEMENT STAIR**

- Missing and Deteriorated Mortar Joints
- Missing, Flaking Paint

*All foundation walls should be cut and re-pointed, with a minimum allowance for 20% brick replacement along the portions of south foundation wall to remain. Since the proposed accessibility additions and modifications will remove a section of the rear wall of the original 1835 construction and reduce the lateral capacity, the remainder of the wall should be removed entirely and replaced with a steel braced frame or reinforced concrete masonry unit (CMU) wall.*

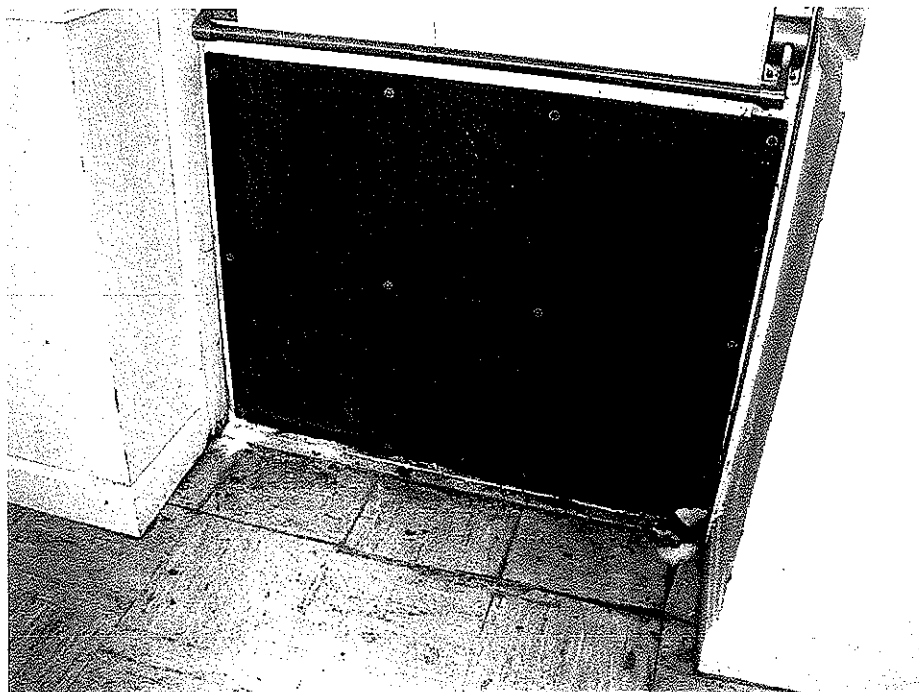
**STAIR EXIT DOOR**

- Plywood Covered Door
- Rusting Steel Plate Reinforcing
- Moisture Damage. Buckling Vinyl Tile

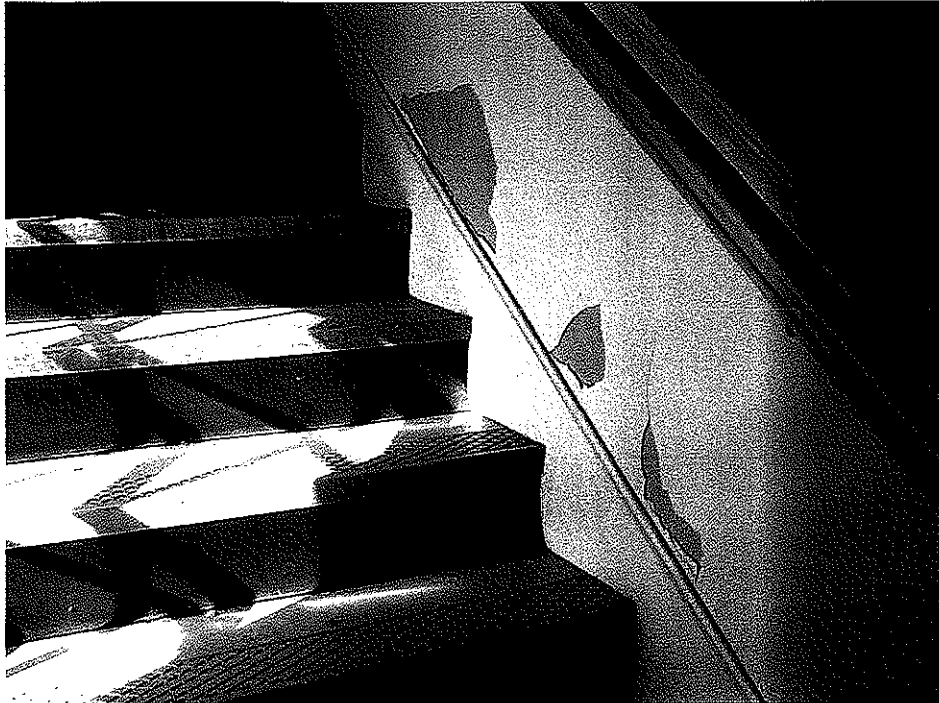
**EXIT STAIR**

- Loose, Spalling Paint
- Vinyl Stair Treads and Risers

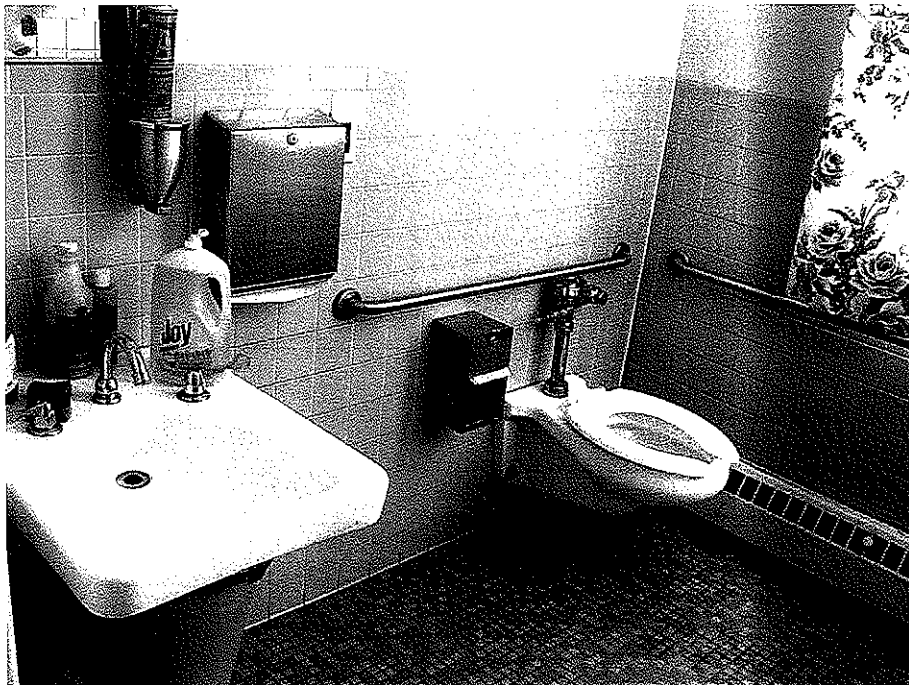
**FIRST FLOOR MEN'S ROOM**

- Non-Accessible / Compliant Toilet Accessories

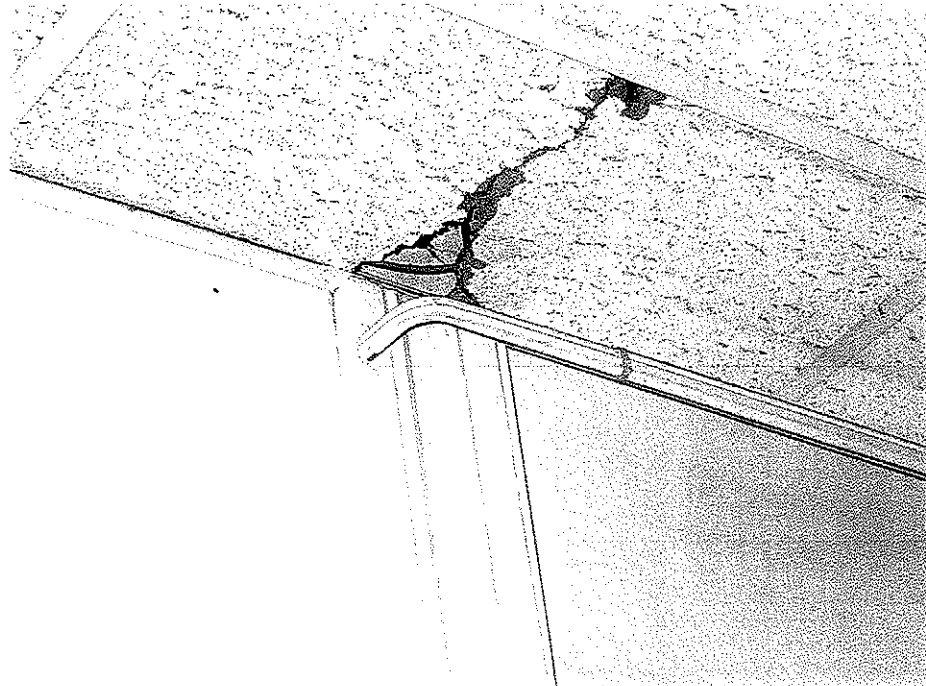
**FIRST FLOOR MEETING ROOM WINDOW HEAD**

- Wood Window Trim at Suspended Ceiling
- Suspended Ceiling Bisects Glass Window

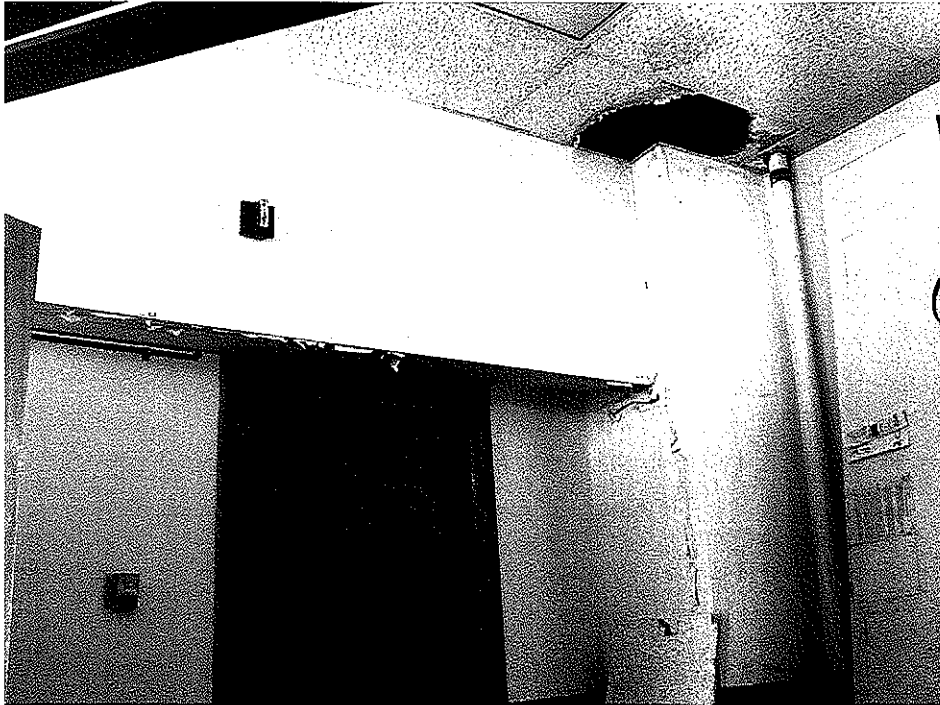
**SECOND FLOOR MEETING ROOM**

- Previous Water Damage Near Chimney

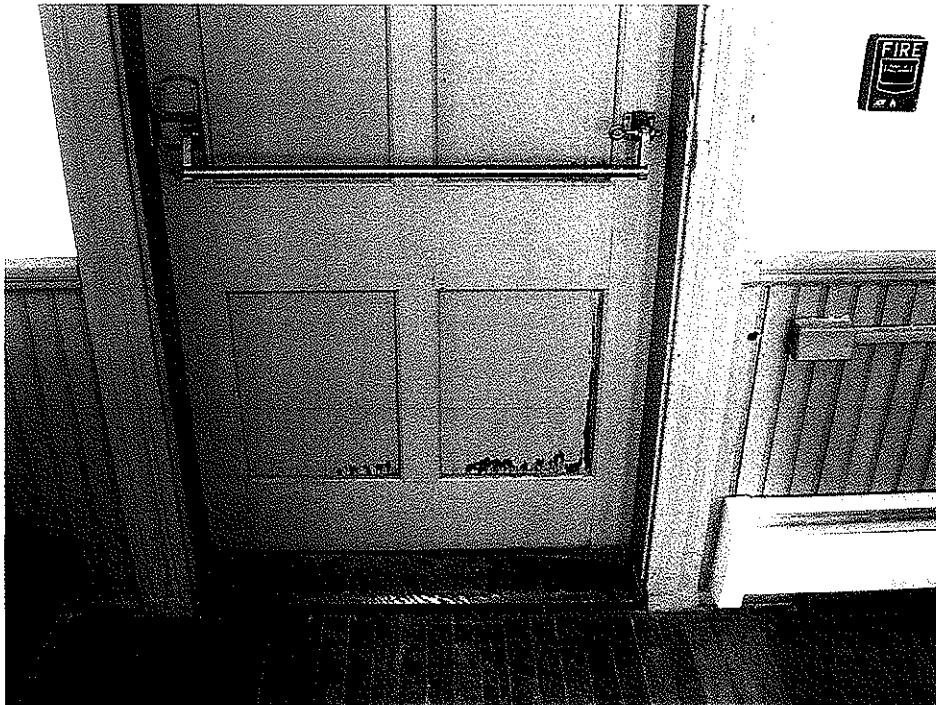
**SECOND FLOOR FIRE ESCAPE EXIT DOOR**

- Moisture Damage at Lower Door
- Wood Wainscoting
- Previously Installed Hydronic Baseboard

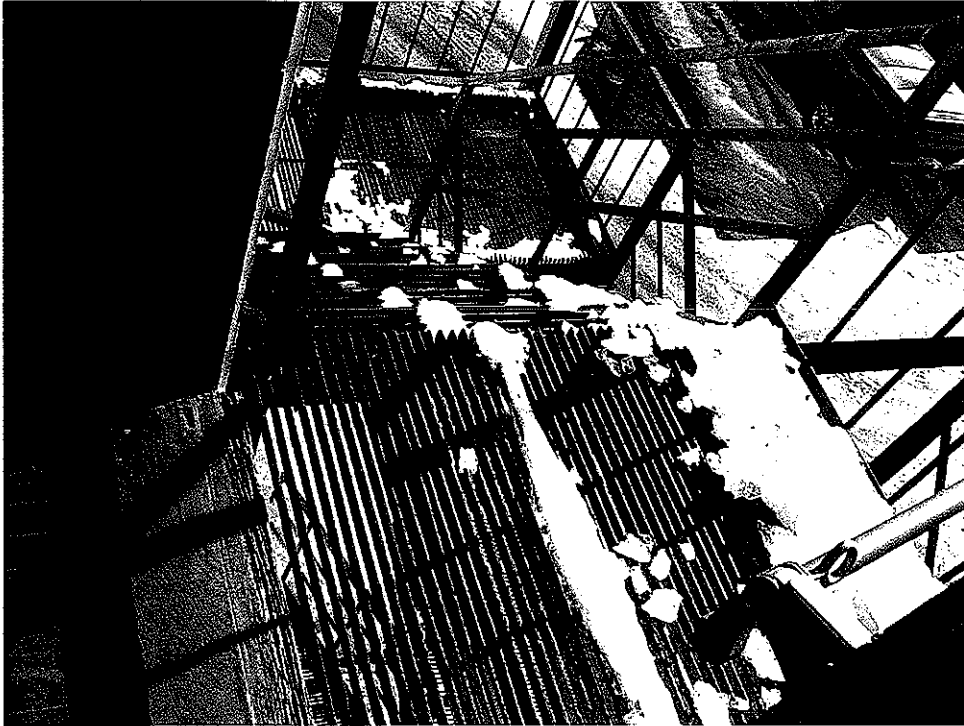
**SECOND FLOOR FIRE ESCAPE**

- Snow and Ice Falls from Roof Obstructing Exit
- Wood Will Partially Rotted

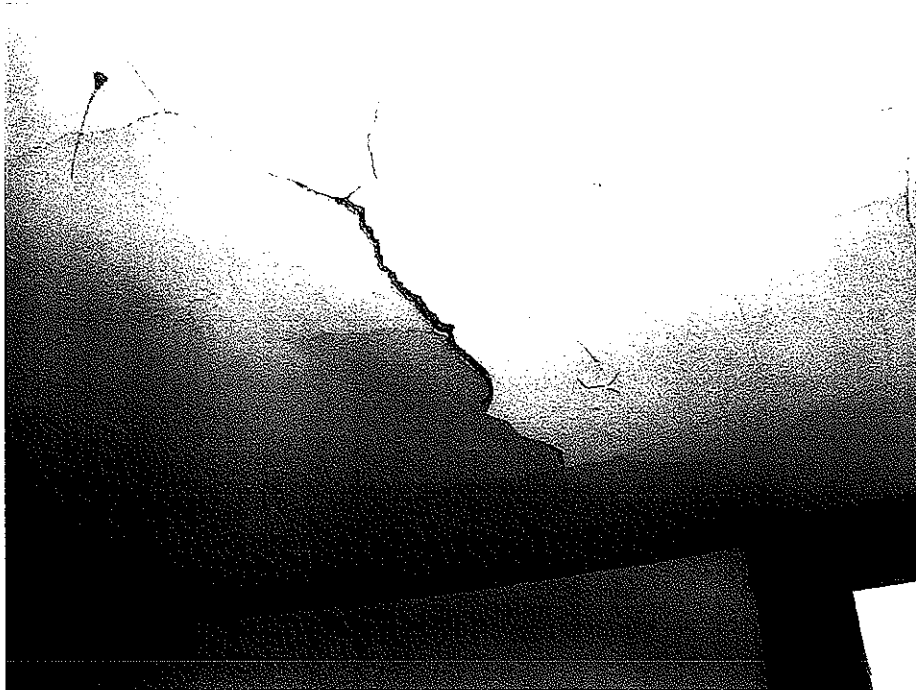
**SECOND FLOOR LOBBY CEILING**

Cracked Plaster

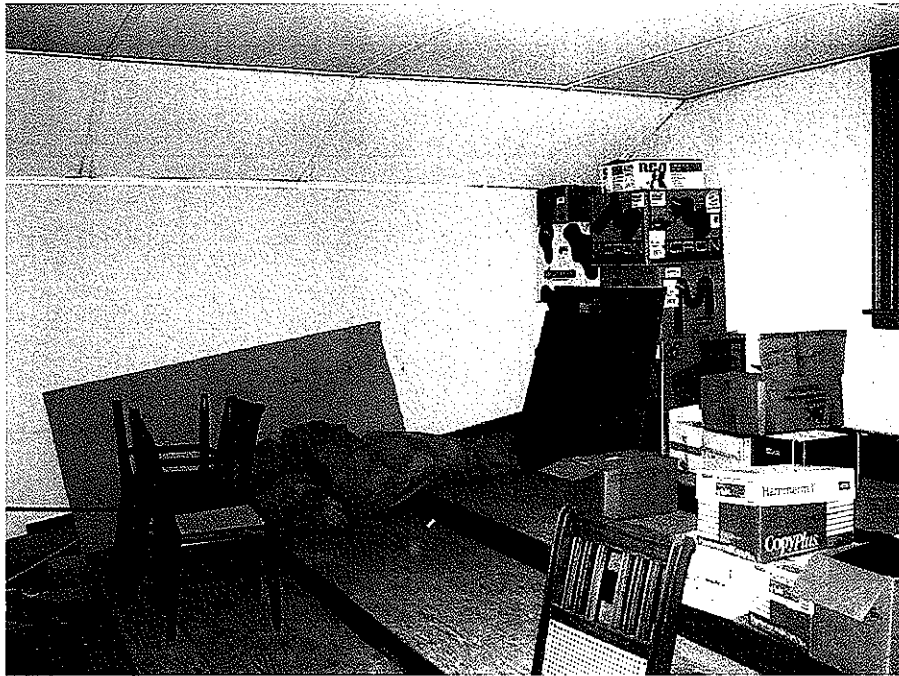
**BALCONY**

- Board and Batten Ceiling
- Original Stepped / Tiered Floor

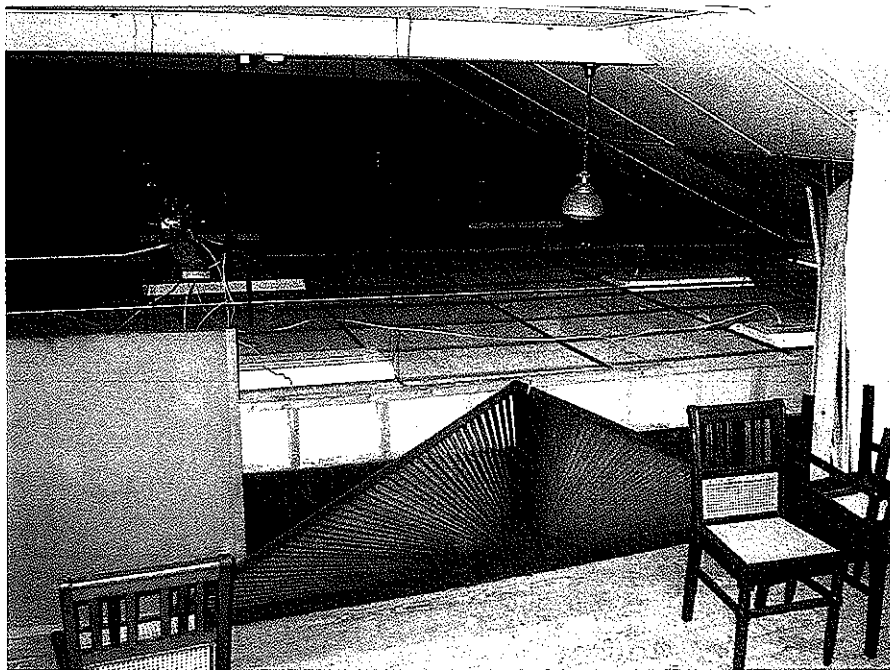
**BALCONY**

- Original Ceiling Above Suspended Ceiling
  - Original Type Light Fixtures
- Timber Truss Tie Rod and Cable Repairs

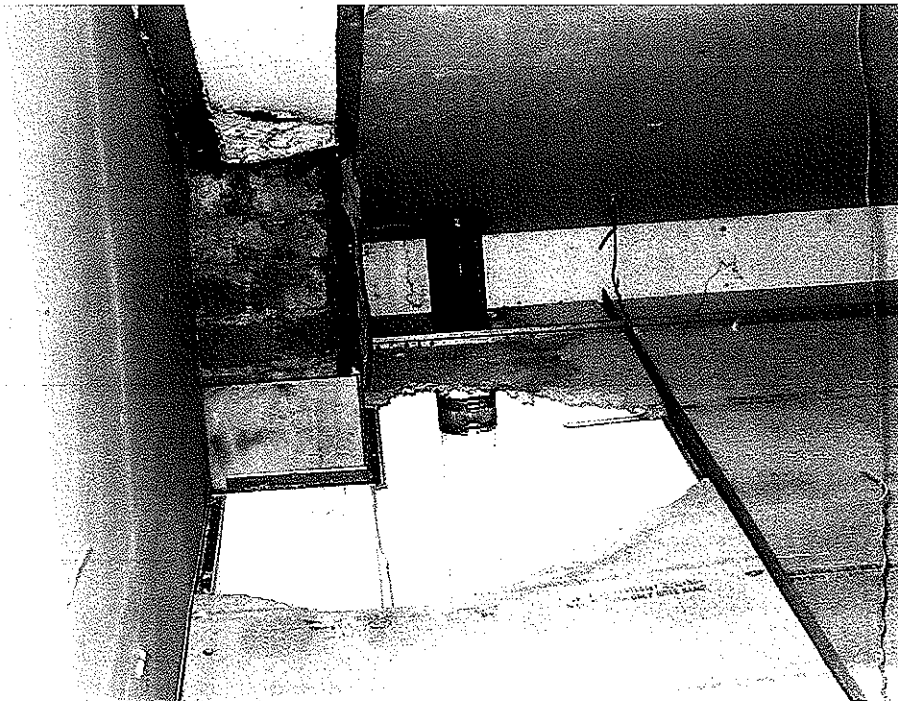
**BALCONY**

- Previous Roof Leak / Damage Near Chimney
