INTERIM REPORT
HORIZONTAL TIE REPLACEMENT
STERLING TOWN HALL
STERLING, MASSACHUSETTS

Harvey & Tracy Associates, Inc.
143 Dewey Street
Worcester, MA 01610

August 1987

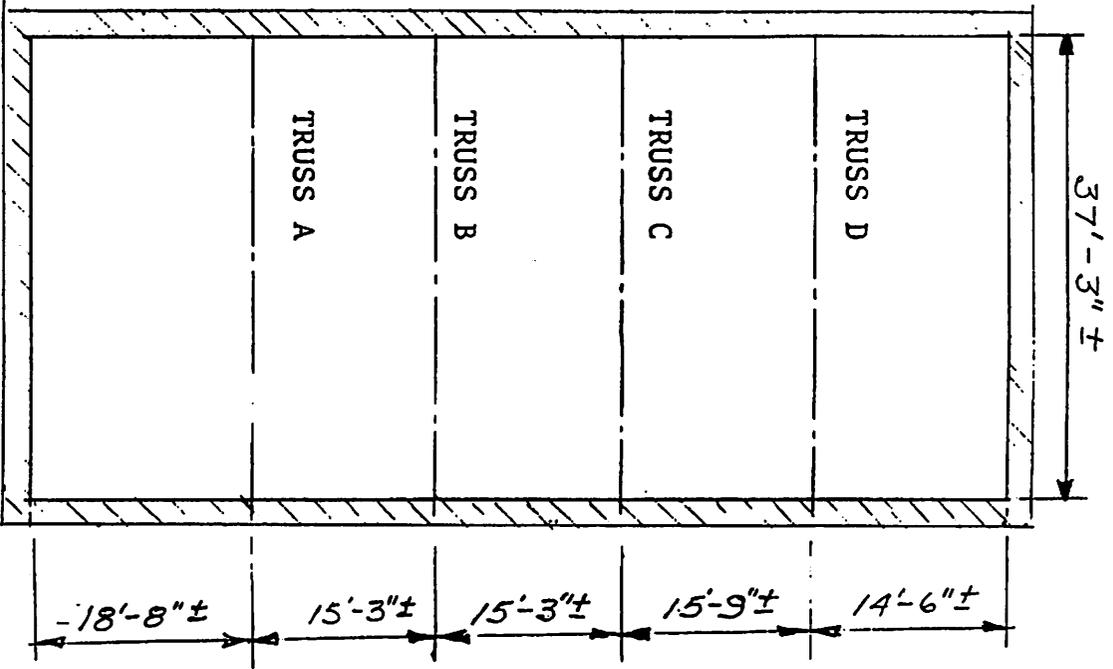
TRUSS LAYOUT PLAN

Several months ago a failure occurred in one of the ties (A)* in the original building. When the failure occurred the eave line on the two opposite sides of the building spread somewhat at this location. Although the only information concerning the failure as related to this office is verbal, it appears that the failure occurred in the connection of the yoke device to the rod at one of the two ends.

The yoke type devices at the end of the ties (A and B)* in the original part of the building had undergone some distortion as might be expected as their configuration introduced forces and stresses that were not designed for. This distortion in turn caused distress in the wood members to which they are attached.

There does not appear to be any distress in the remaining tie (D)* in the building addition. A visual review in the attic (limited because of low head room) indicated that there were cracks in some of the wood framing components of the roof.

The pieces of the original tie rod assemblies (A and B)* which had failed were discarded when the replacement ties were installed. Therefore, it is impossible to determine precisely what the mode of failure was. Because the two failures occurred at different times it is also impossible to ascertain what type of loading the building may have been subjected to at the time those failures did take place.

The replacement tie rod assemblies installed to date (A, B, and C)* do not appear to be structurally adequate for code mandated loads and in the case of ties A and B particularly because these incorporate the yoke devices described previously.

The one remaining tie rod assembly (D)* in the building addition does not at this time evidence any visible signs of distress.

New tie rod assemblies should be designed and installed to replace all of the existing tie assemblies including the ones recently installed.
