Review Draft 2.29.12
Rehabilitation Study
Old Town Hall
Sterling, Massachusetts

TABLE OF CONTENTS:**ACKNOWLEDGMENTS****EXECUTIVE SUMMARY****METHODOLOGY****PART 1: BUILDING HISTORY & SIGNIFICANCE**

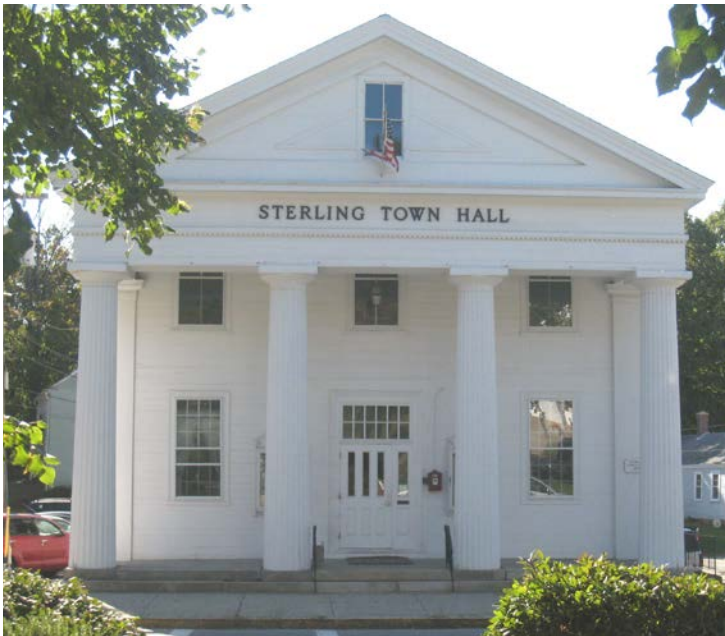
Facade (north elevation).

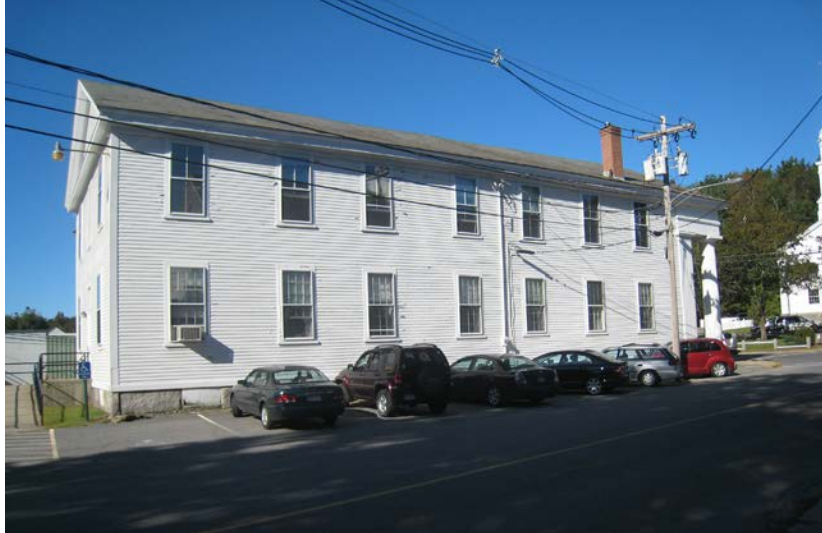
At the west elevation, two windows were replaced with egress doors at both levels where a fire escape was installed. The foundation on this side of the building is faced with brick. Note the increased building height gained due to the sloping site.

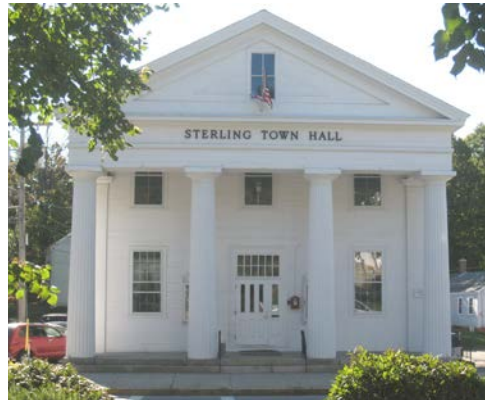
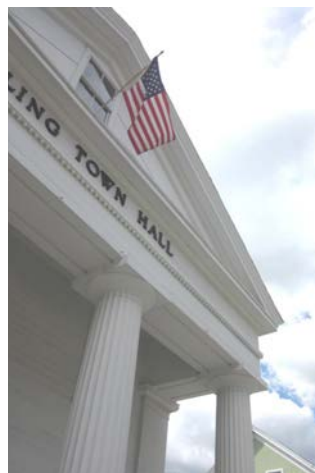
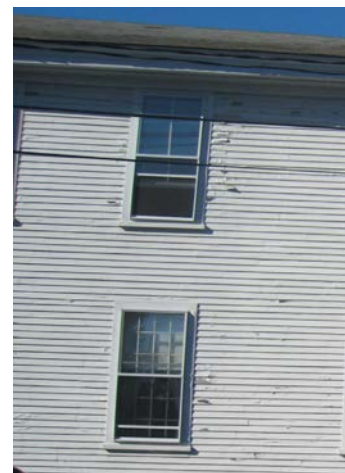
Top: Entrance portico with columns supporting an entablature.
Left: Lettering at the frieze. Right: 12 over 12 sash at first level, 2 over 2 sash at second level.

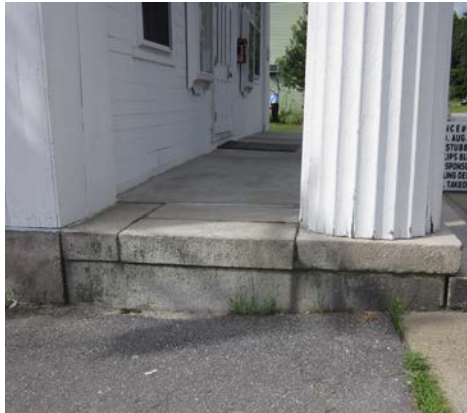
**Decorative & Stylistic Details:
Interior**

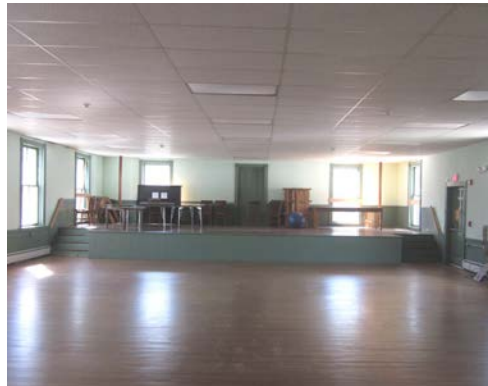
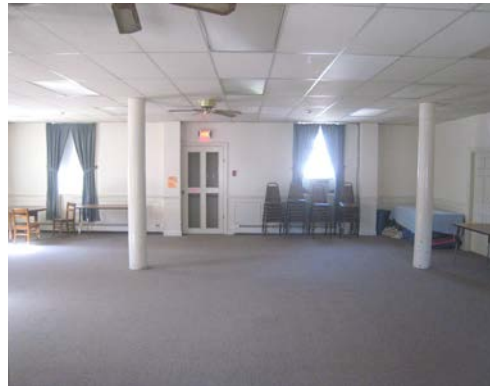
Above left: Stage, beadboard wainscot in second floor assembly hall.
Above right: Wood columns and paneled wainscot in first floor recreation room.
Lower right: Greek Revival door casing with characteristic channels and round corner medallions on the second floor. Note: modern wood trim has replaced original door casings on the first floor.

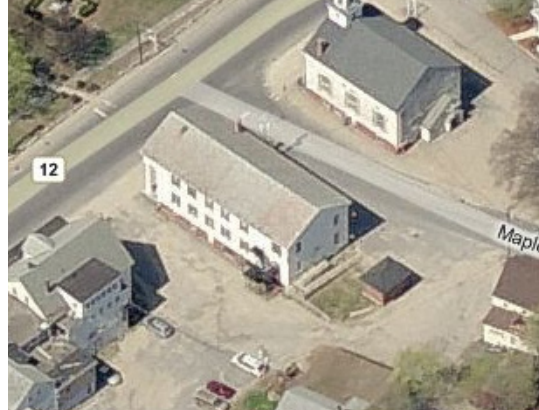
Aerial view of site from south west. (Image from Bing.com)

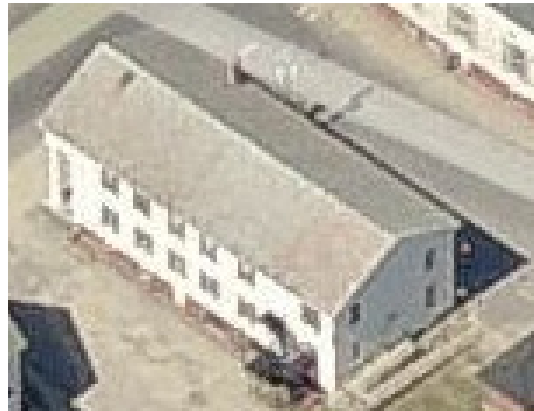
Aerial view of roof from south west. (Image from Bing.com)

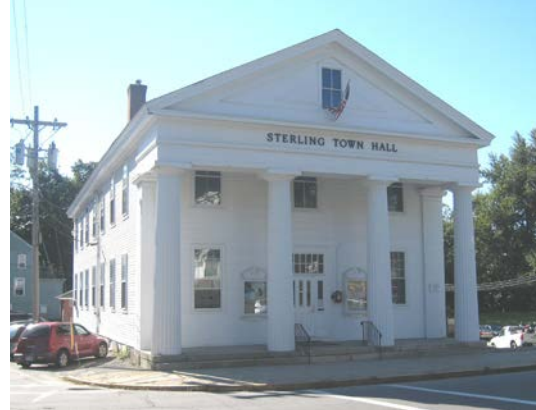
The facade (north elevation).

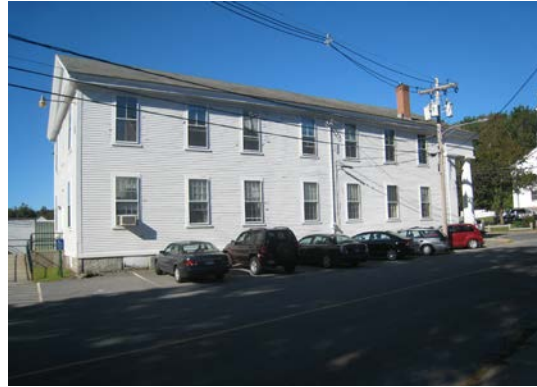
- Spot repair and repaint wood clapboards. Repaint the entire elevation on a cyclical schedule.
- Repair, reglaze and repaint all windows on the first and second levels.
- **Restore the basement windows?**
- Repoint the granite foundation.

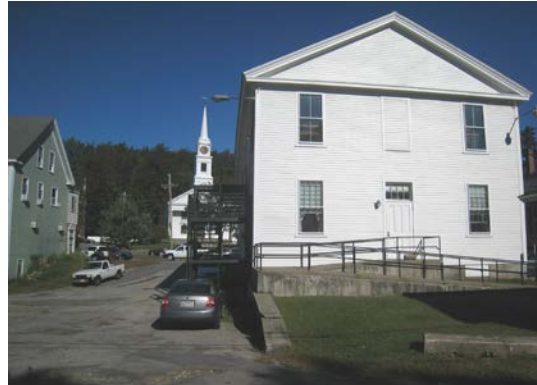
- Repaint the entire elevation on a cyclical schedule.
- Repair, reglaze and repaint all windows on the first and second levels.
- Restore the basement windows?
- The proposed schematic design calls for the concrete ramp to be removed. If it remains, it should be repaired and the railings refinished.

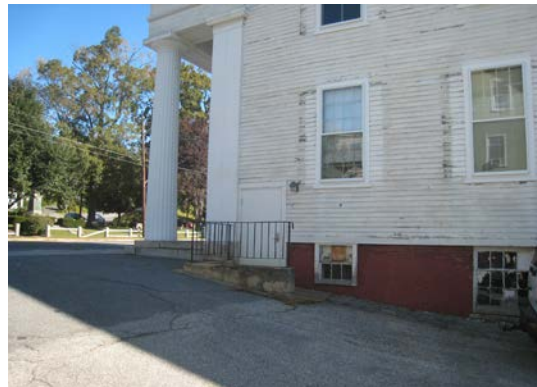
Cracked and stained concrete entry platform at the northwest corner. Painted masonry foundation with failed mortar joints and peeling paint.

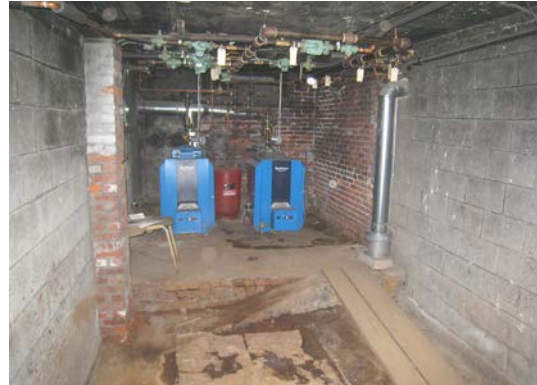
New boilers installed in the basement. Areas of moisture seen on the floor.

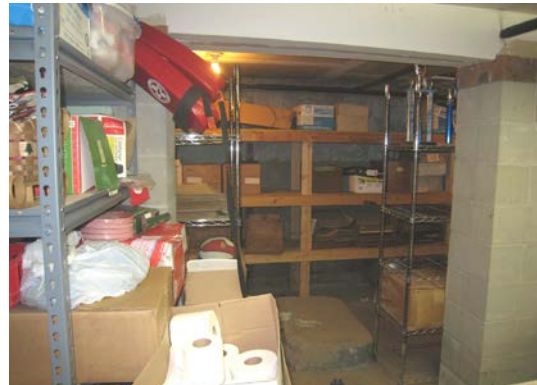
Supply storage in the basement.

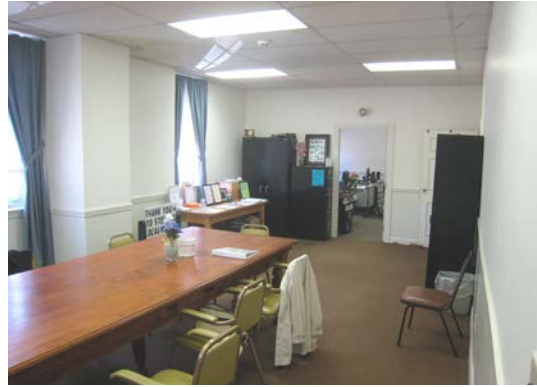
- Sister the joists as required with new framing.
- Remove dropped ceiling.
- Restore original staircase configuration and finishes.
- Replace restrooms with new, code complaint accessible facilities

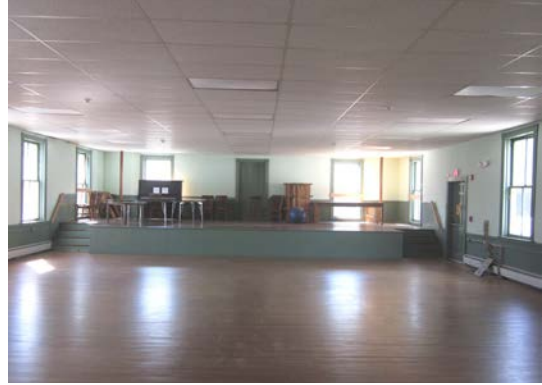
Dropped ceiling detracts from the aesthetics of the assembly room.

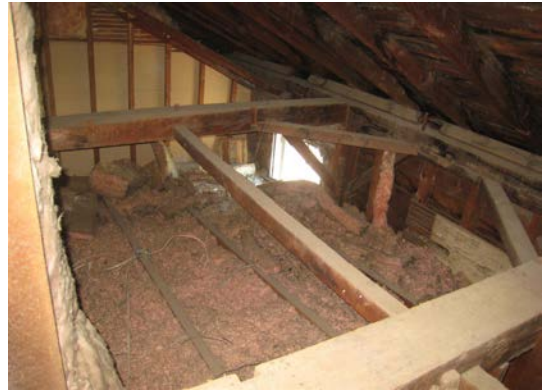
Attic and roof framing over the assembly room.

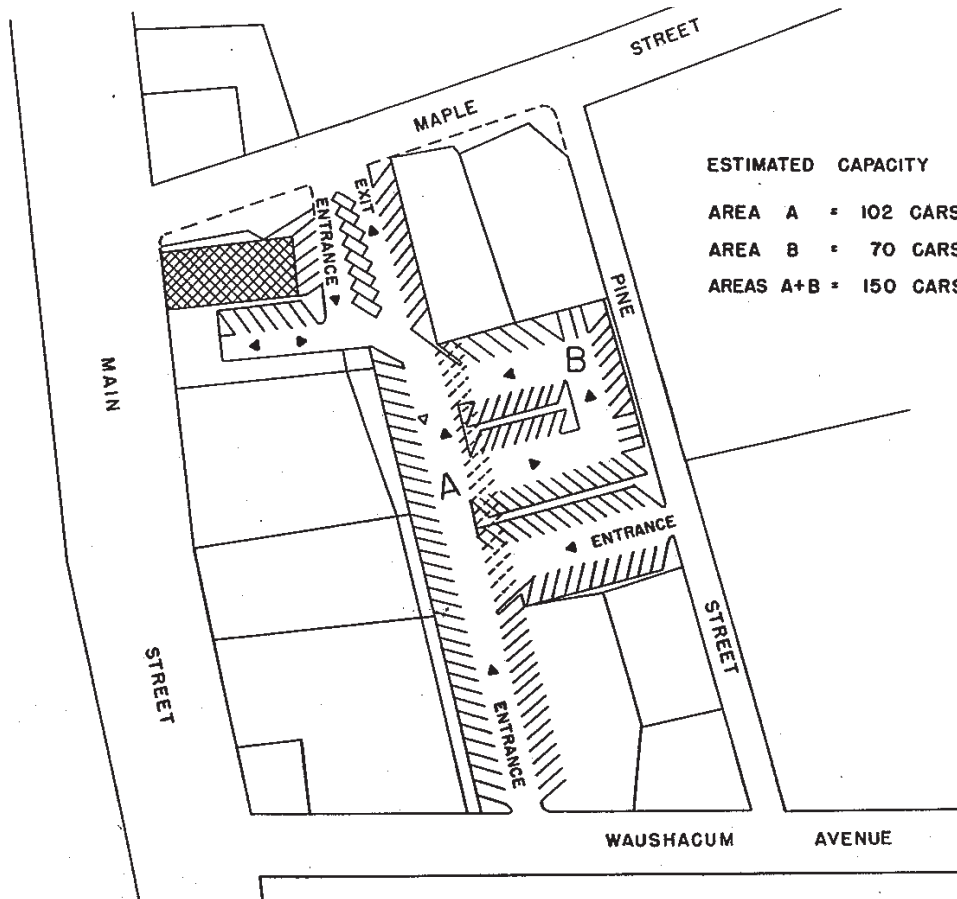
Municipal parking lot plan from 1962 Town of Sterling Master Plan.

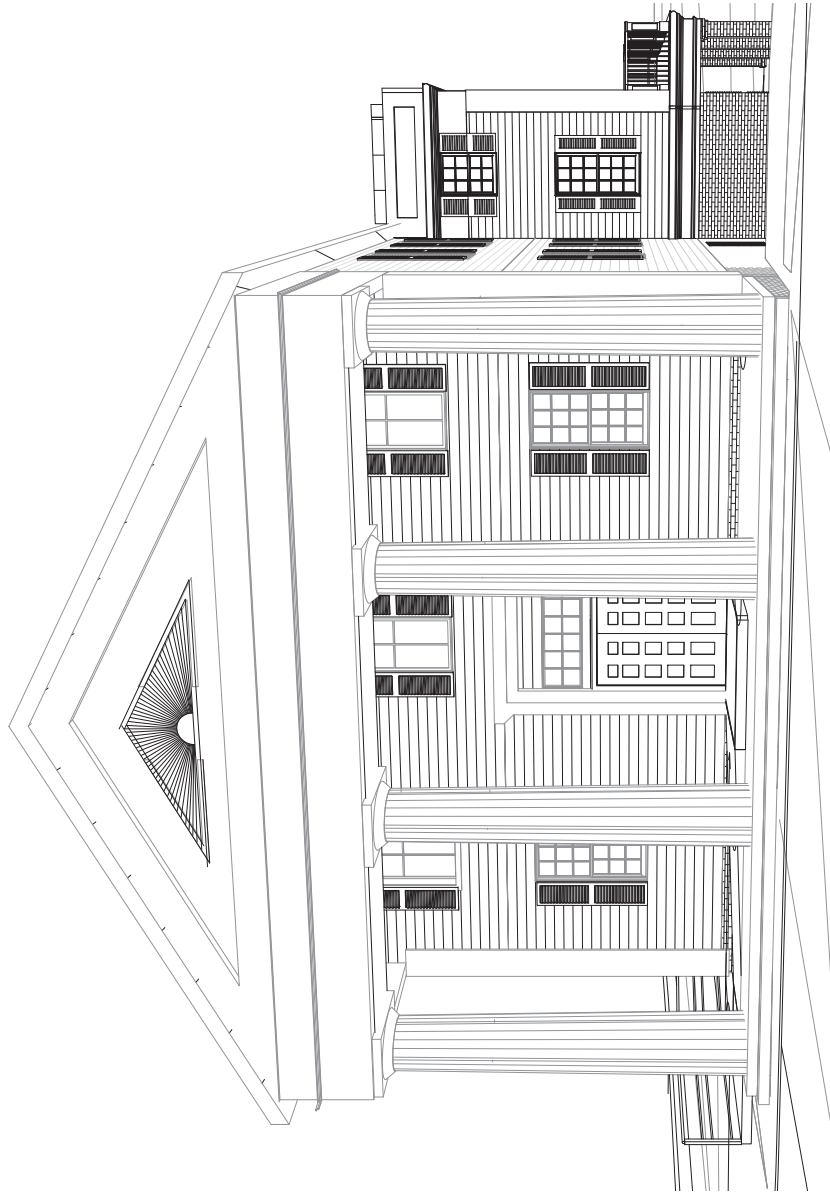
SCHEMATIC DRAWINGS & SPECIFICATIONS

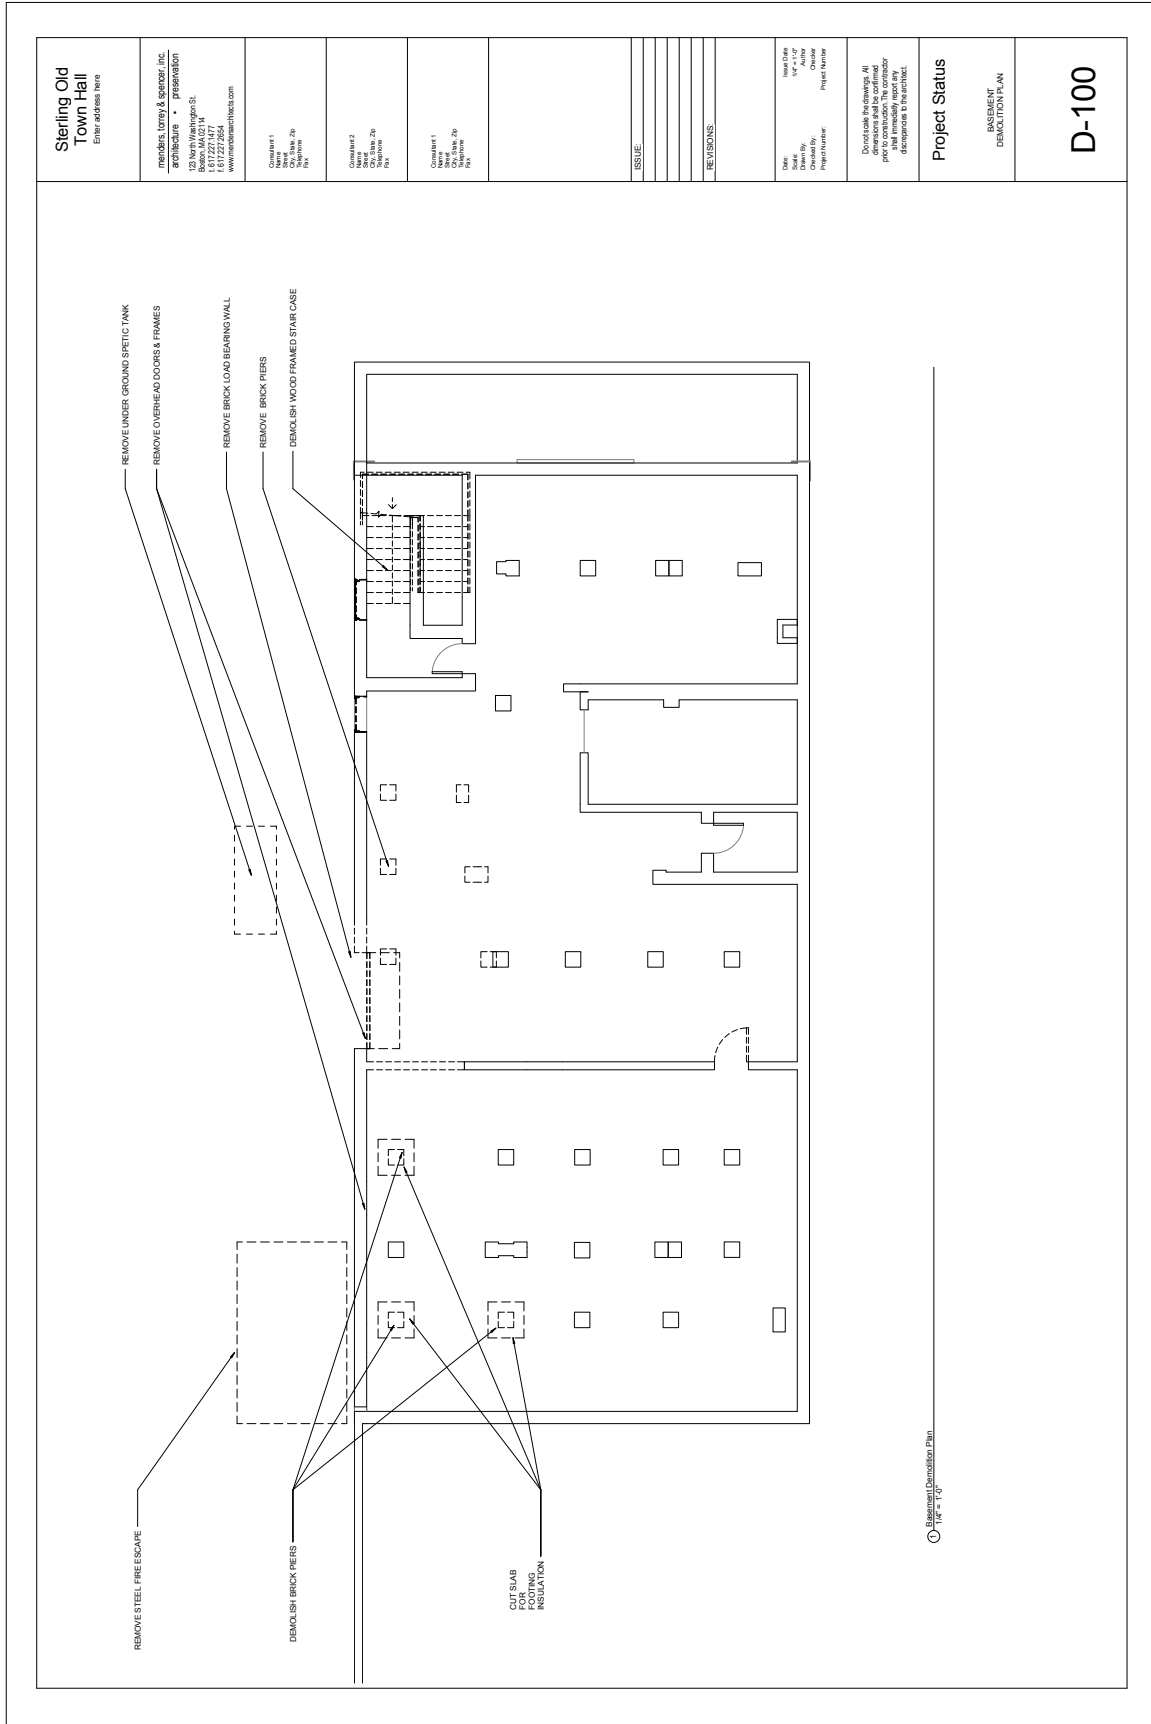
Sterling Old Town Hall Enter address here	
menders, torrey & spencer, inc. architecture + preservation 123 North Washington St. Boston MA 02114 617.227.2624 www.mtsarchitects.com	
Consultant 1 Name: _____ Title: _____ Signature: _____ Date: _____	Consultant 2 Name: _____ Title: _____ Signature: _____ Date: _____
Consultant 1 Name: _____ Title: _____ Signature: _____ Date: _____	Consultant 2 Name: _____ Title: _____ Signature: _____ Date: _____
ISSUE: _____	
REVISIONS: _____	
Date: _____ Scale: 1/4" = 1'-0" Checked By: _____ Project Number: _____	Issue Date: _____ Scale: 1/4" = 1'-0" Checked By: _____ Project Number: _____
Do not scale the drawings. All dimensions shall be confirmed from the field. The contractor shall immediately report any discrepancies to the architect.	
Project Status BASEMENT DEMOLITION PLAN	
D-100

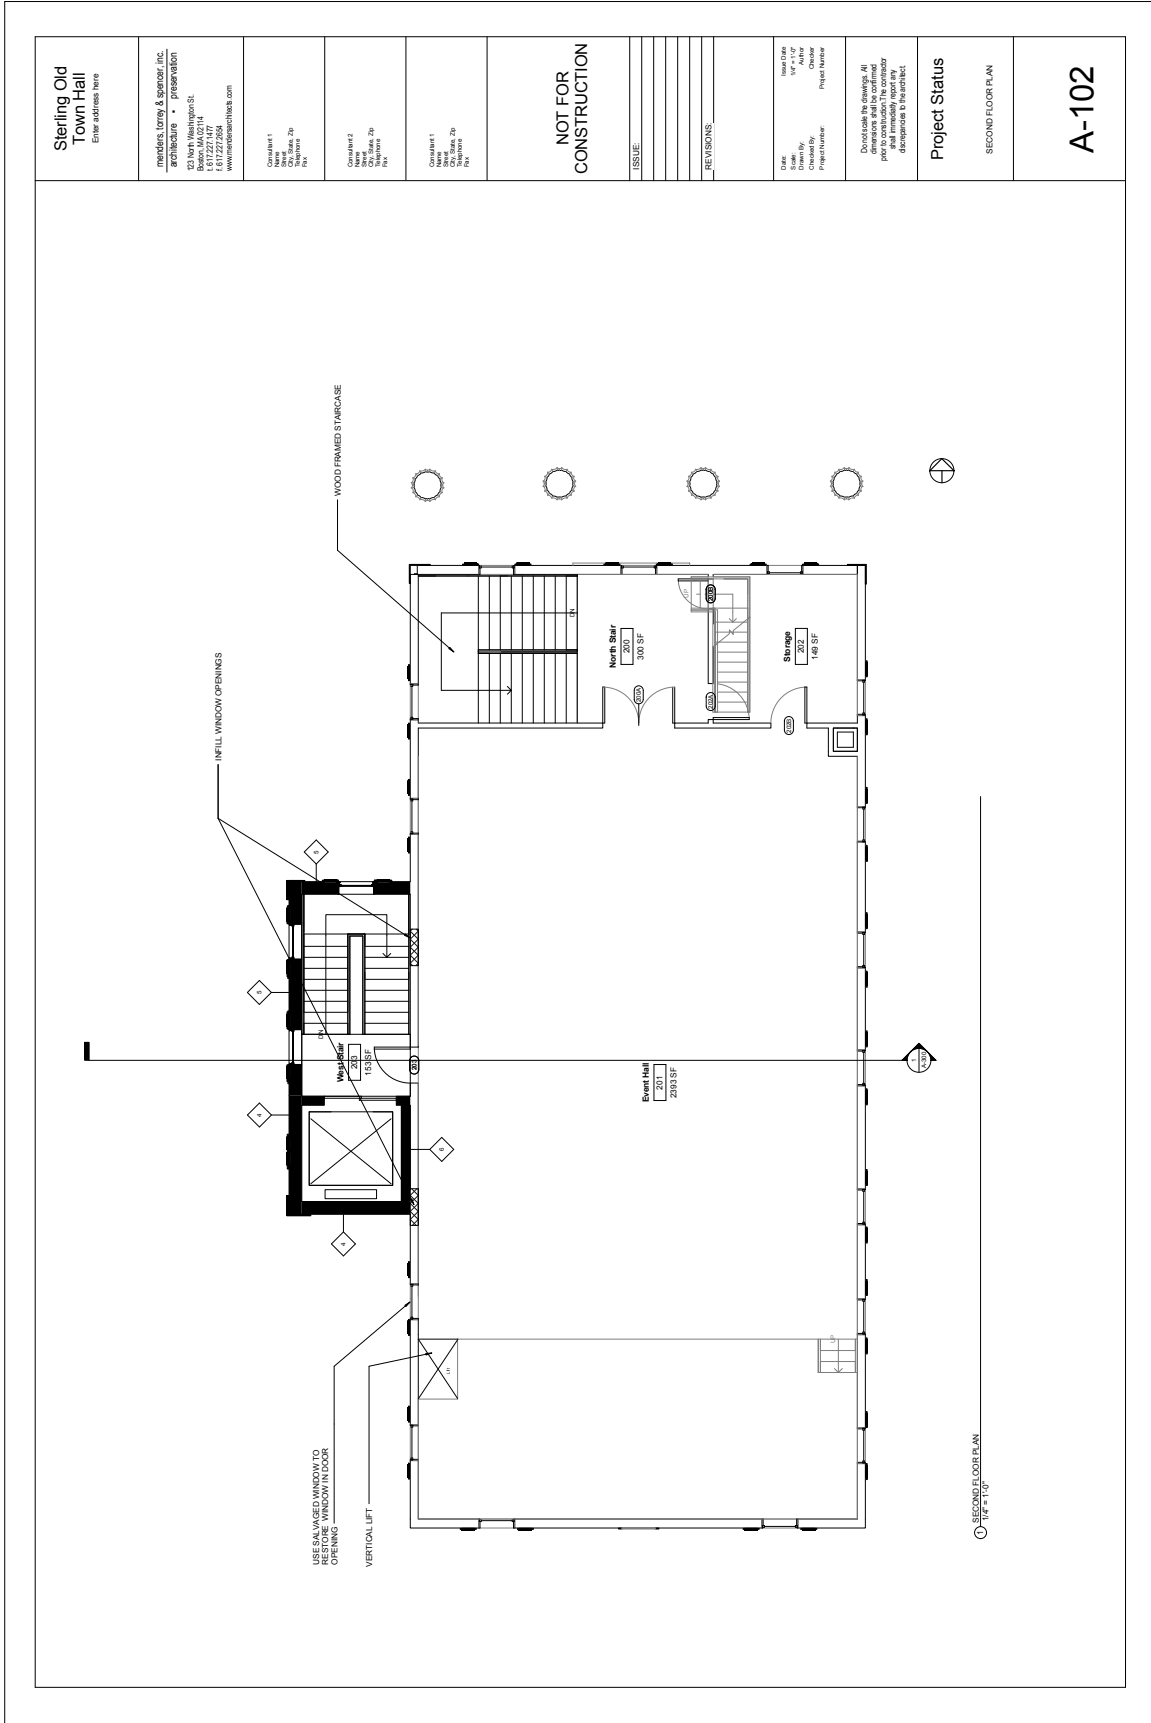
<p>Sterling Old Town Hall Enter address here</p>	<p>menders, torrey & spencer, inc. architecture • preservation 23 North Washington St. Boston, MA 02114 617.227.2854 www.mtsarchitect.com</p>	<p>CONTRACT 1 Sheet No. 20 Revisions 0</p>	<p>CONTRACT 2 Sheet No. 20 Revisions 0</p>	<p>CONTRACT 1 Sheet No. 20 Revisions 0</p>	<p>NOT FOR CONSTRUCTION</p>	<p>ISSUE:</p>	<p>REVISIONS:</p>	<p>DATE: _____ Scale: 1/4" = 1'-0" Checked By: _____ Project Number: _____</p>	<p>Download the drawings. All dimensions shall be confirmed prior to construction. If any discrepancies are noted, please contact the architect immediately, report any and all discrepancies to the architect.</p>	<p>Project Status SECOND FLOOR PLAN</p>	<p>A-102</p>
---	---	--	--	--	------------------------------------	---------------	-------------------	--	---	--	---------------------

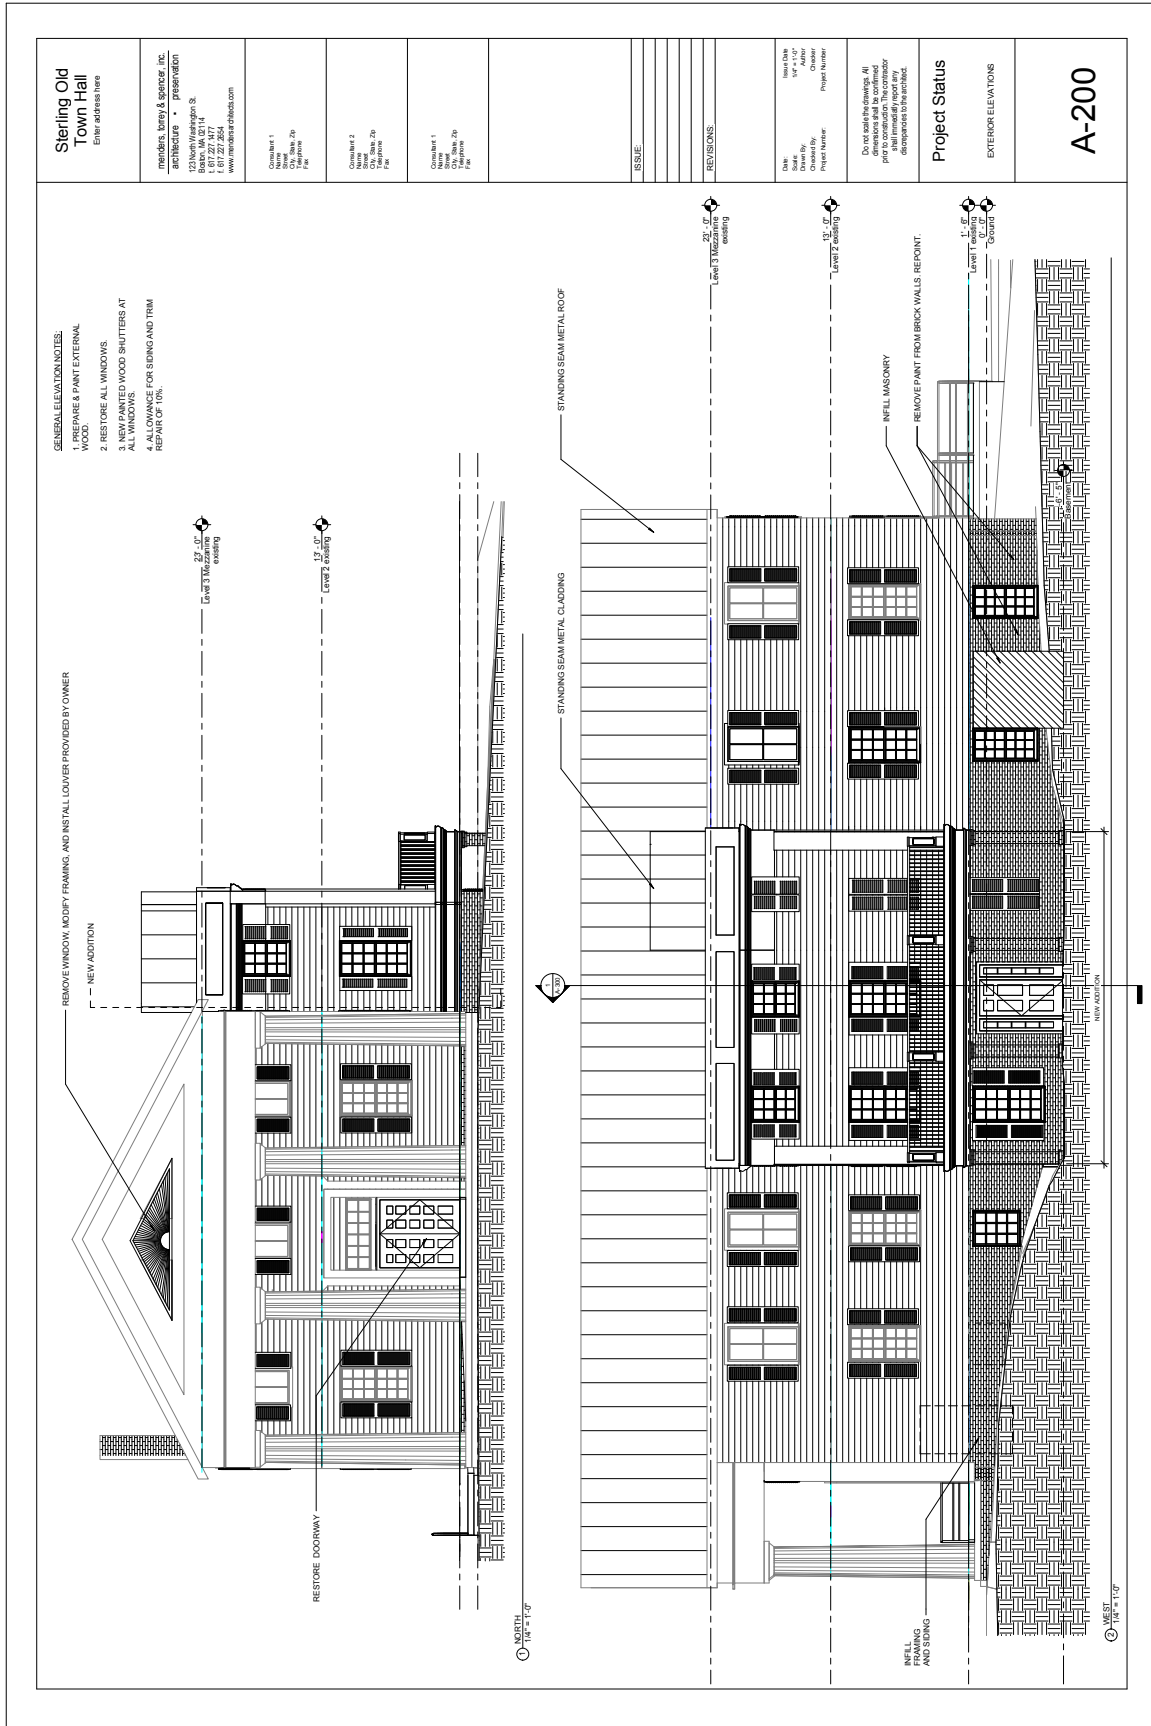
Sterling Old Town Hall Enter address here	
Menders, Torrey & Spencer, Inc. ARCHITECTS • PRESERVATION 123 North Washington St. Boston, MA 02114 T 617.227.2854 www.mtsp.com	
Consultant 1 Name Title Telephone No. Fax	Consultant 2 Name Title Telephone No. Fax
Consultant 1 Name Title Telephone No. Fax	Consultant 2 Name Title Telephone No. Fax
DATE: _____ DRAWN BY: _____ CHECKED BY: _____ PROJECT NUMBER: _____ SHEET DATE: 10/11/10 SHEET NO.: 10/11/10	
Do not scale the drawings. All dimensions shall be confirmed prior to construction. Your attention is directed to the fact that the final report may differ from the preliminary report.	
Project Status EXTERIOR ELEVATIONS	
A-200
