**FEASIBILITY STUDY FOR THE ADAPTIVE REUSE OF THE
- STERLING TOWN HALL
STERLING, MASSACHUSETTS**

FOR THE STERLING BUILDING NEEDS COMMITTEE

**Prepared by
Suzanne O. Carlson, Architect
94 Cross Point Road Edgecomb, Maine**

January 15, 1998

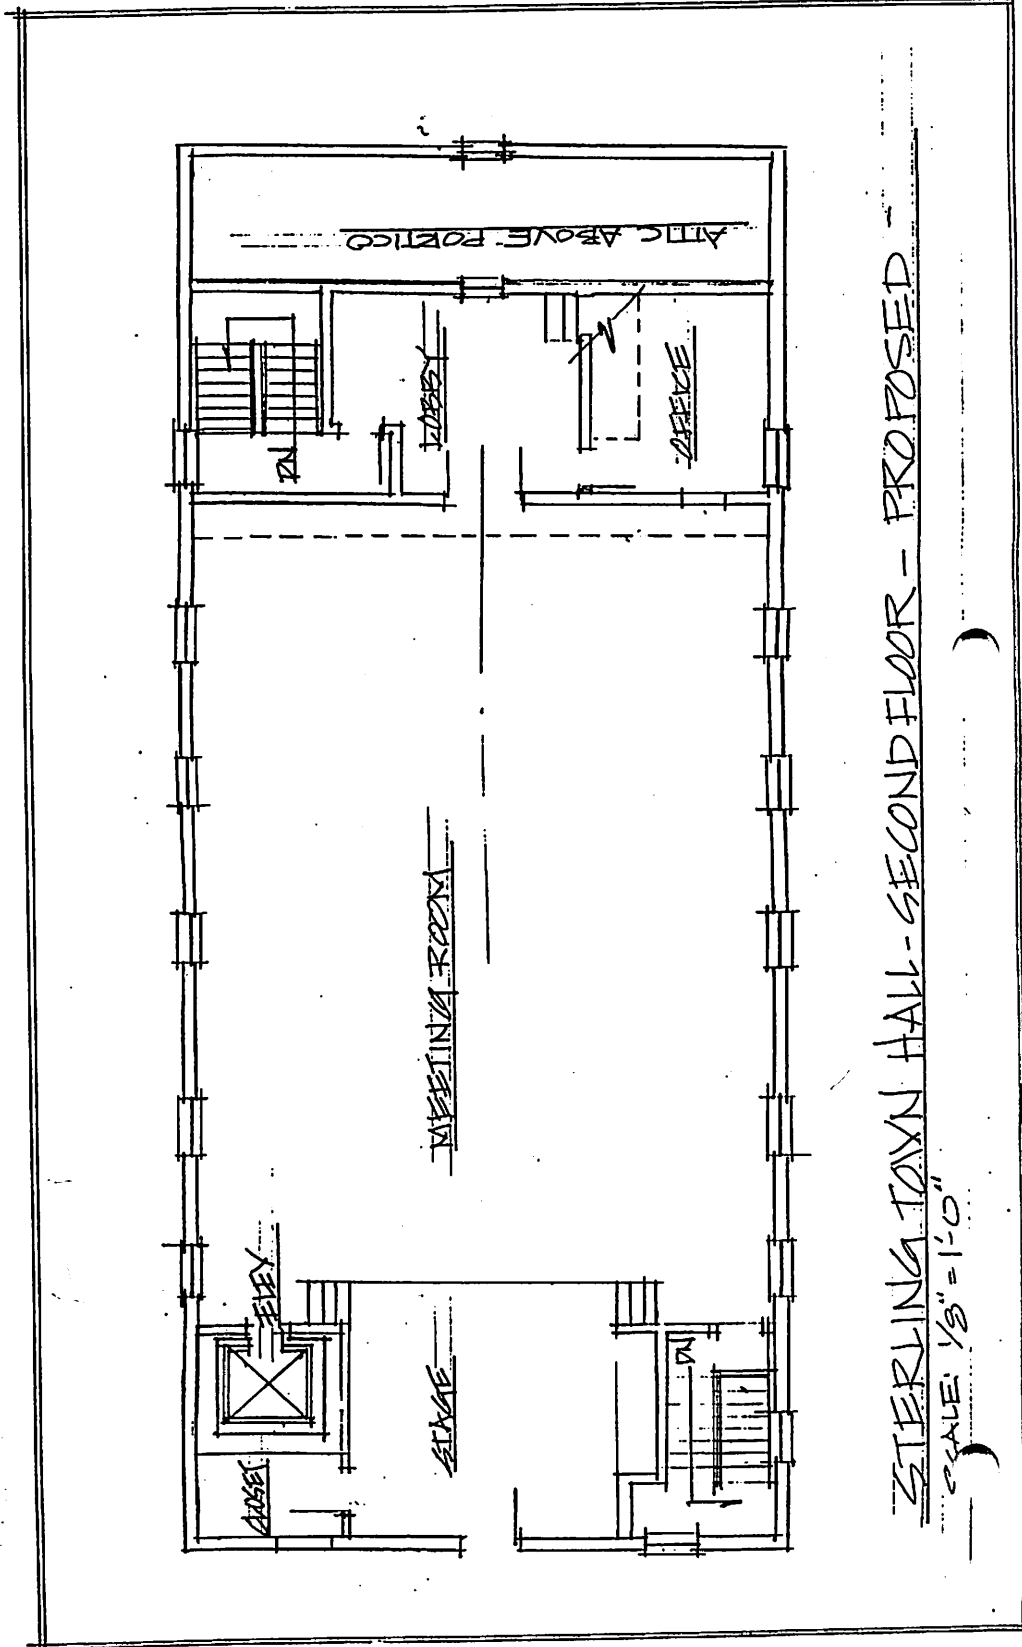
STERLING TOWN HALL - SECOND FLOOR - PROPOSED

Approx Area of 2nd
Floor where
FRAMING MODIFICATIONS
HAVE NOT BEEN MADE

Some structural reinforcement may be required at the front bay on the second floor to increase loading capacity for that section and is addressed in the structural report.

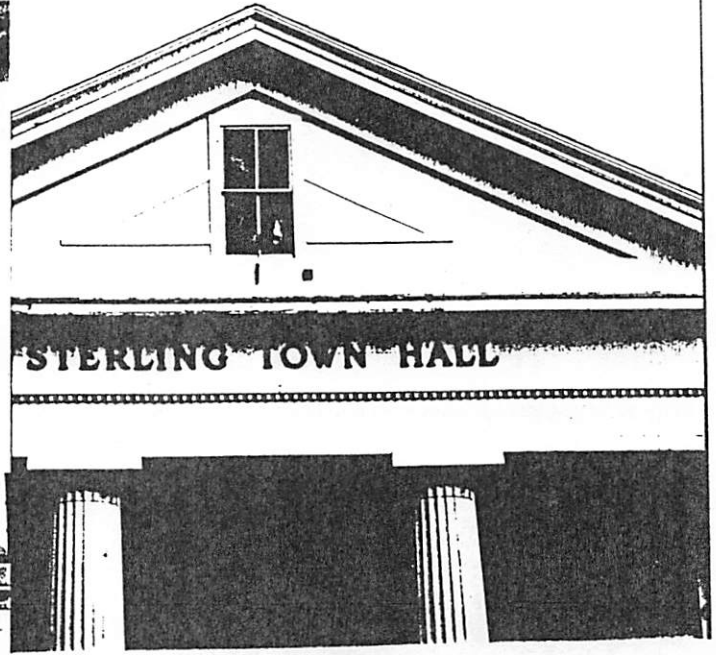
WEST ELEVATION

The large overhanging pediment appears to be structurally sound with gable and soffit woodwork in excellent condition. The four large Doric columns are in excellent condition. The venting system seems to be working well and there is no indication of deterioration in any of the elements. The boarding is also in good condition. Part of the granite platform has been replaced with concrete, but the overall effect of the granite steps and base has been retained.

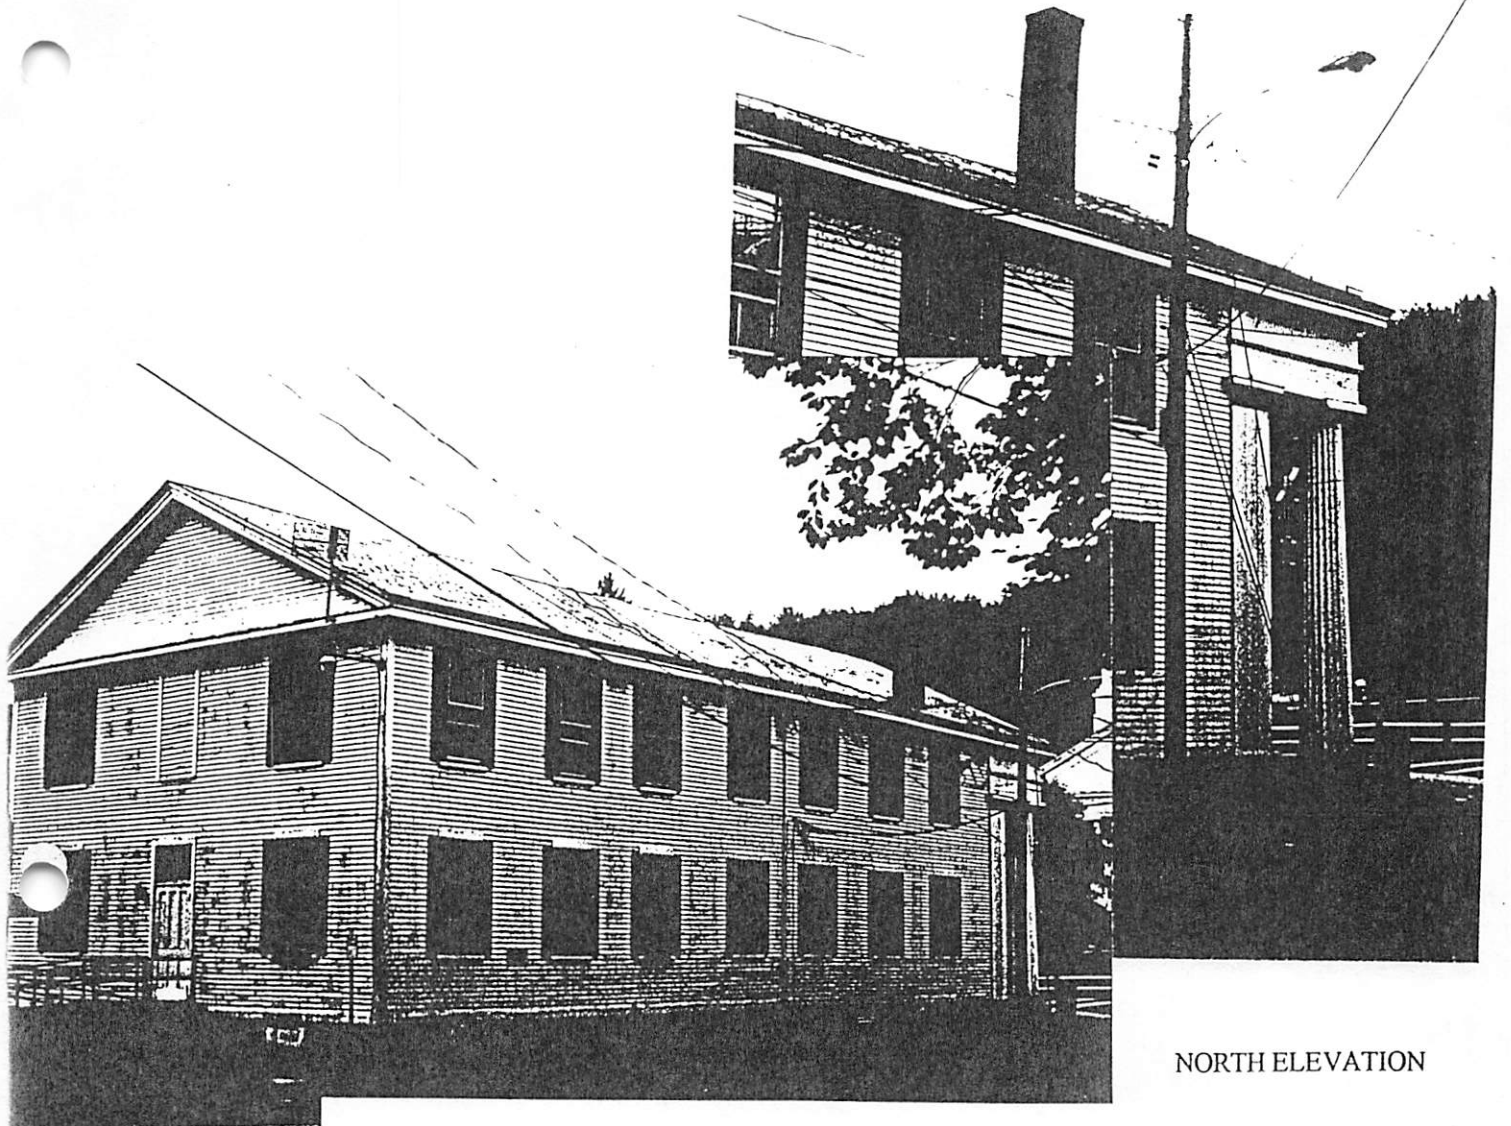
NORTH ELEVATION

The cap of the front corner pilaster is missing and there is some damage to the water table and bottom clapboards. All wood needs painting. Granite veneer at foundation is in sound condition, however louvers and window fill is in poor condition.

The slate roof appears in good condition, but the chimney is listing dangerously and should be taken down to the roofline and rebuilt as soon as possible.

The exterior also needs general maintenance; preparation and painting, repair or replacement of windows. Replacement windows would be costly and would be required to meet the Secretary of the Interiors Standards for Historic Preservation. This decision could wait until it is possible to analyze usage and heat loss versus pay back period for the cost of insulated historically appropriate windows. The chimney, however need immediate attention, and should be taken down to the roof and rebuilt.

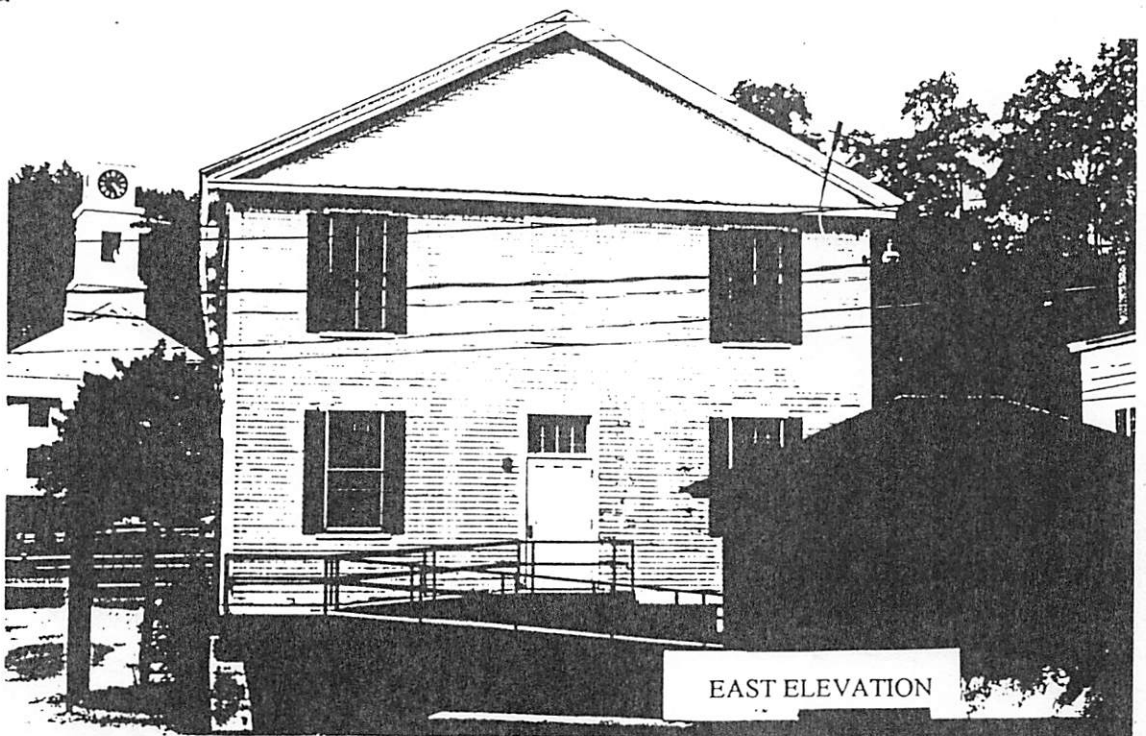
EAST ELEVATION

A poured concrete handicapped ramp with a steel pipe rail leads to the rear door. Paint is deteriorated and badly in need of paint. Overhead electric service feeds from a pole in the back to the north wall and thence to an outside meter on the north wall.

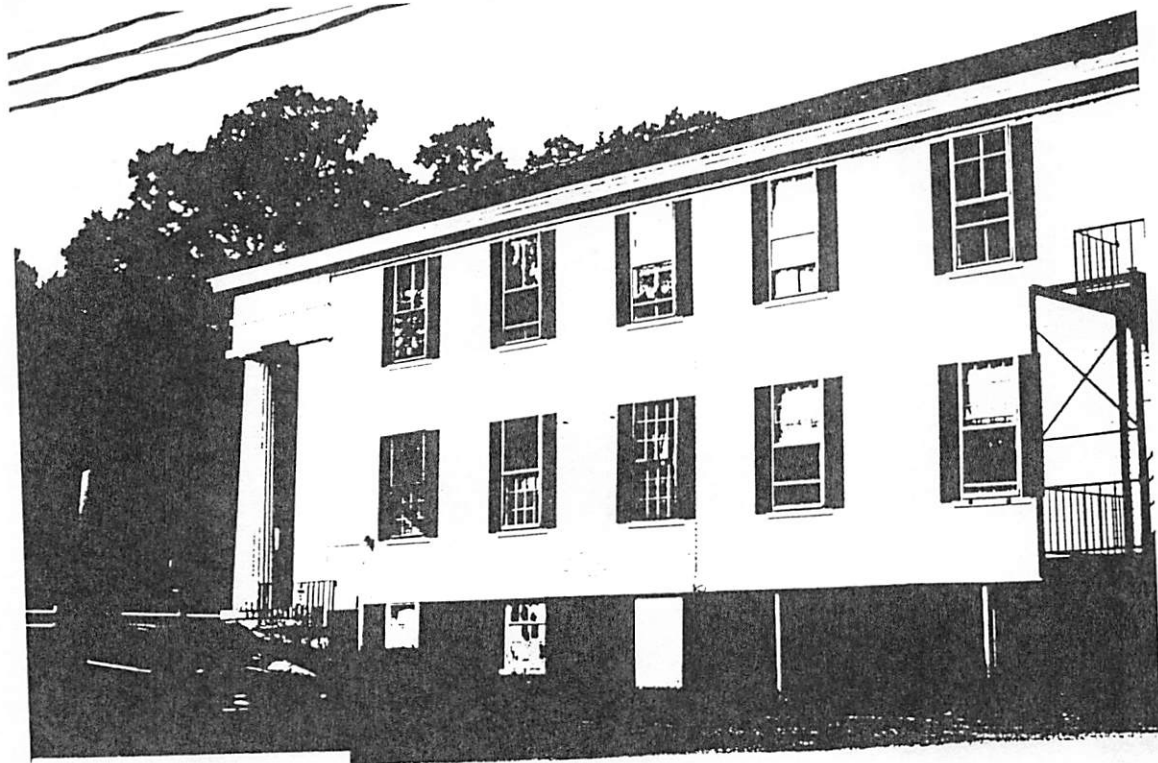
SOUTH ELEVATION

The symmetry of the side wall fenestration is broken by a door and steel fire escape leading from the second floor to grade at basement level. Brick basement wall is in bad condition and needs repair. Windows and doors at basement are in poor condition. The railing design at west end door is not appropriate to the period. All wood needs painting.
