August 2, 2011  
File No. 5506

**Re: Preliminary Asbestos Inspection Report &  
Lead Based Paint Survey  
Old Town Hall  
31 Main Street  
Sterling, MA**

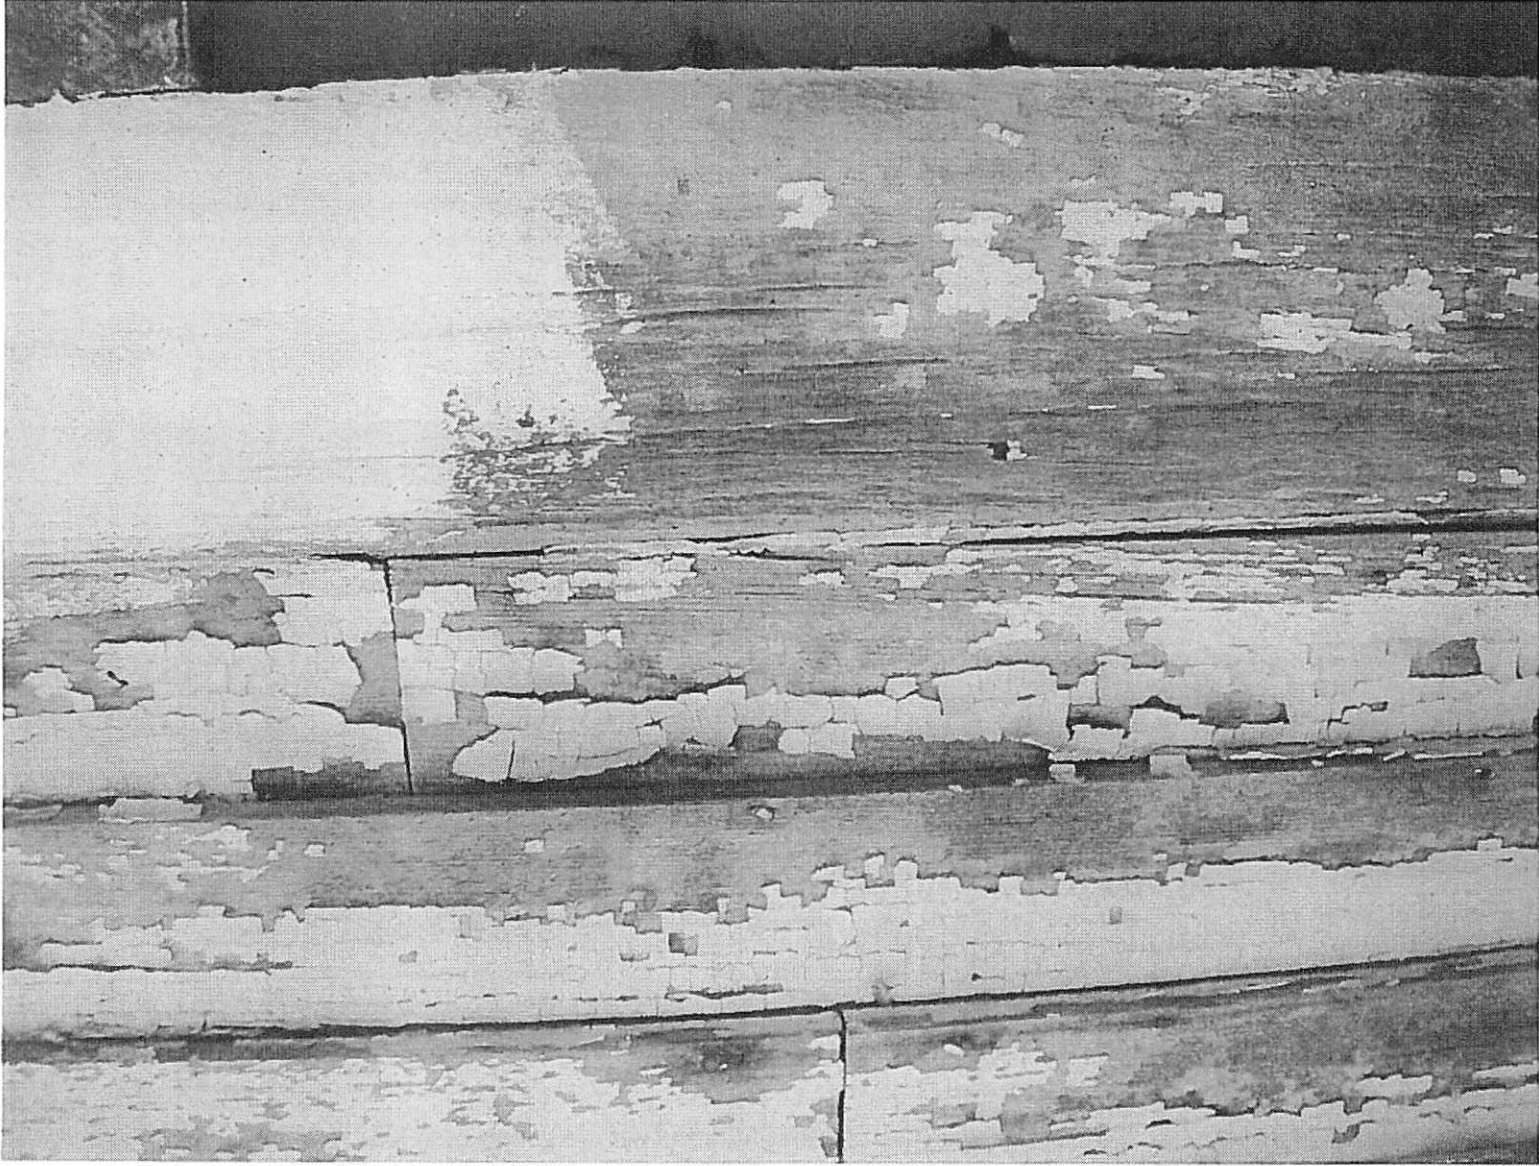
## Photographic Log - Sample LBB-2.

- Sample LBP-2 obtained from the white siding paint on the southern exterior side of the building contained 32.82 milligrams per kilogram (mg/kg) of lead. [Please note that mg/kg can also be expressed in parts per million (ppm)]
- Sample LBP-3 obtained from the red paint adhered to the exterior brick foundation contained lead at a concentration of 0.92 mg/kg.
- Sample LBP-4 obtained from the back paint on the exterior wood garage type doors contained lead at a concentration of 0.03 mg/kg.
- Sample LBP-5 obtained from the green wall paint on the third floor balcony contained 1.29 mg/kg of lead.
- Sample LBP-6 obtained from the white paint on fiber board on the third floor balcony contained lead at a concentration of 0.27 mg/kg.
- Sample LBP-7 obtained from the dark green trim on the chair rail on the second floor auditorium contained lead at a concentration of 0.21 mg/kg.

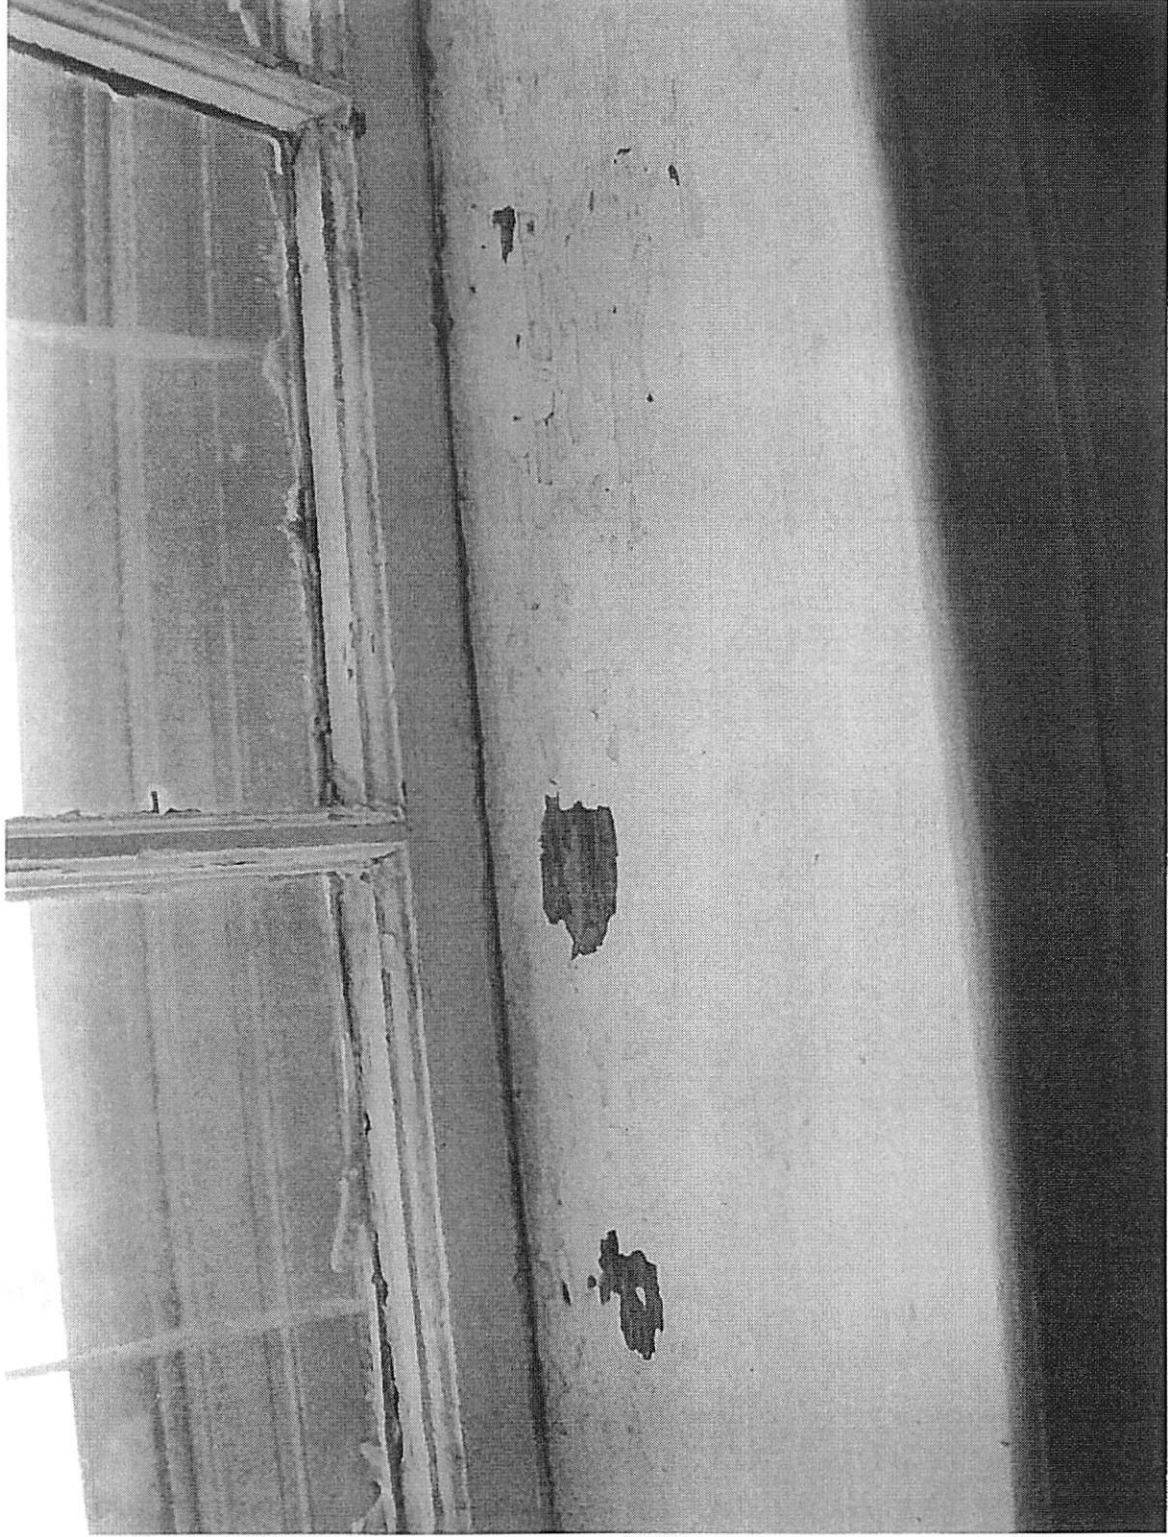
**Photographic Log – Sample LBP-9.**

- Sample LBP-9 obtained from the white paint on the window sill in the first floor function room (Room 3) contained lead at a concentration of 0.30 mg/kg.

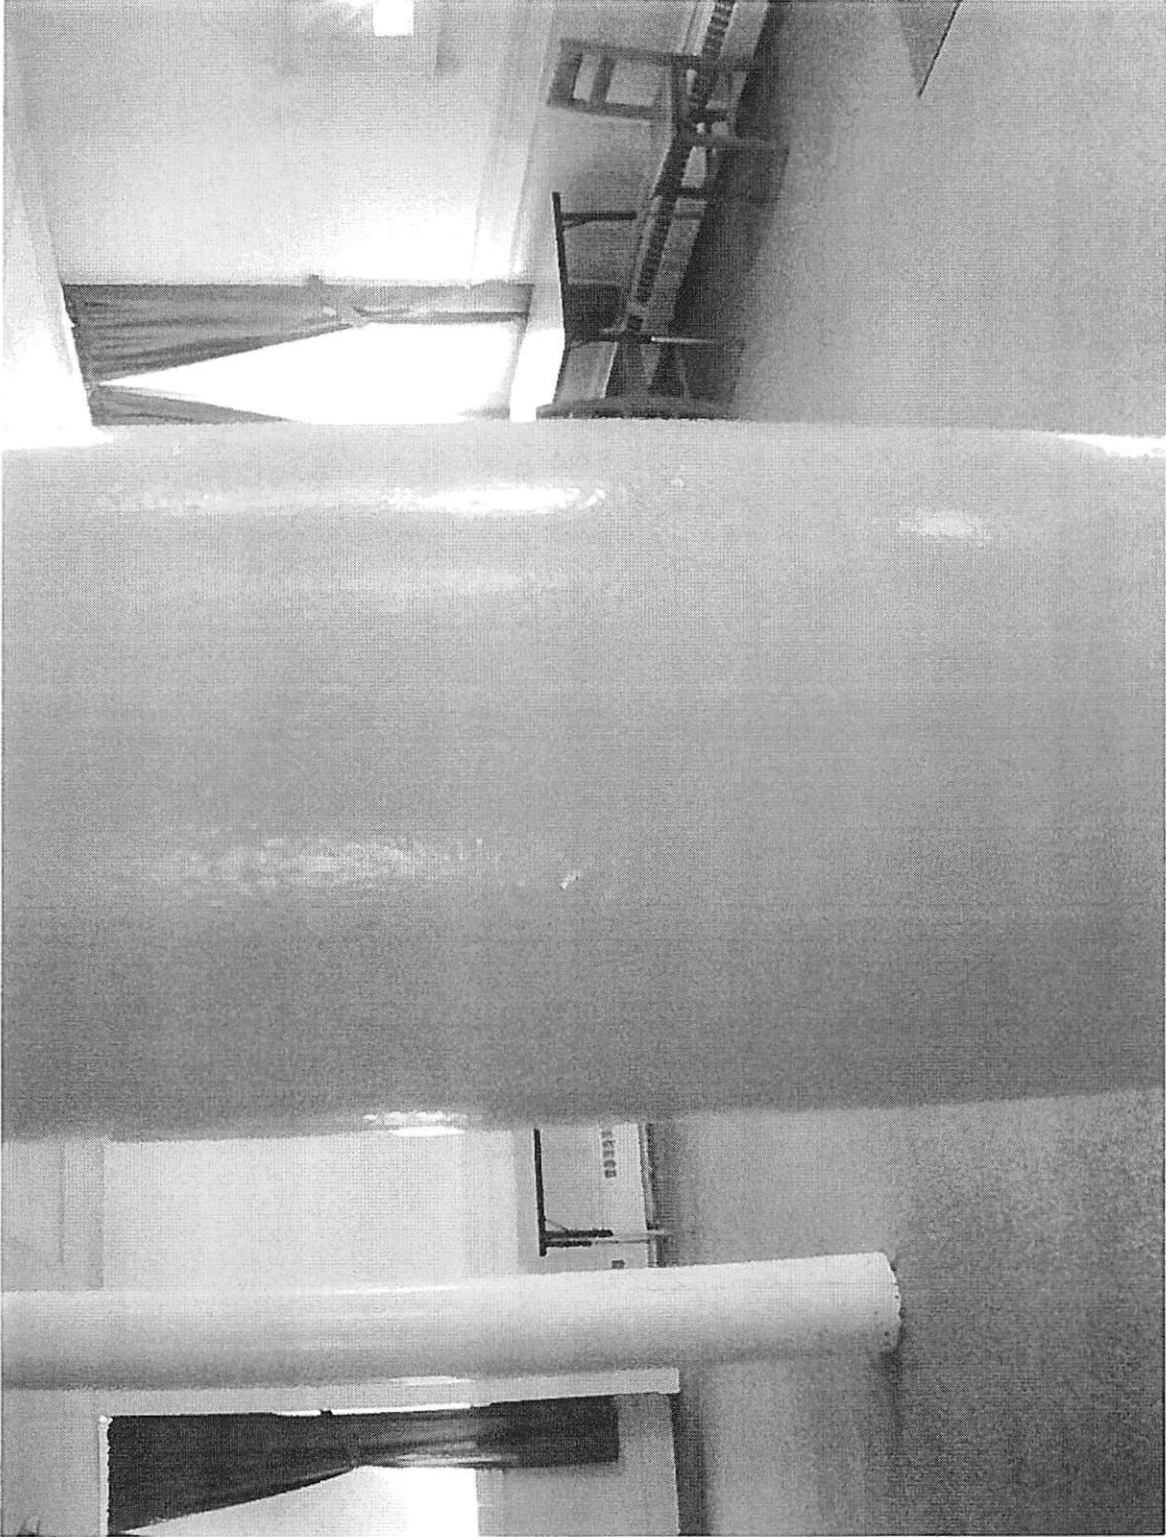
**Photographic Log – Sample LBP-12.**

- Sample LBP-12 obtained from the white paint on the column in the first floor function room (Room 3) contained lead at a concentration of 0.05 mg/kg.
- Sample LBP-13 obtained from within several trash bags stored within the basement contained lead at a concentration of 2.41 mg/kg.

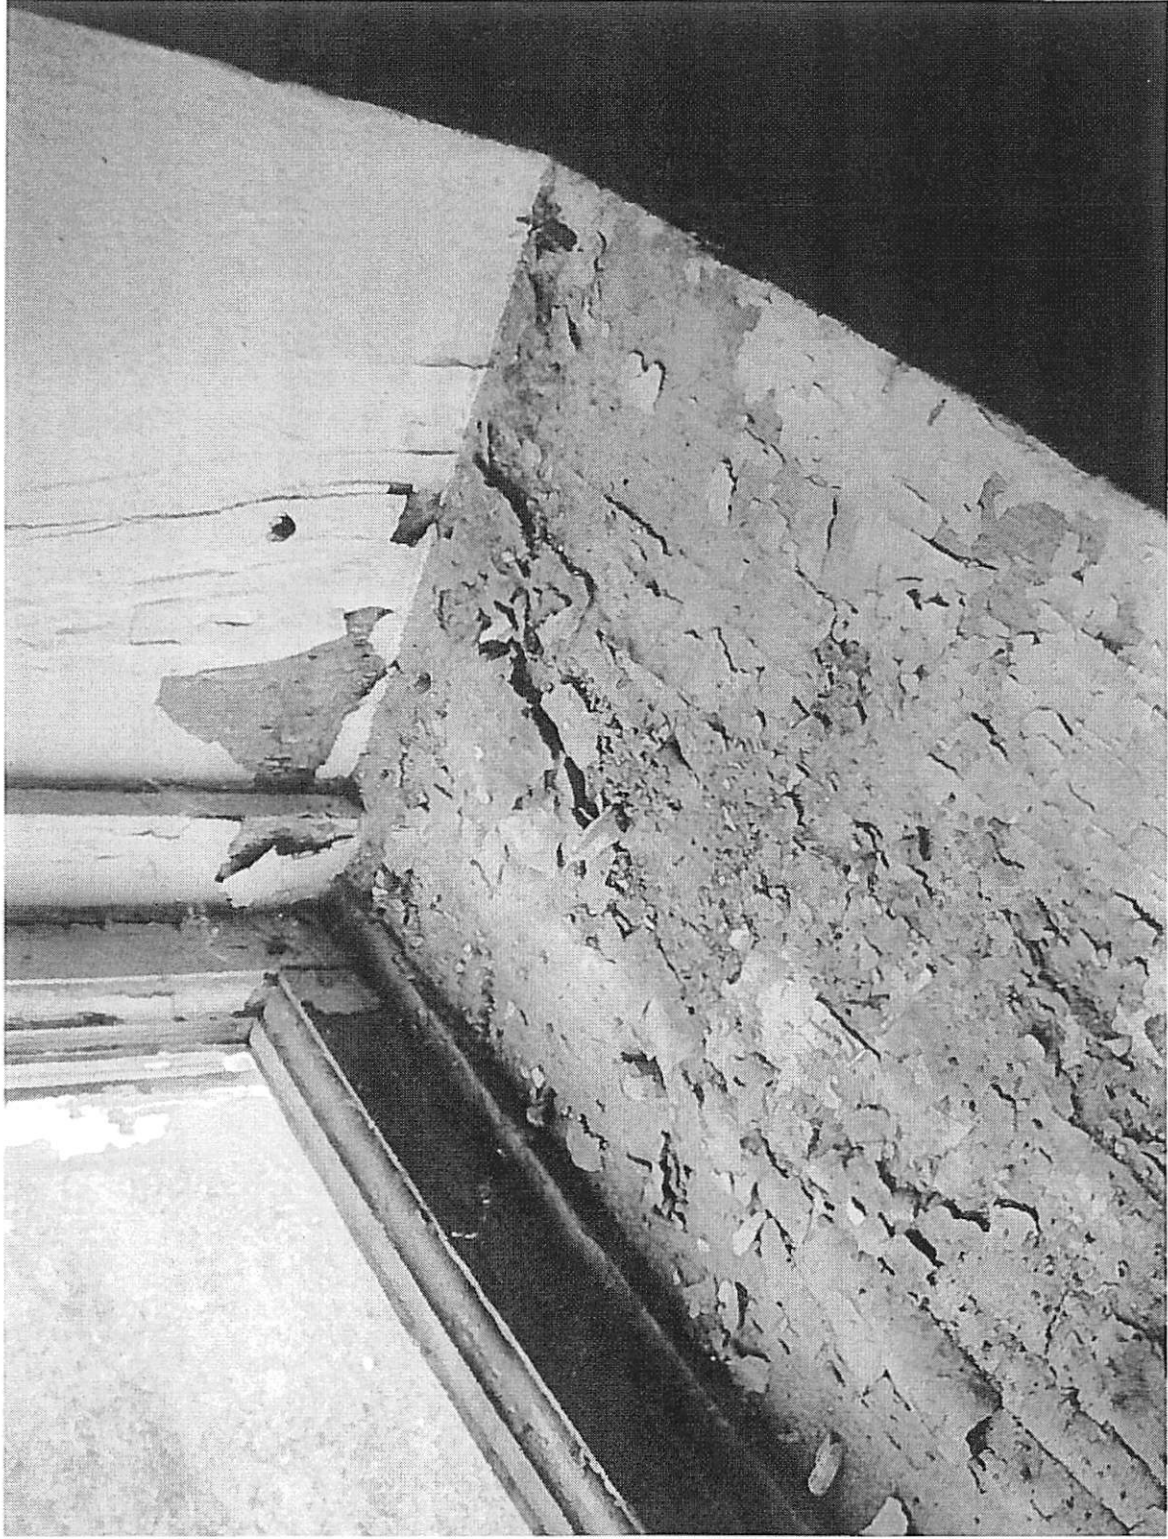
**Photographic Log – Samples LBP-15 & LBP-16.**

- Sample LBP-15 collected from the white paint on the window sill in the stairwell at the basement level contained lead at a concentration of 10.54 mg/kg.

- Sample LBP-16 obtained from the grey paint on the window sill in the stairwell at the basement level contained lead at a concentration of 16.93 mg/kg.

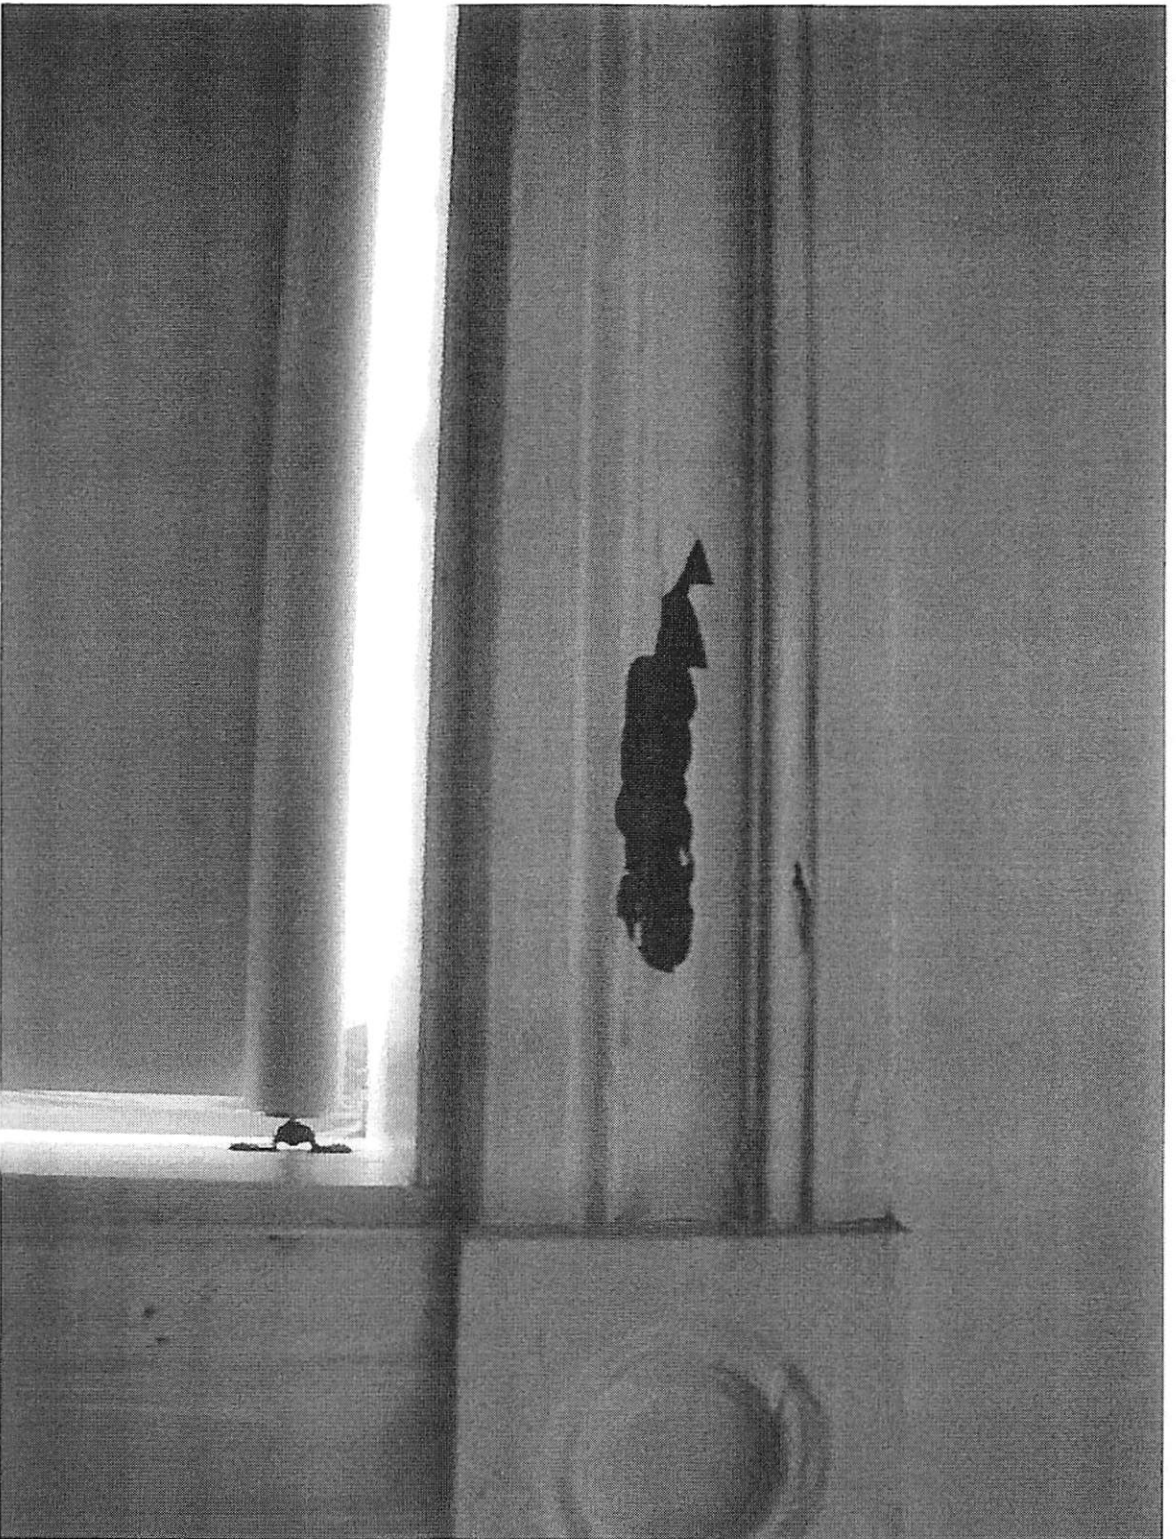
**Photographic Log – Samples LBP-20.**

- Sample LBP-20 obtained from the white paint on the window trim between the first and the second floors in the stairwell contained lead at a concentration of 0.09 mg/kg.

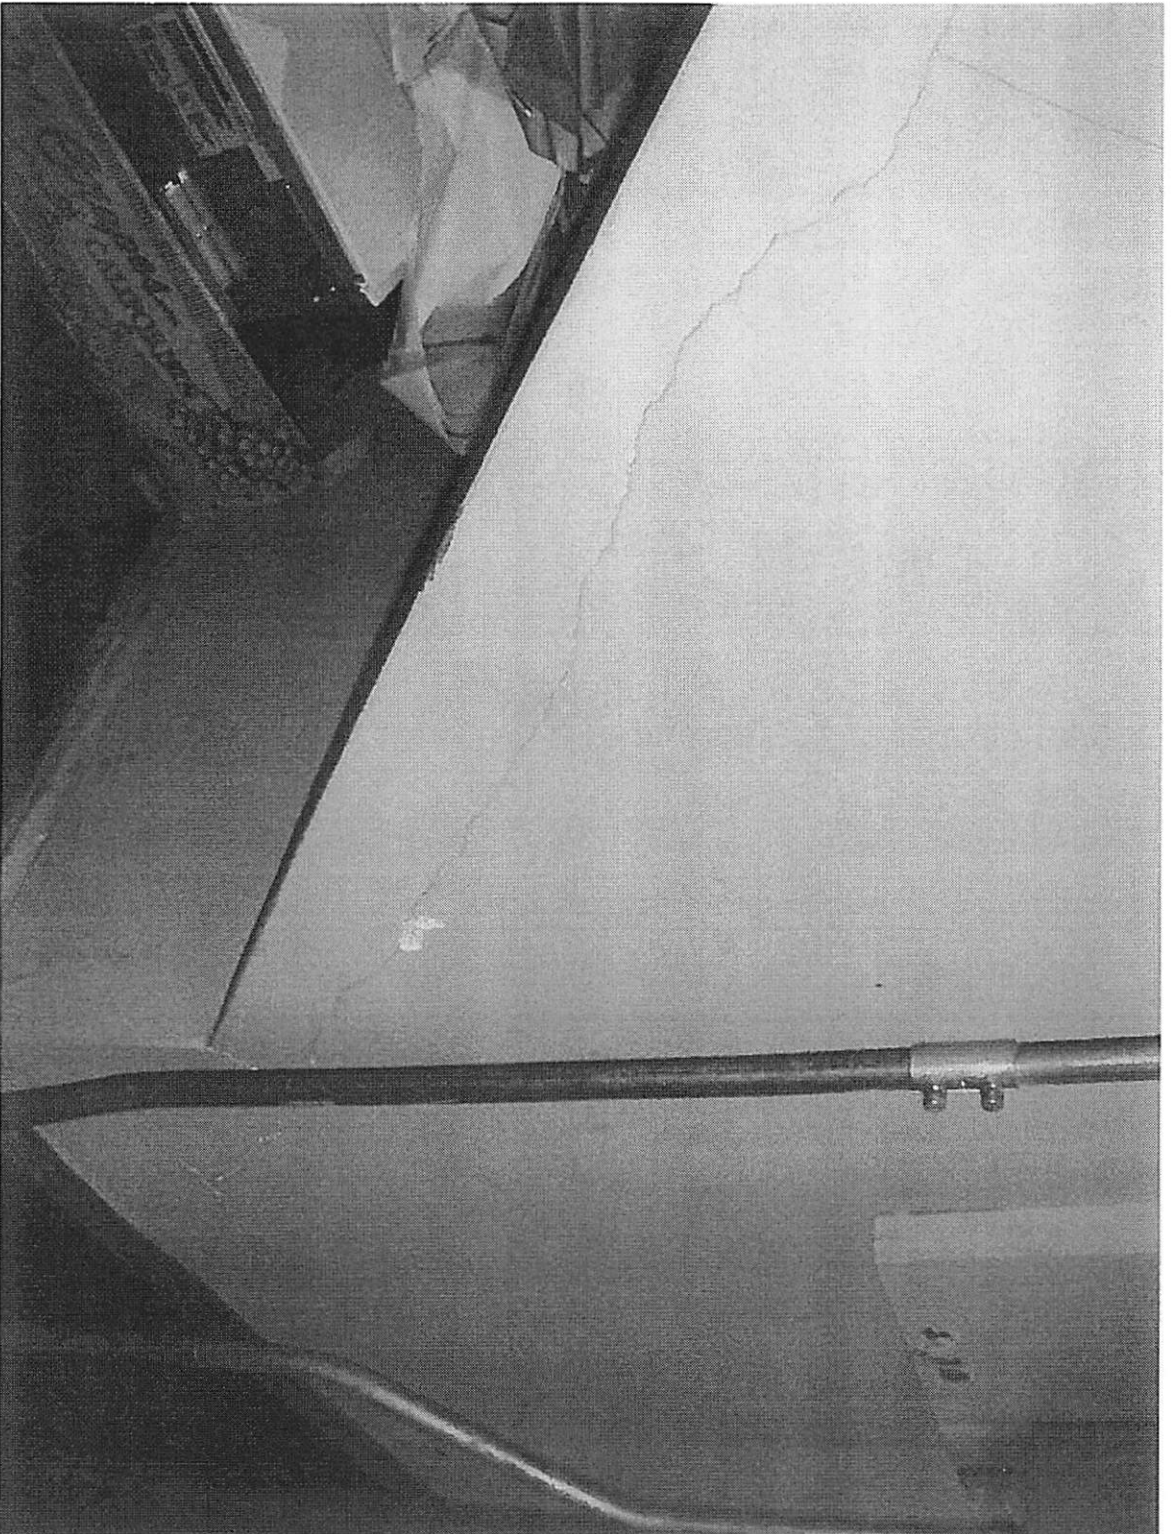
**Photographic Log – Samples LBP-21.**

- Sample LBP-21 obtained from the yellow paint on the wallboard in the second floor storage room contained lead at a concentration of 0.06 mg/kg.
- Sample LBP-22 obtained from the white paint on the window frame in the ladies bathroom located on the first floor contained lead at a concentration of 0.09 mg/kg.

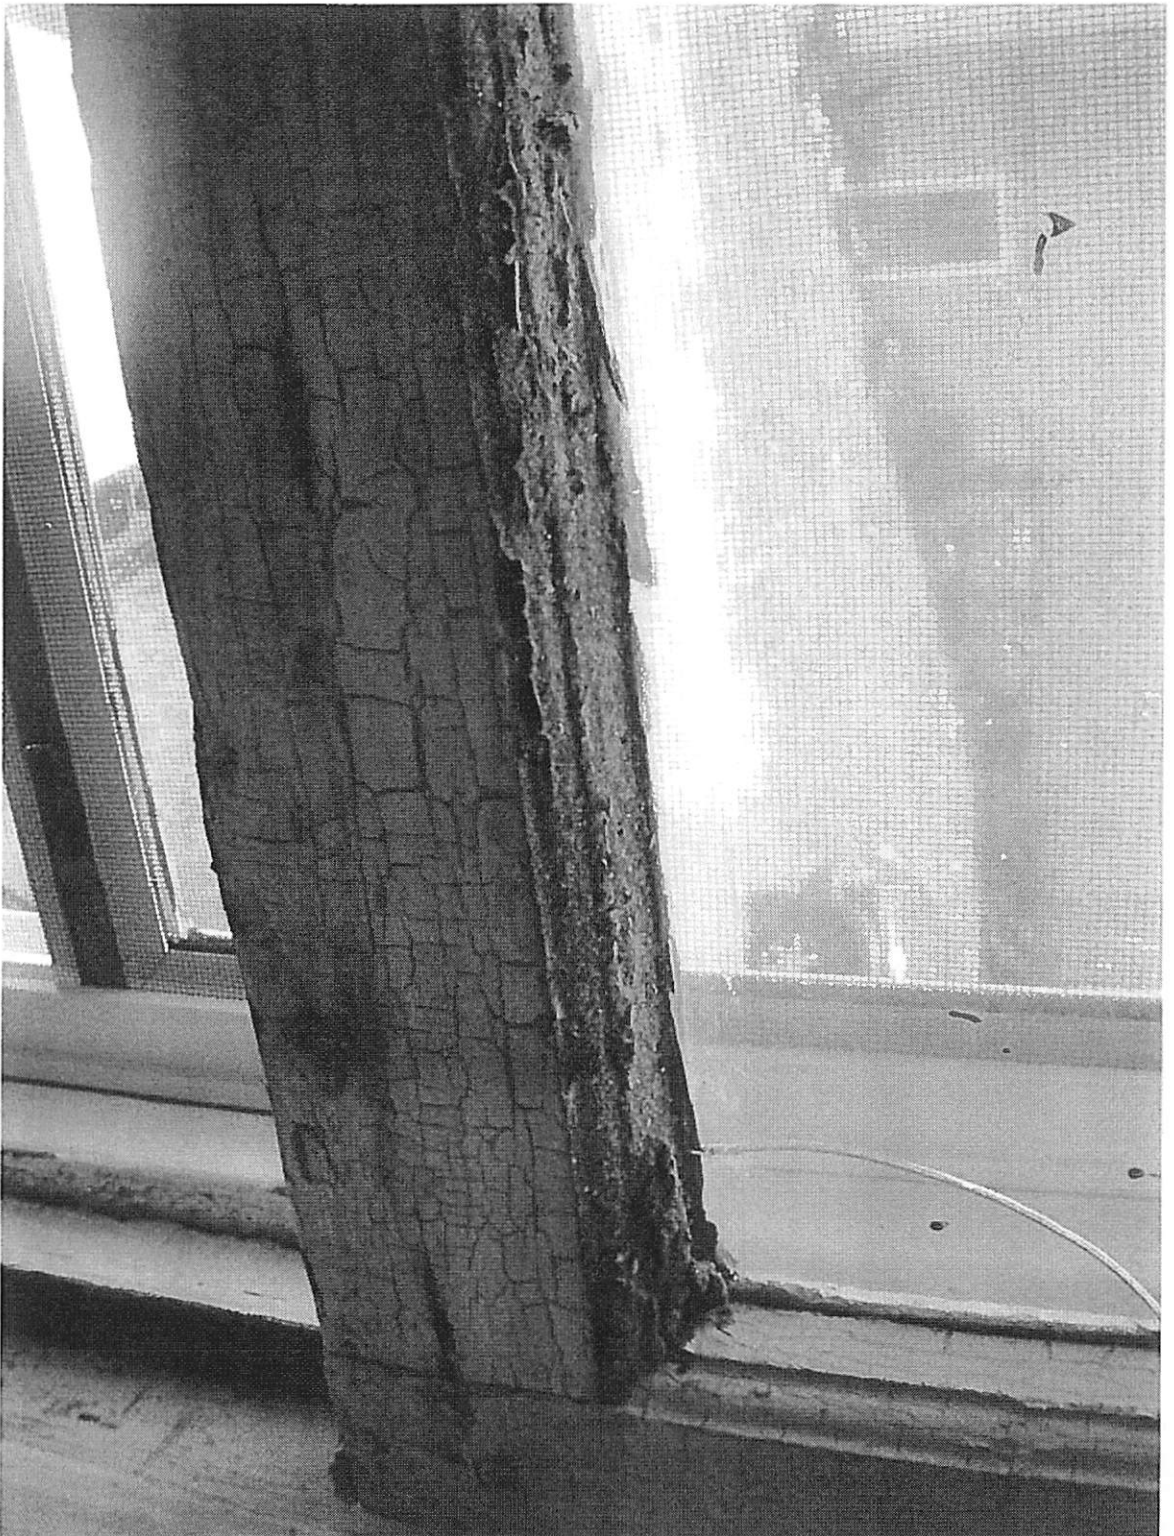
**Photographic Log – Samples LBP-22 & LBP-23.**

- Sample LBP-23 obtained from the green paint on the window sill in the ladies bathroom on the first floor contained lead at a concentration of 0.82 mg/kg.
