1835 Town Hall Committee

Report to the Board of Selectmen
November 2, 2016

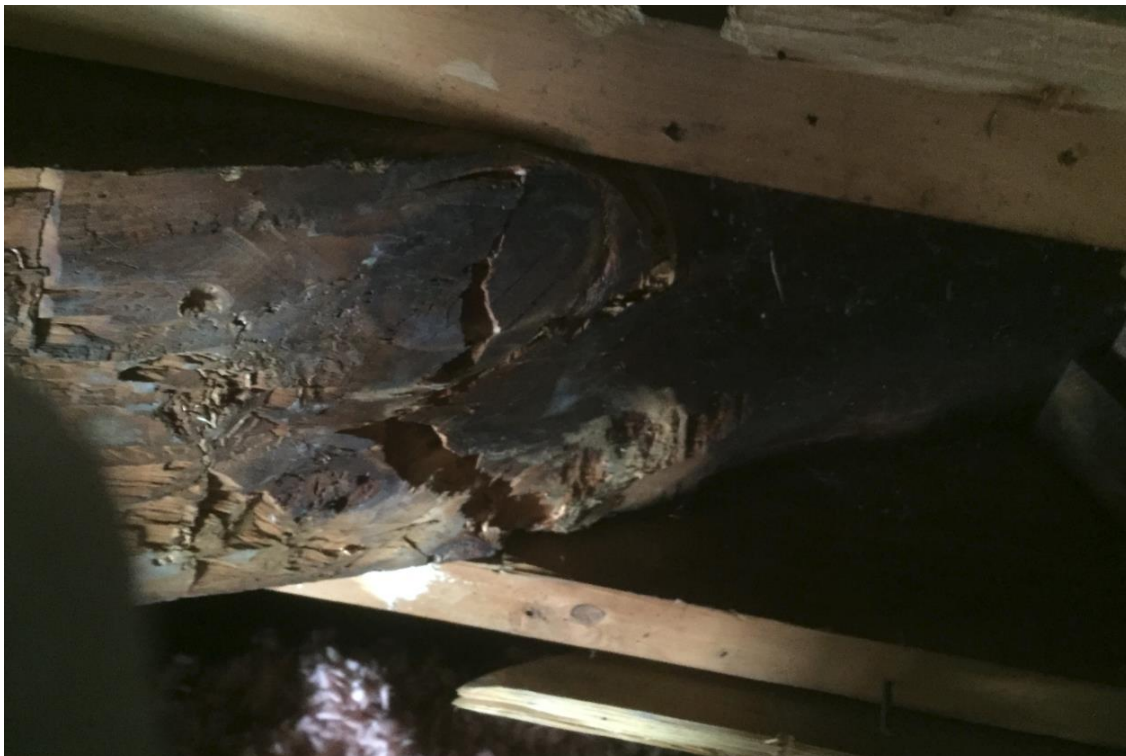
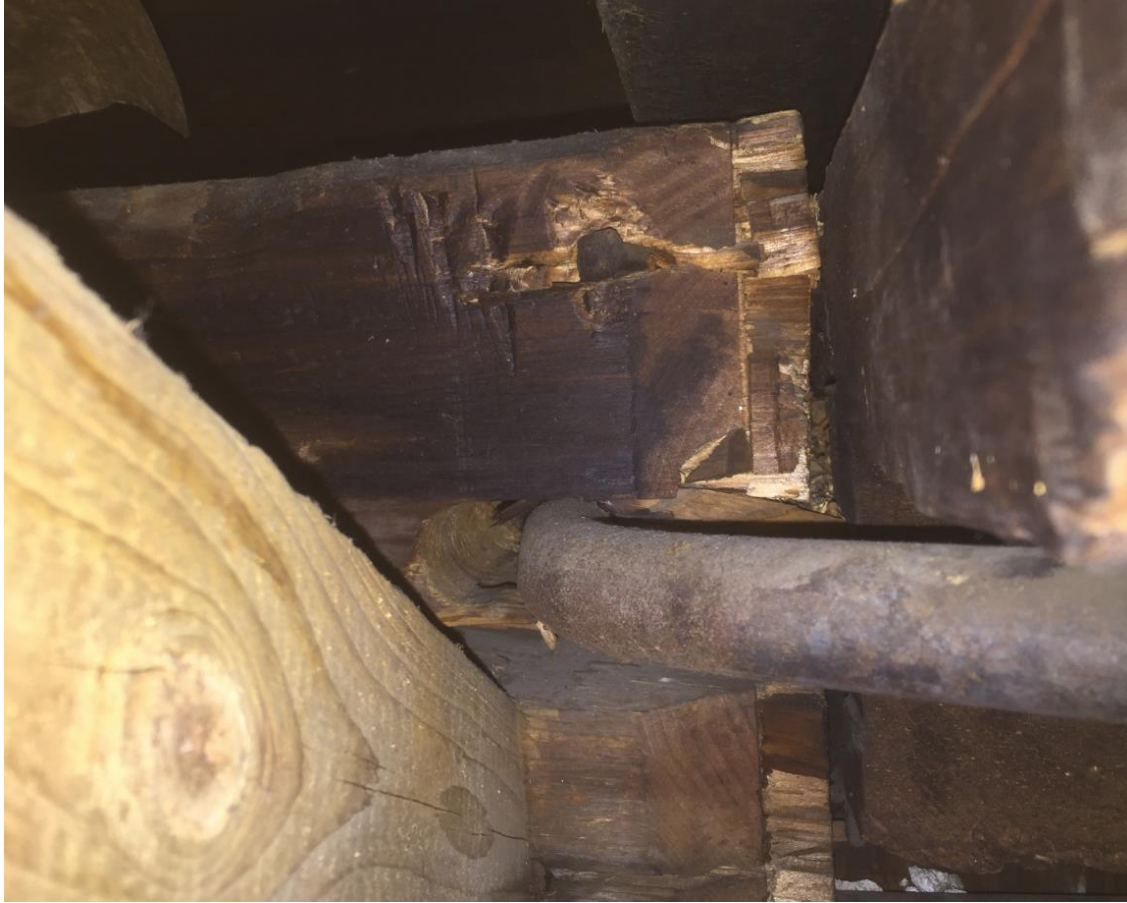
The ceiling area surrounding the beam showing signs of damage have been uncovered and the pictures have been taken. The Committee thanks John Kilcoyne and especially Rich Lane for making this happen. The pictures reveal a major fault in the rafter support section of the second support bay which is worse than the structural issues we already knew about in the first support bay. There are four support bays and it is assumed that there is no damage to the third and fourth. However, until the entire ceiling is opened up, we do not know the full extent of structural damage or integrity. The Committee would like the entire ceiling excavated in the near future.

The engineer, Peter Reynolds, reviewing the damaged area has suggested back to back steel channels surrounding and supporting the existing rafter with welded plates for existing tie rod. This is similar to the 2012 study which called for steel I-beams supporting all existing rafters with steel collar ties. The Committee agrees conceptually with the method of reinforcement but believes that a better alternative to steel reinforcement would be laminated veneer lumber (LVL¹).

It is the hope of the Committee that structural repairs cause minimal damage to the existing roof decking. However, reinforcing the rafter and collar tie structure will certainly require opening up the structure from below (ceiling) and possibly from above (decking) as well. Therefore, the repairs to the structure should be concurrent with the resurfacing of the roof.

The Building Sub-Committee is working to create a plan to permanently reinforce all rafters and collar ties with laminated veneer lumber as needed. As part of that plan, a description of how installation will be performed.

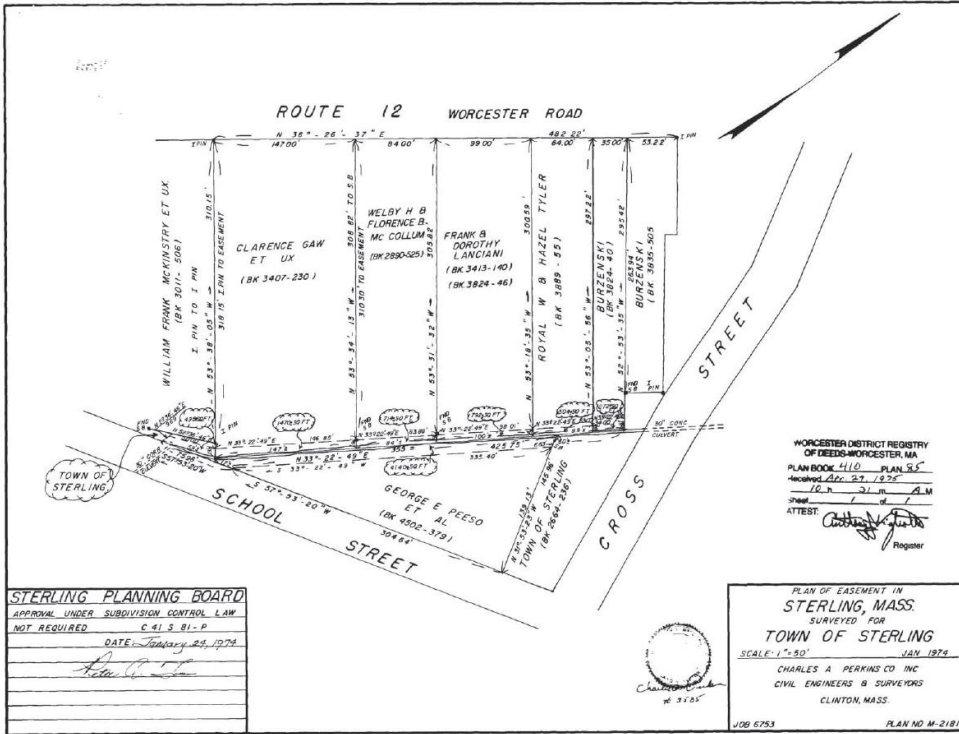
- There is an easement dating to 1975 between Cross street and School street. Book 410 Plan 85

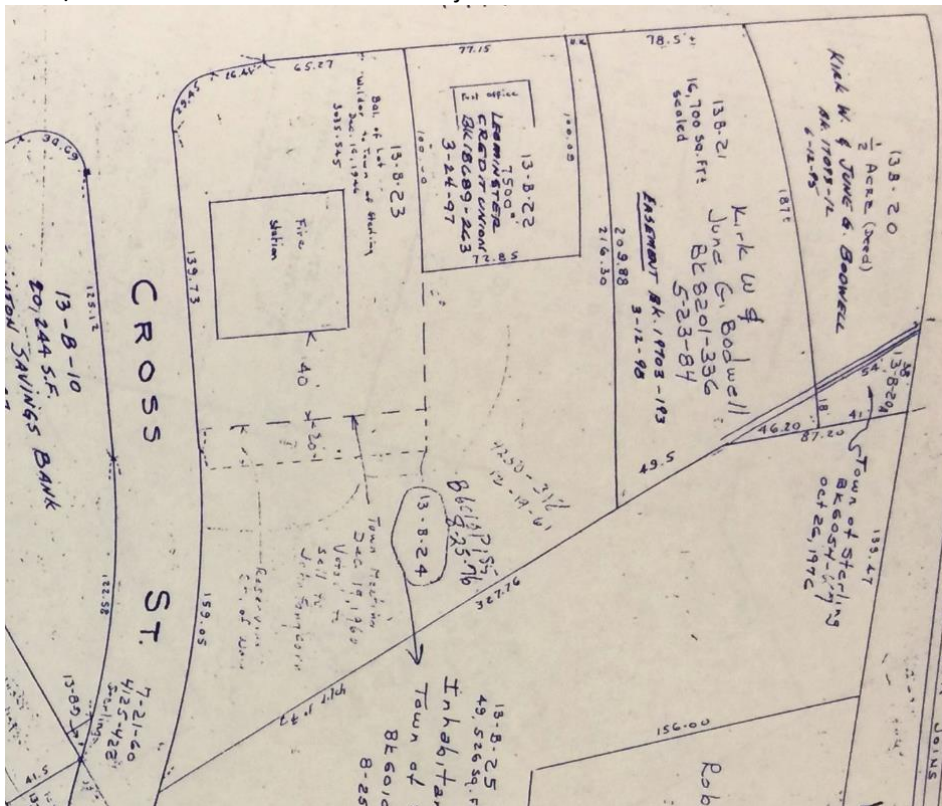
- The Assessors map 13-B (circa 1945) depicts in an unclear way the continuation of the ditch/culvert behind the Firehouse adjacent to Memorial Field

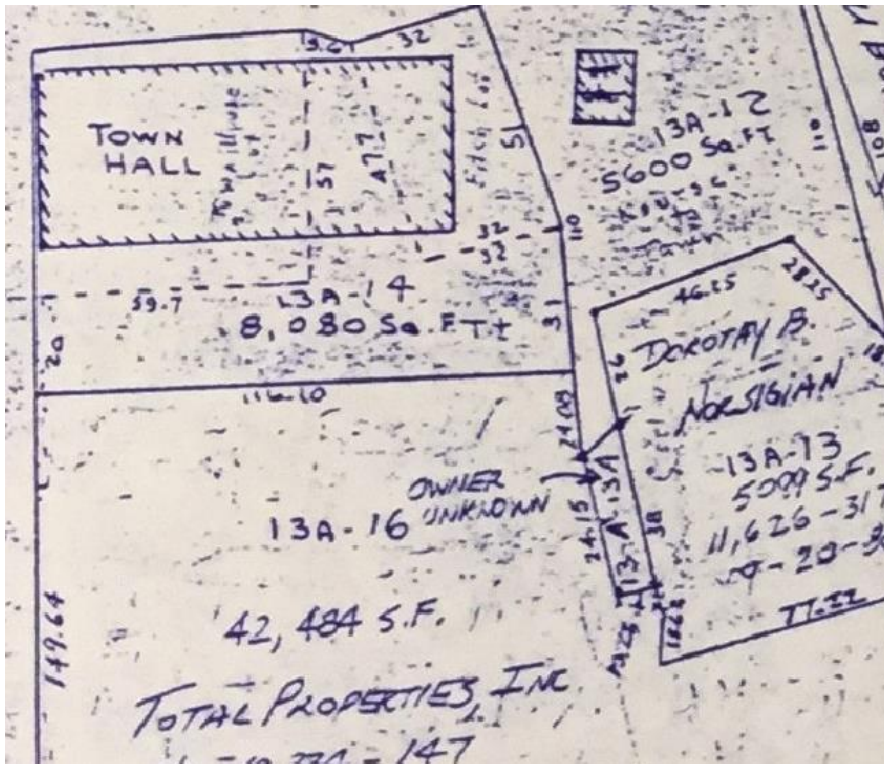
- We requested the plans from DPW for this drainage line, but they do not have any plans going back that far.
- We requested to review plans/maps stored in the vault but were advised that December was the soonest we could have access due to the election.
- We have sought assistance from DCR to see if they have plans that might show this drainage as part of their “Cider Mill Ditch/Sterling Filter Beds” There is some evidence that the ditch has always been the property of the Town of Sterling and it is vaguely supported by Assessors Map 13A which shows an area behind 27 Main Street connecting to Town Hall property that has no known owner which coincides with the line of the town ditch.
