STERLING 1835 TOWN HALL

**ARCHITECTURAL / STRUCTURAL ASSESSMENT
and
FEASIBILITY STUDY FOR UNIVERSAL ACCESSIBILITY
of the
STERLING 1835 TOWN HALL BUILDING**

JULY 8, 2005

PHASE I: ARCHITECTURAL CONSERVATION ASSESSMENT

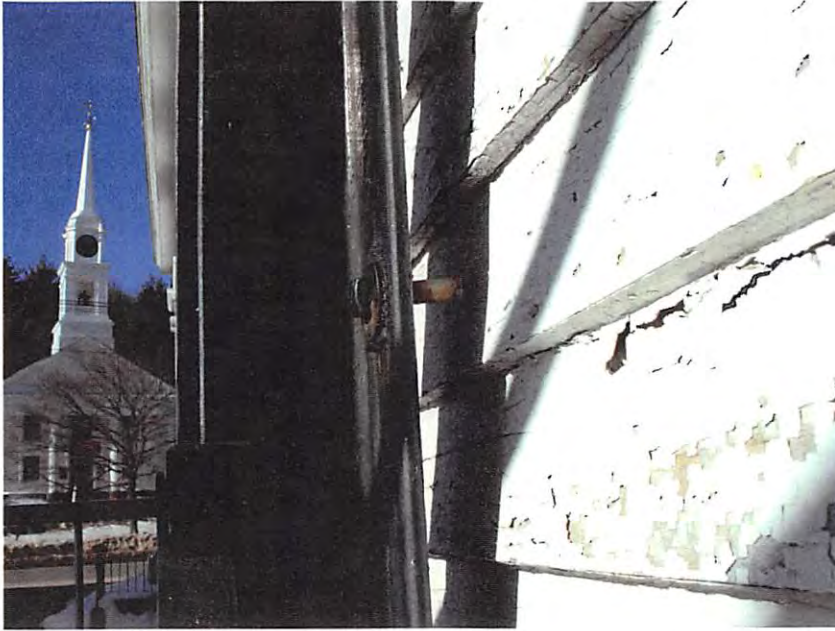
Inadequate anchorage of Fire Escape

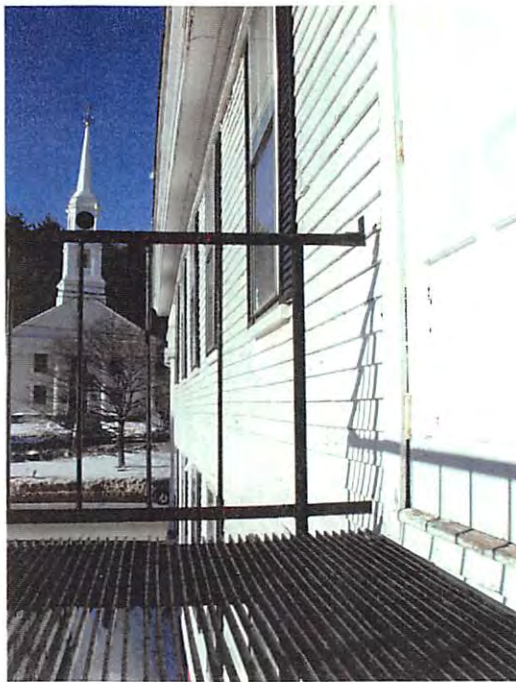
Inadequate anchorage of Railing

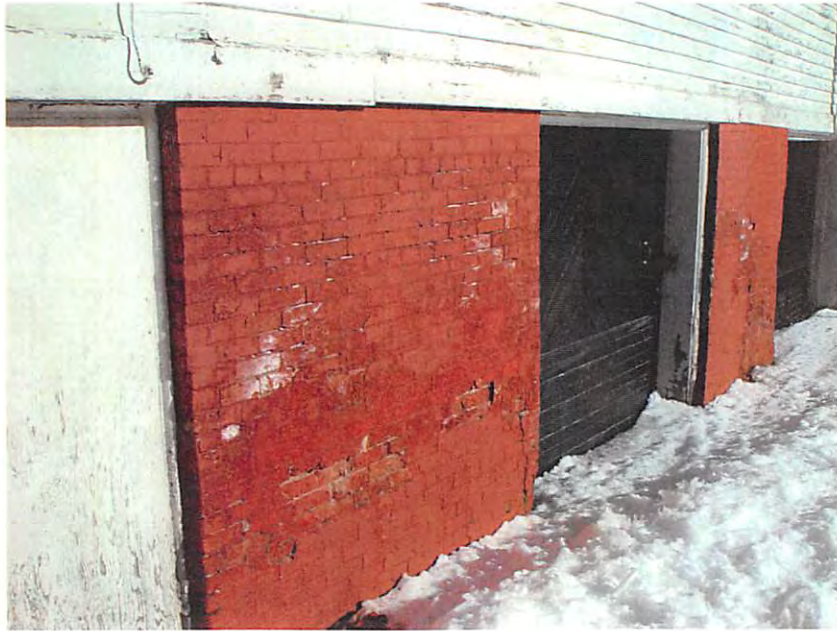
Right Side Brick Foundation

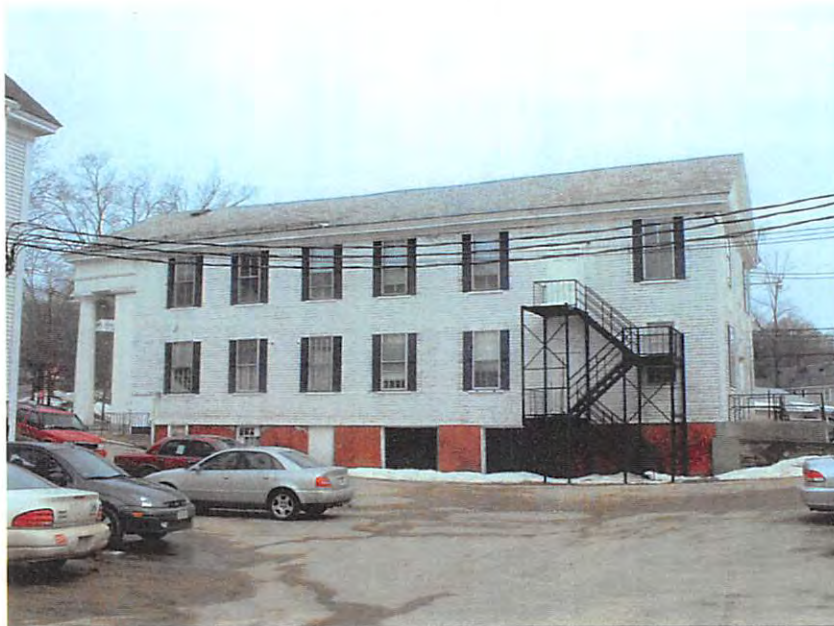
The wood roof deck has sagged and deflected in areas but does not appear to have done so to the point of structurally impairing its load carrying capacity. In one particular area it appears previous truss repair may have lifted the truss ridge and caused a visible crown along the roof ridge.

Right Side Building Elevation – Hump in Roof Ridge

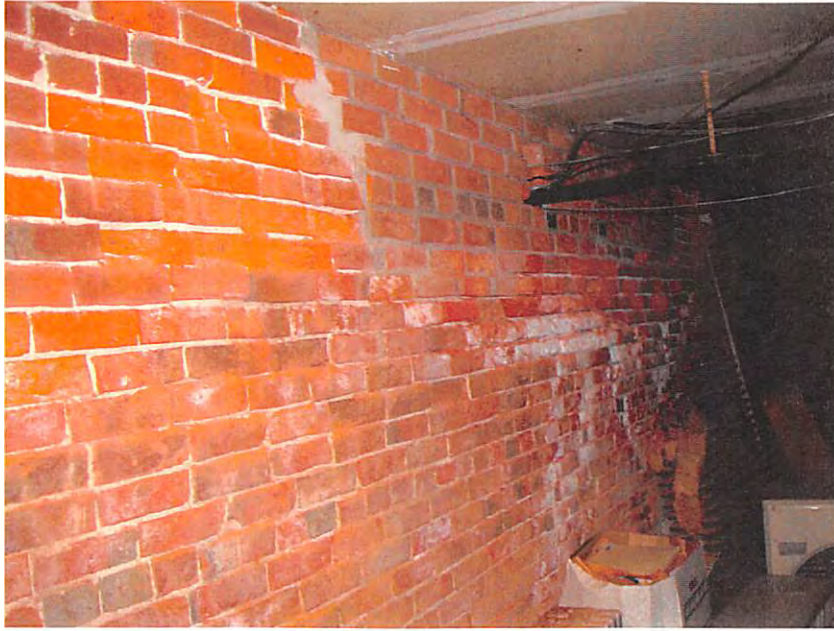
Interior brick wall requiring re-pointing

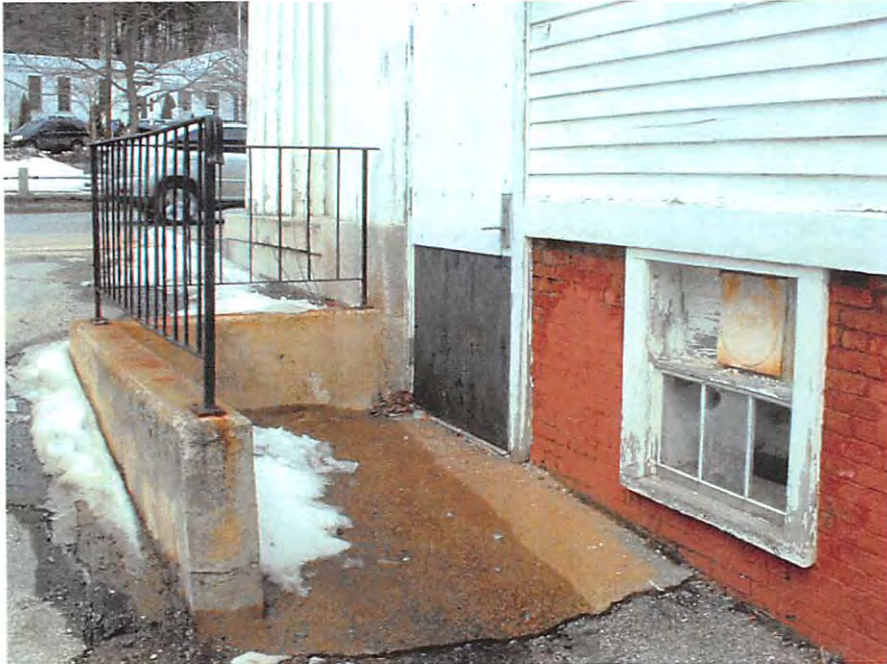
STAIR EXIT DOOR AND AREAWAY

- Door Boarded Up and Steel Plate Added
- Cracked Concrete Wall
- Rusting Metal Railing
- Broken Basement Window Boarded Up
- Brick Missing Upper Right of window Opening

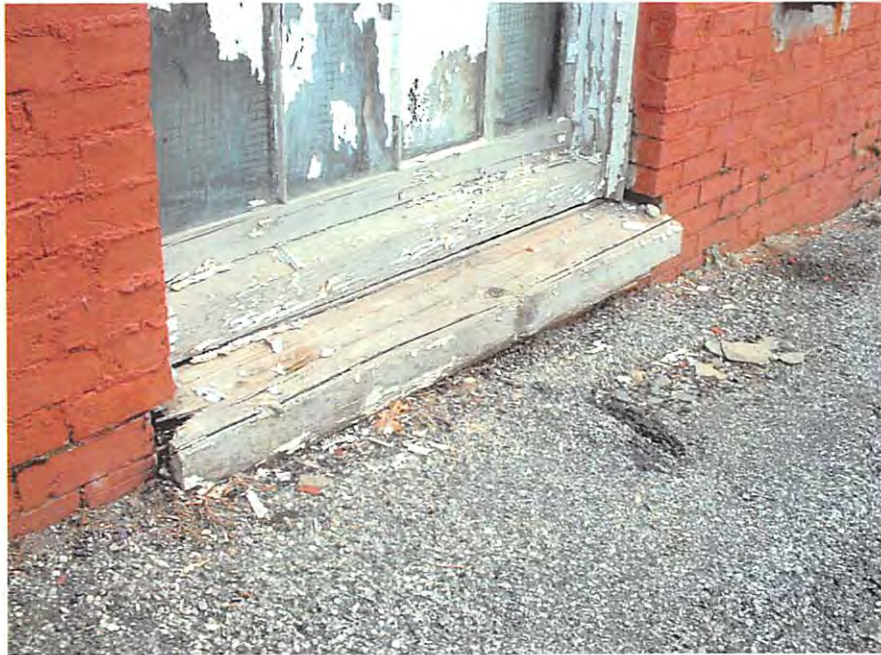
BASEMENT WINDOW SOUTH ELEVATION

- Rotted Wood Window Sill
- Paint Failure at Window
- Broken / Missing Glazing Putty

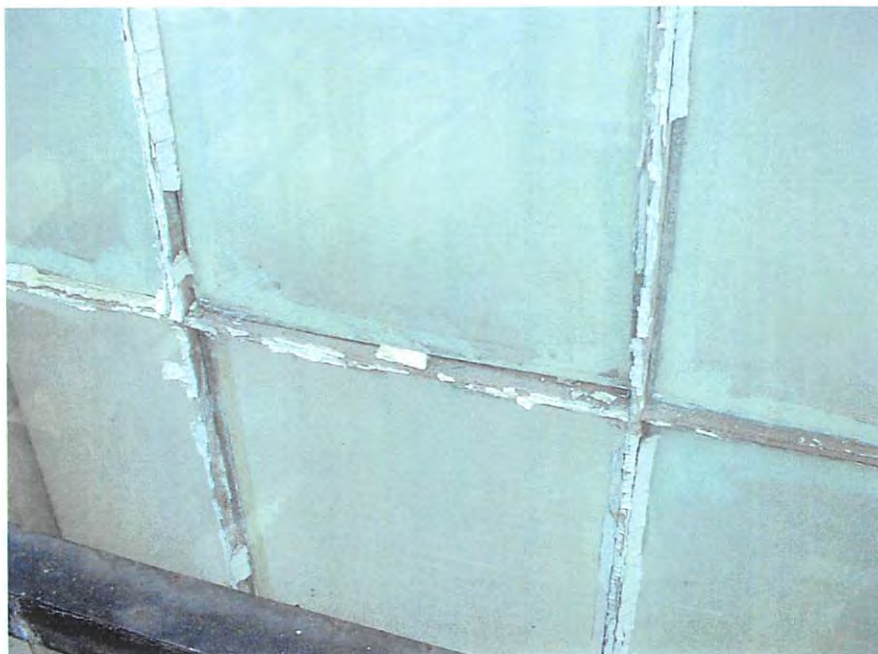
FIRST FLOOR WINDOW SOUTH ELEVATION

- Broken / Missing Glazing Putty

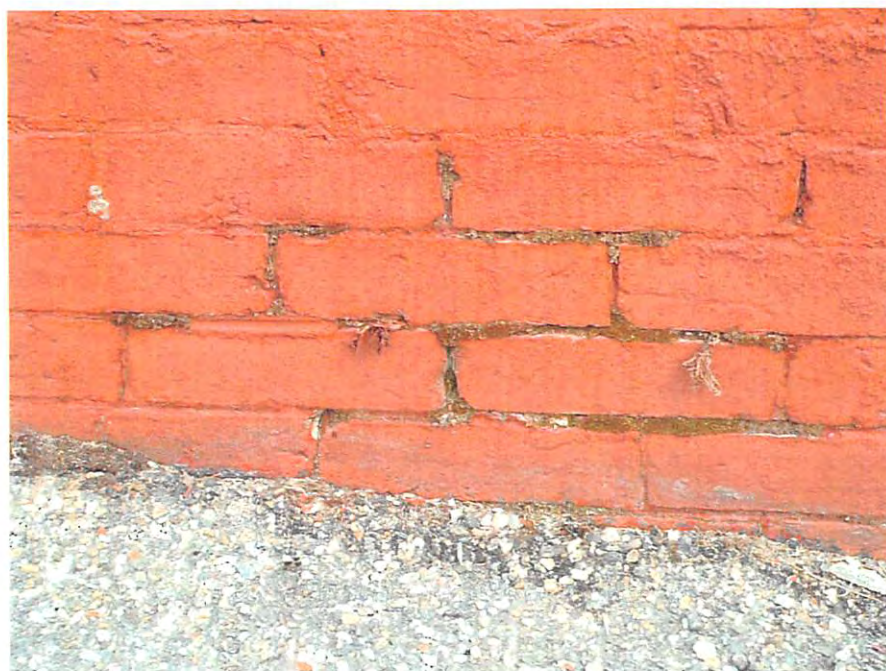
FIRST FLOOR WINDOW SOUTH ELEVATION

- Moss Growing in Mortar Joints

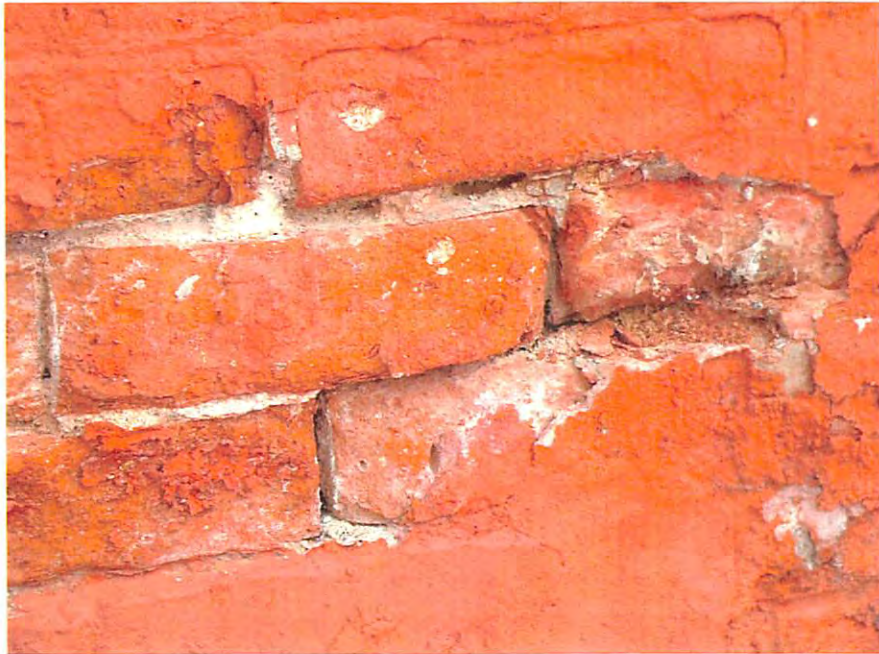
BRICK FOUNDATION SOUTH ELEVATION

- Spalled Deteriorated Brick
- Deteriorated / Missing Mortar

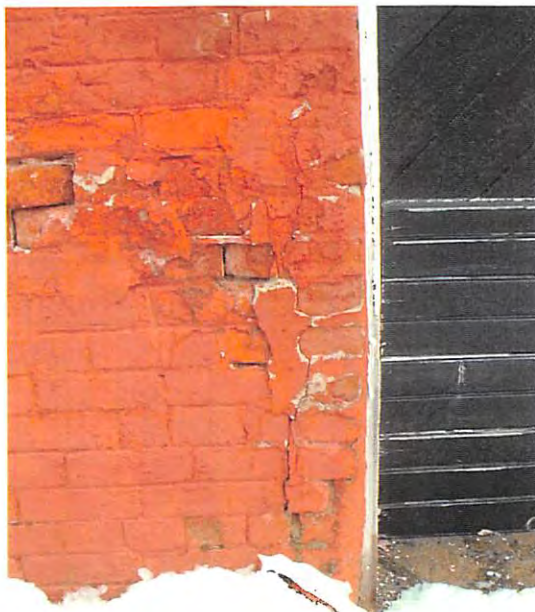
BRICK FOUNDATION SOUTH ELEVATION

Several significant areas of brick damage have occurred particularly at the jambs of the rolling Basement doors from probable accidental, physical contact and appears in at least one location to have been previously repaired.

- Broken Previously Repaired Masonry Jamb
- Cracked Broken Masonry
- Deteriorated / Missing Mortar
- Typical of (2) Doors

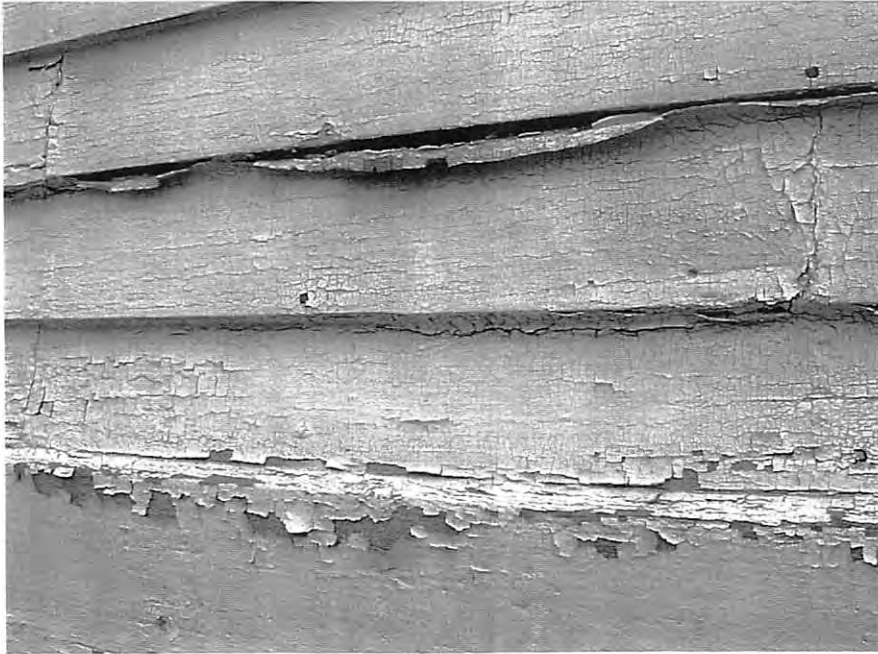
WOOD SIDING SOUTH ELEVATION

- Cracked, Crazed, Peeling, Curling Paint Failure

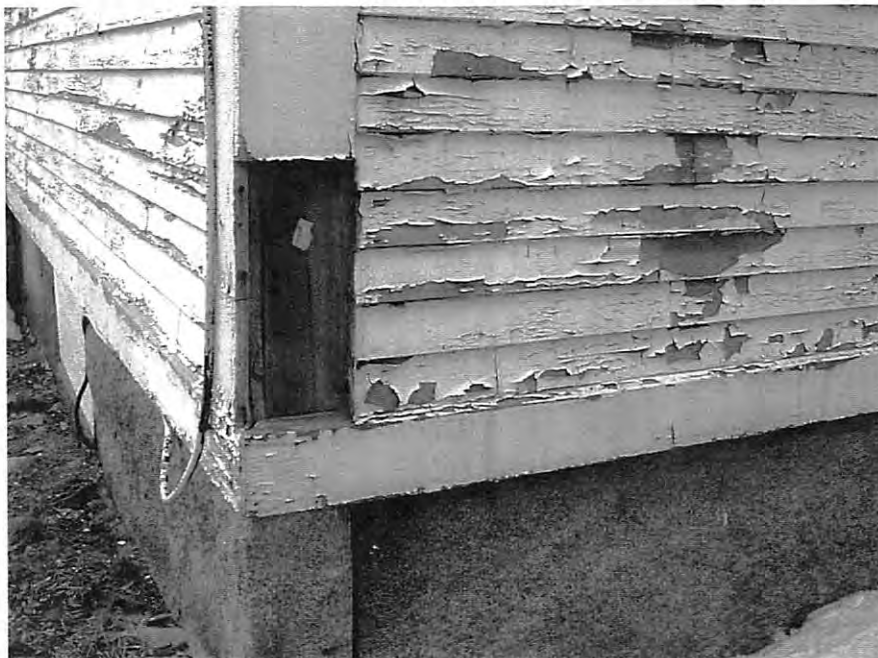
WOOD CORNERBOARD / SIDING NORTHEAST BUILDING CORNER

- Paint Failure at Clapboard Siding
- Missing Cornerboard Trim

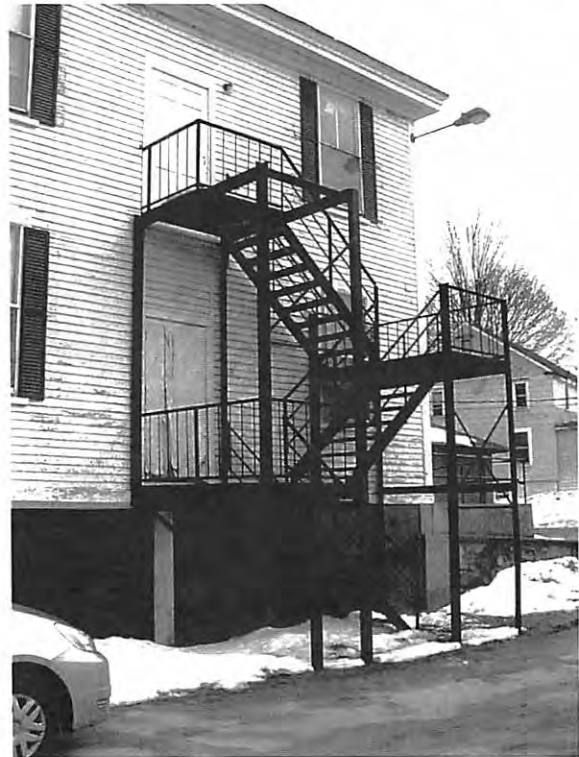
STEEL FIRE ESCAPE

- Basement window sills in proximity to ground are fully rotted.
- Steel fire escape has surface corrosion especially near joints and edged. Steel supports are in contact with ground and subject to prolong moisture contact. Top rail of fire escape is 36" high, current code would require 42" guard rail.

- Steel Supports in Contact with Ground
- First Floor Door Boarded Up
- Non-Historical Light Fixtures

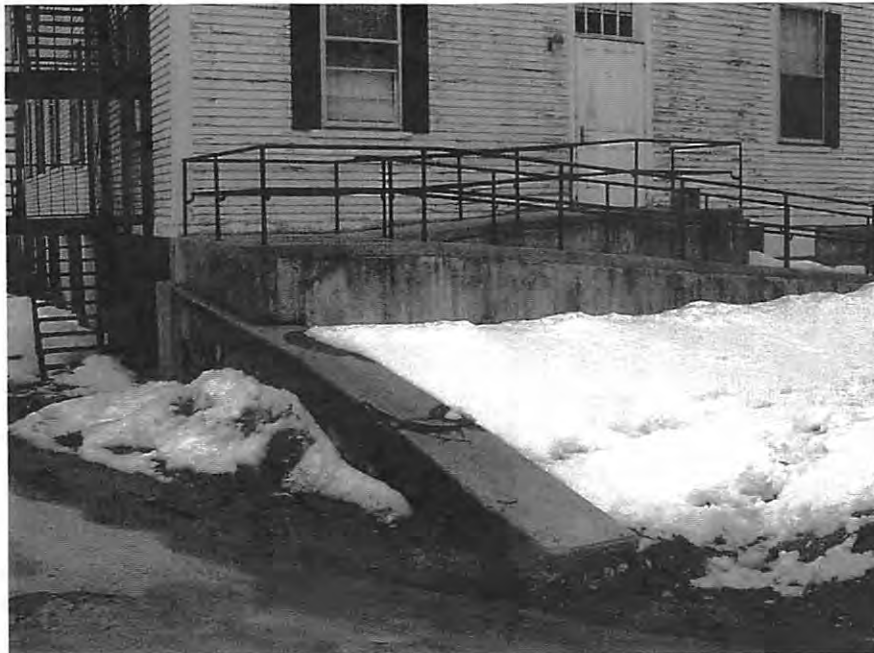
STONE / CONCRETE RETAINING WALL

The rear of the building contains a concrete access ramp in good condition with only minor cracking, steel handrails with failing paint and surface corrosion, and a stone retaining wall with broken mortar joints and broken concrete capstone. There is also concrete paving over the granite foundation that is spalling.

- Broken Concrete
- Exposed Reinforcing Bar
- Loose / Broken Stone Mortar Joints

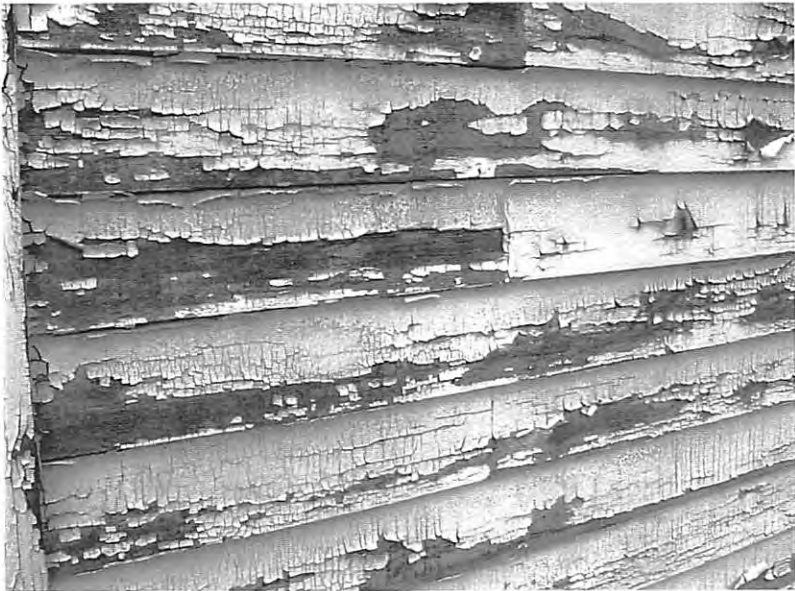
WOOD SIDING NORTH ELEVATION

- Cracked, Crazed, Peeling, Curling Paint Failure

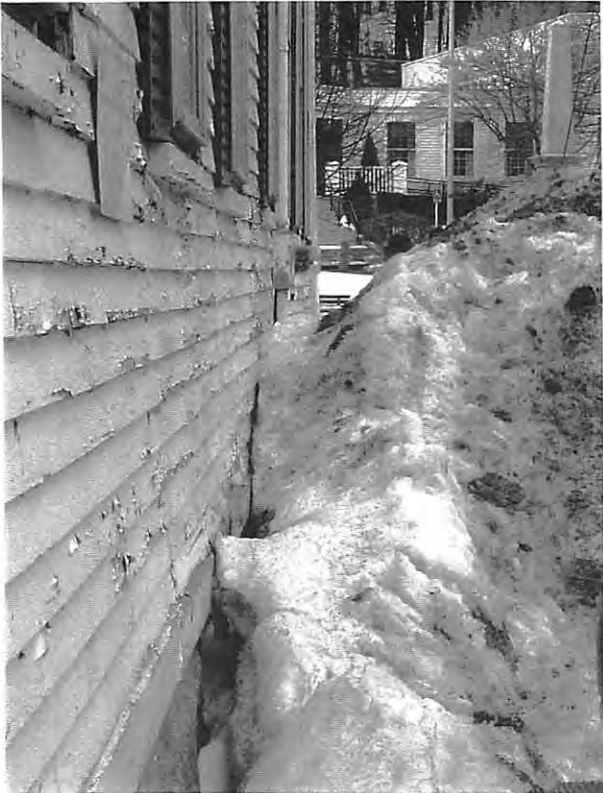
NORTH ELEVATION SNOW PILE

Street snow plowing deposits large amounts of snow along North elevation and prevents parking near the building and possible car damage from snow and ice falls. At one time this snow deposit was observed to have been built up over six feet high and was in contact with the building. This is certainly damaging the wood framed and sided building and needs to be prevented in the future. The boiler make-up air vent is also located in this area and is obstructed by snow at times.

- Snow Pile Obstructing Electric Meter
- Snow Pile Obstructing Boiler Air Intake

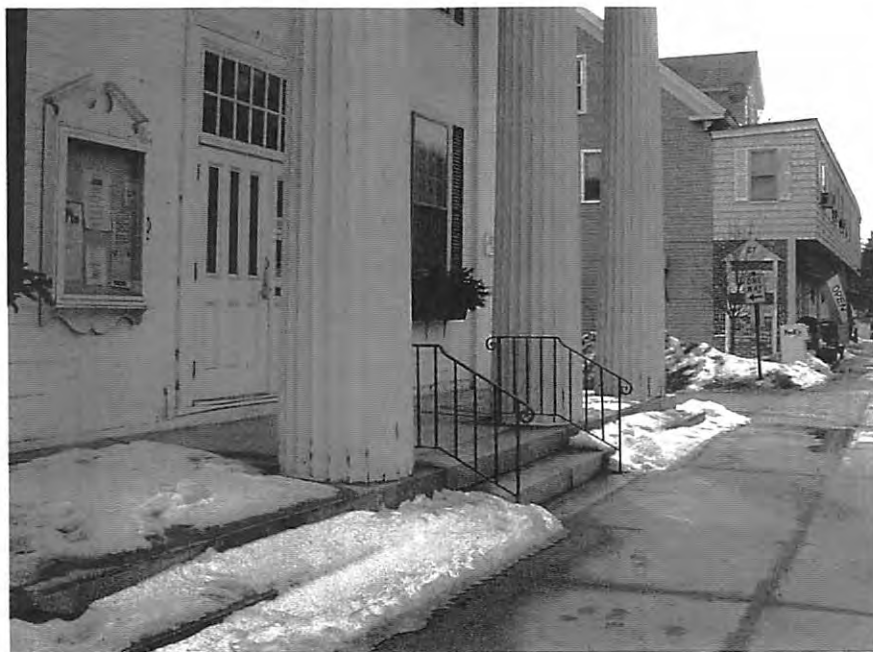
MAIN ENTRANCE PORTICO

- Previous concrete portico slab installation appears to be trapping moisture at wood column base because slab was installed higher than column base stone.

- Recess Granite Below Columns

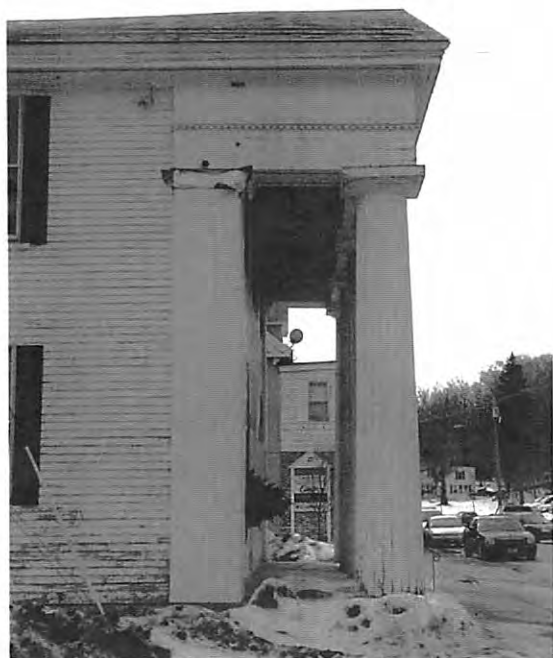
NORTH PORTICO ELEVATION

- On-Going Corner Capital Repairs

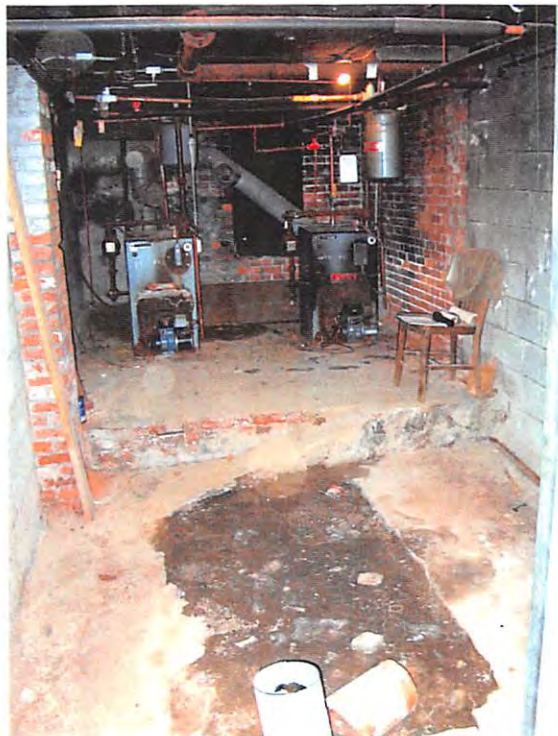
BASEMENT BOILER ROOM

- Open Concrete Floor Slab

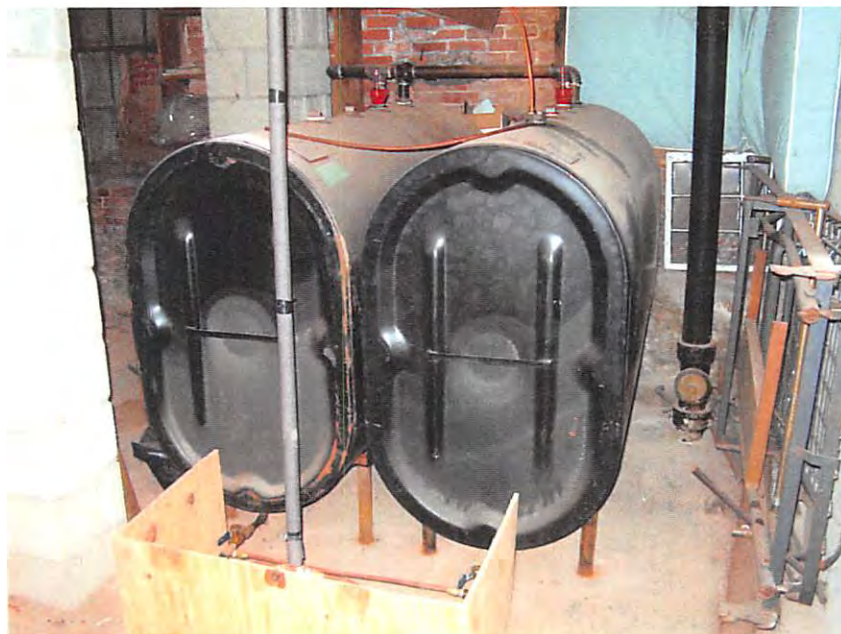
BASEMENT FUEL OIL TANKS

- Plywood Protection Skirt at Exposed Piping and Valves
- Existing Sewer Entrance
- Newer CMU Structural Piers (Left)
- Mattress to Block Basement Window Opening (Upper Right)

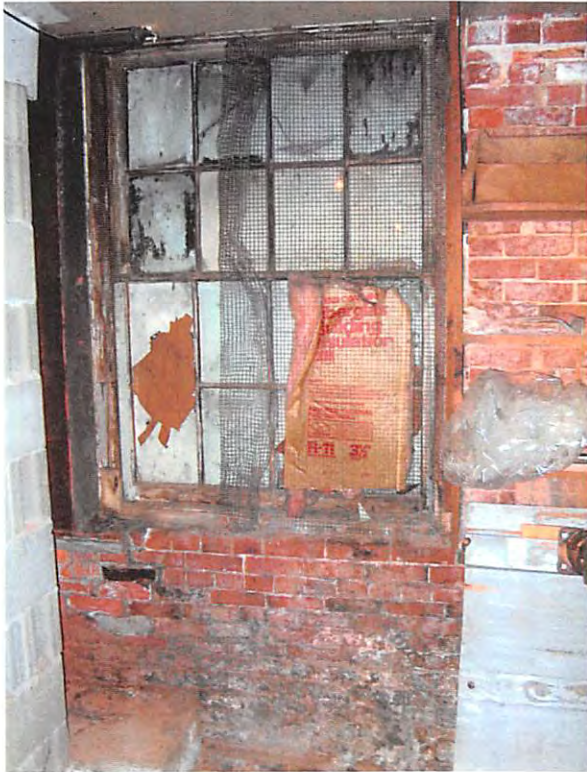
BASEMENT WINDOW

- Broken, Deteriorated Wood Window
- Moisture Damage at Masonry below Window

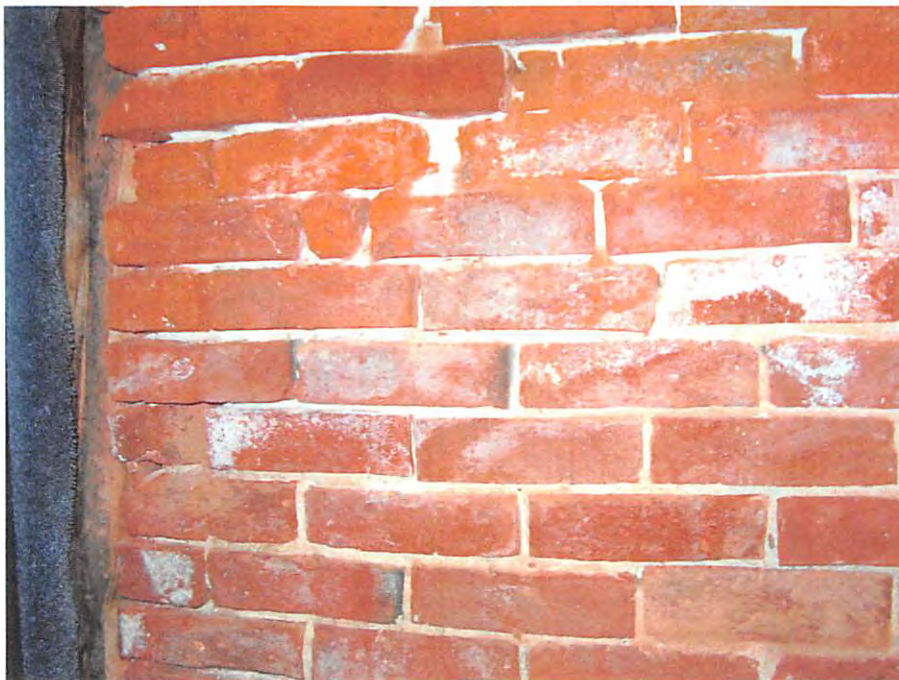
BASEMENT BRICK INTERIOR BEARING WALL

- Deteriorated and Missing Mortar

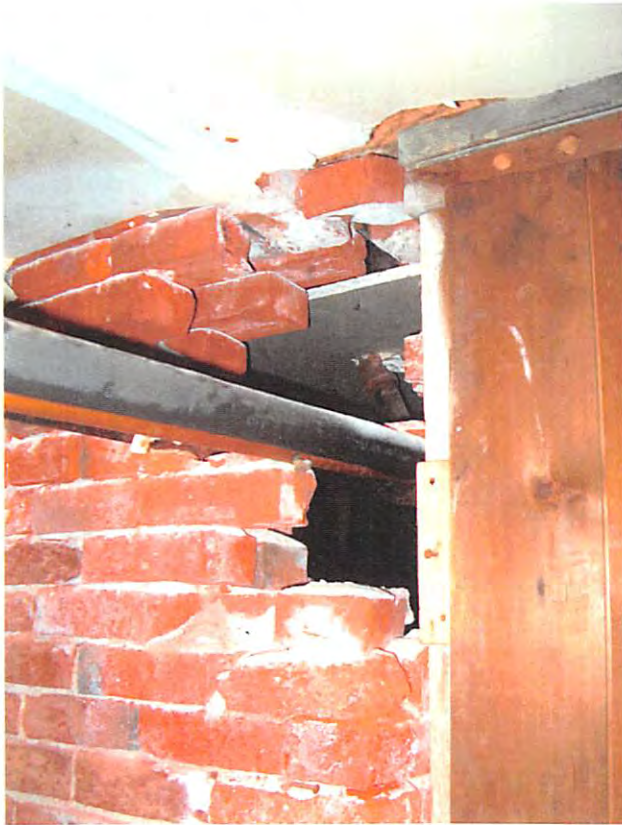
BASEMENT BEARING WALL

- Brick Removed for Pipe Installation
- Missing / Deteriorated Mortar

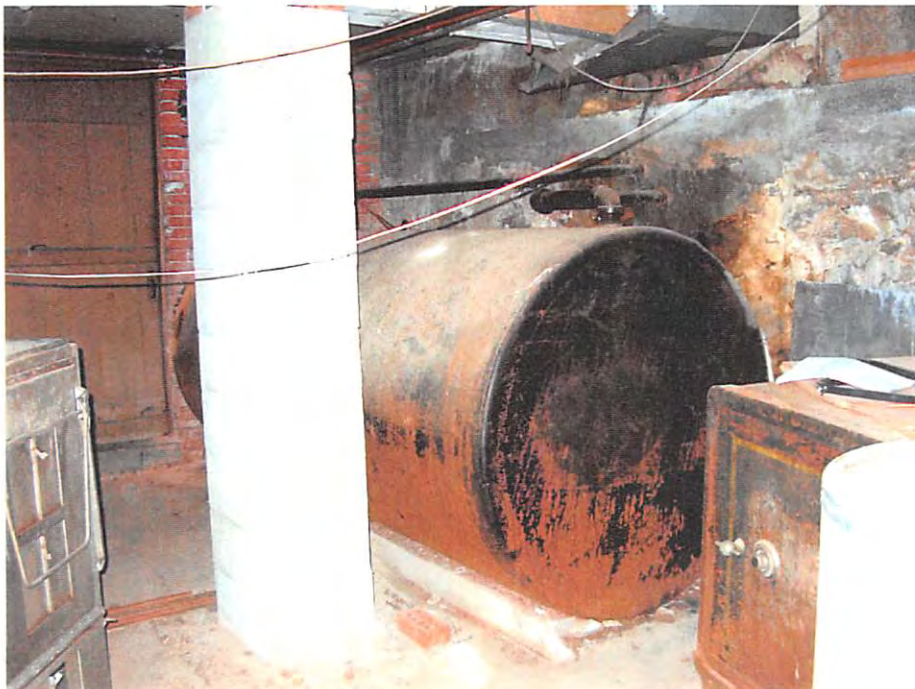
BASEMENT ABANDONED FUEL OIL TANK

- CMU Supplemental Pier
- Rubble Stone Foundation Intact

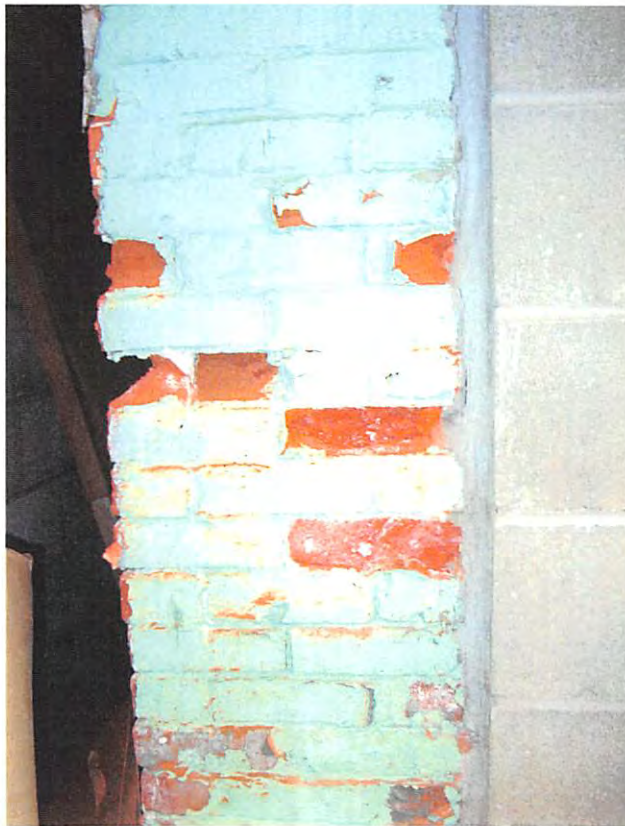
BASEMENT COLUMN REPAIR

- Deteriorated Brick Pier
- Supplemental CMU Pier

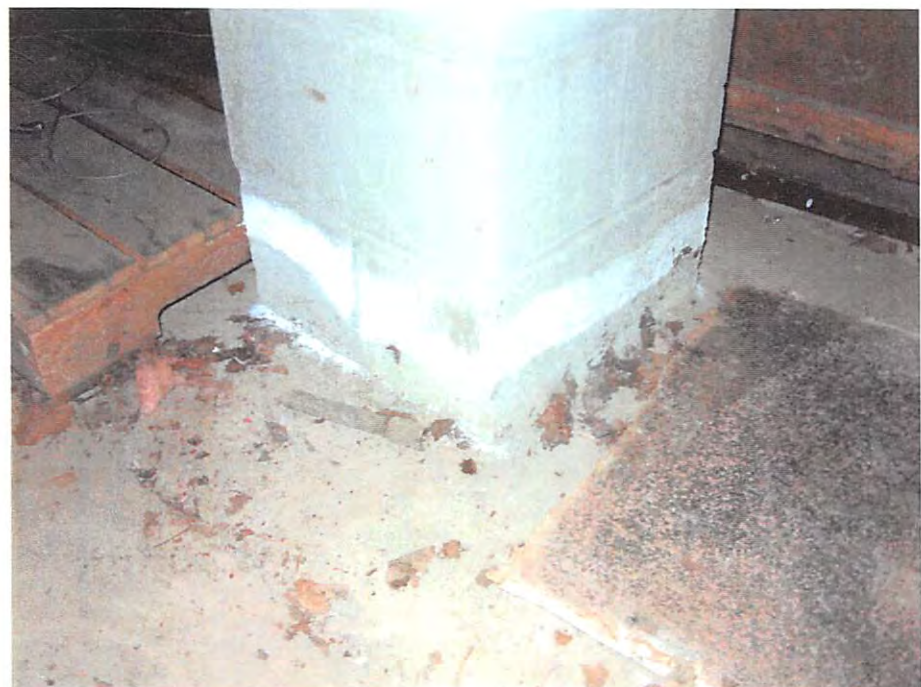
BASEMENT COLUMN REPAIR

- Supplemental CMU Pier
- Efflorescent Staining from Previous High Water

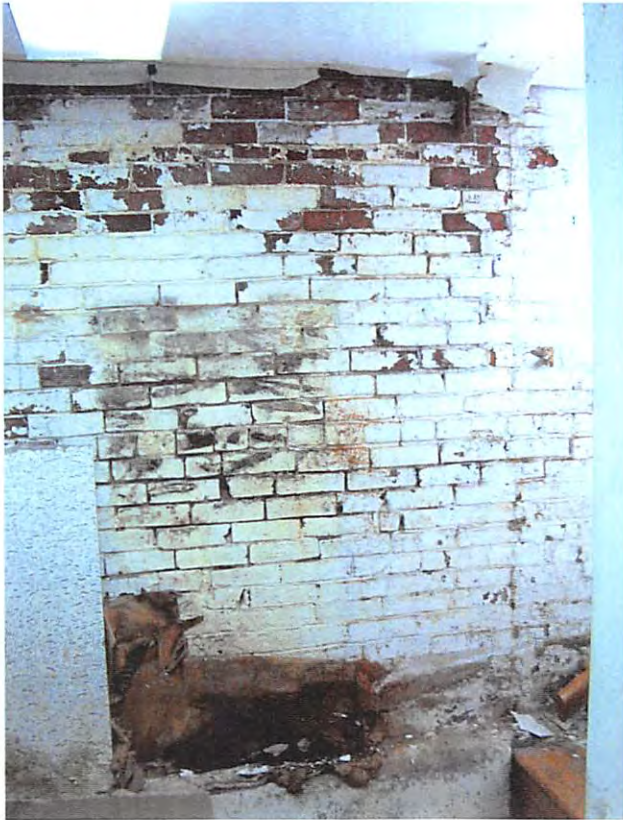
FOUNDATION WALL AT BASEMENT STAIR

- Missing and Deteriorated Mortar Joints
- Missing, Flaking Paint

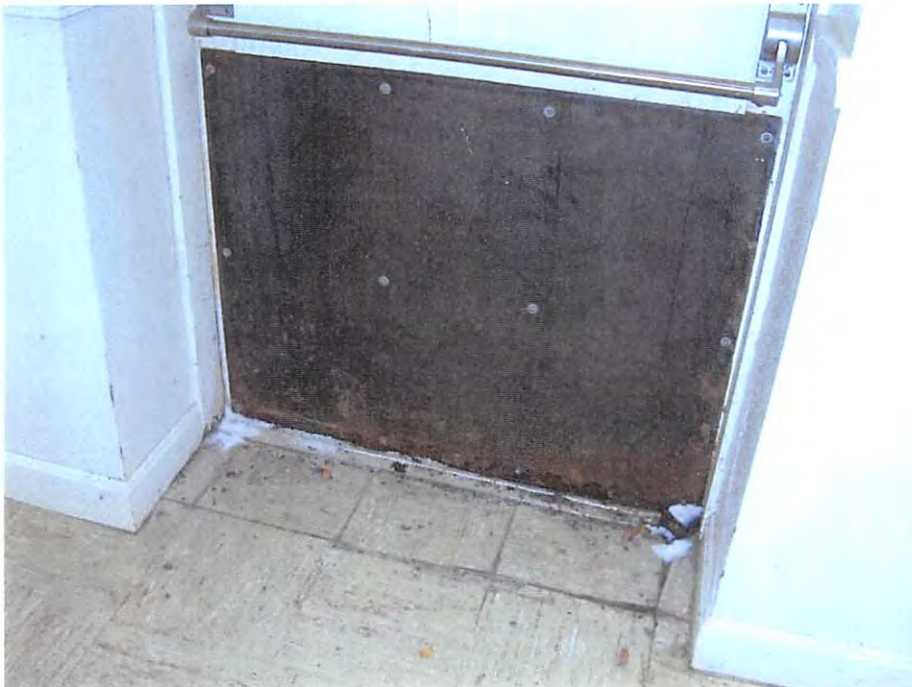
STAIR EXIT DOOR

- Plywood Covered Door
- Rusting Steel Plate Reinforcing
- Moisture Damage. Buckling Vinyl Til

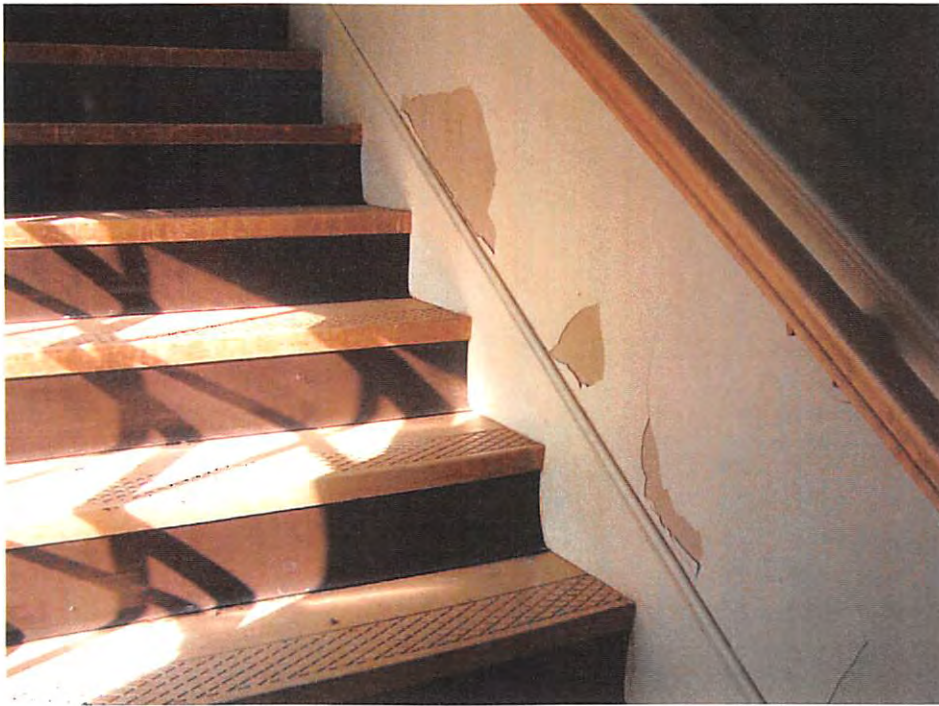
EXIT STAIR

- Loose, Spalling Paint
- Vinyl Stair Treads and Risers

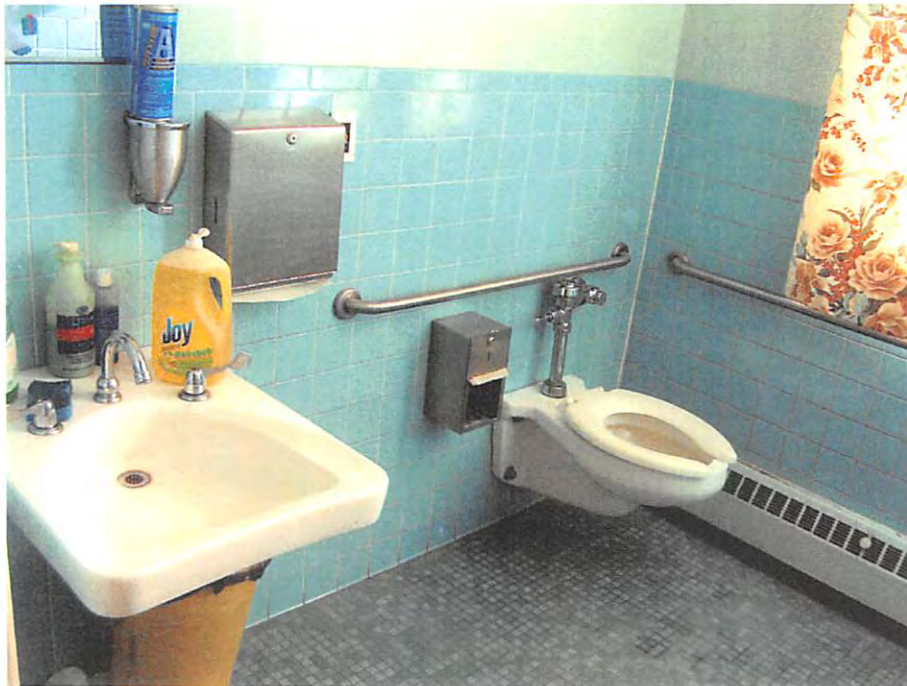
FIRST FLOOR MEN'S ROOM

- Non-Accessible / Compliant Toilet Accessories

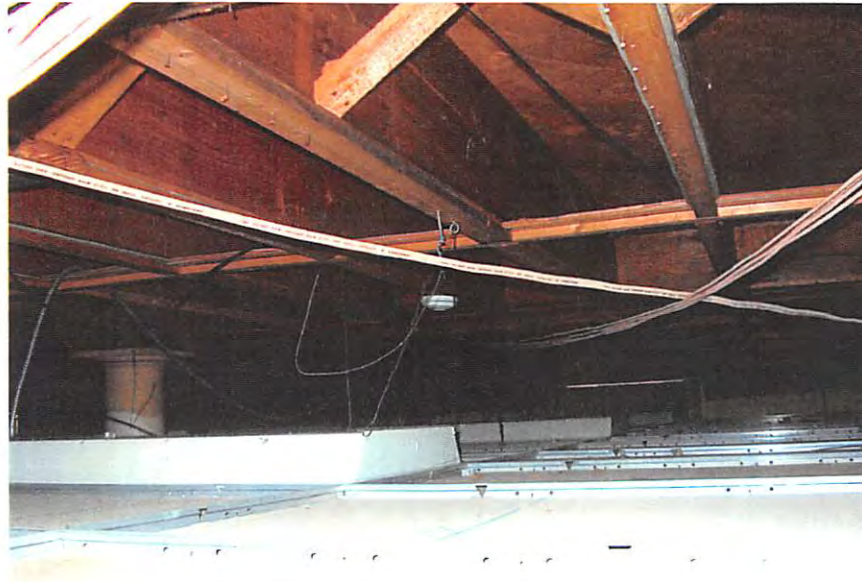
FIRST FLOOR MEETING ROOM CEILING PLENUM

- Previously Installed Suspended Ceiling / Lighting
- Remaining Furring from Original Ceiling Finish
- Original Column Capital Concealed Above Ceiling
- Loose Electrical Wiring
- Plenum Smoke Detector

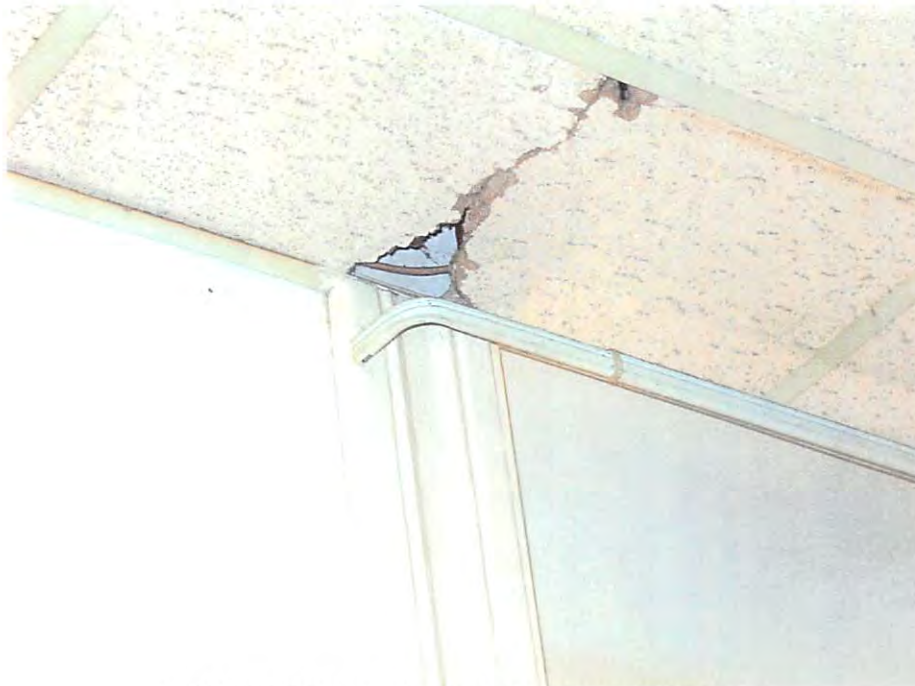
FIRST FLOOR MEETING ROOM WINDOW HEAD

- Wood Window Trim at Suspended Ceiling
- Suspended Ceiling Bisects Glass Window

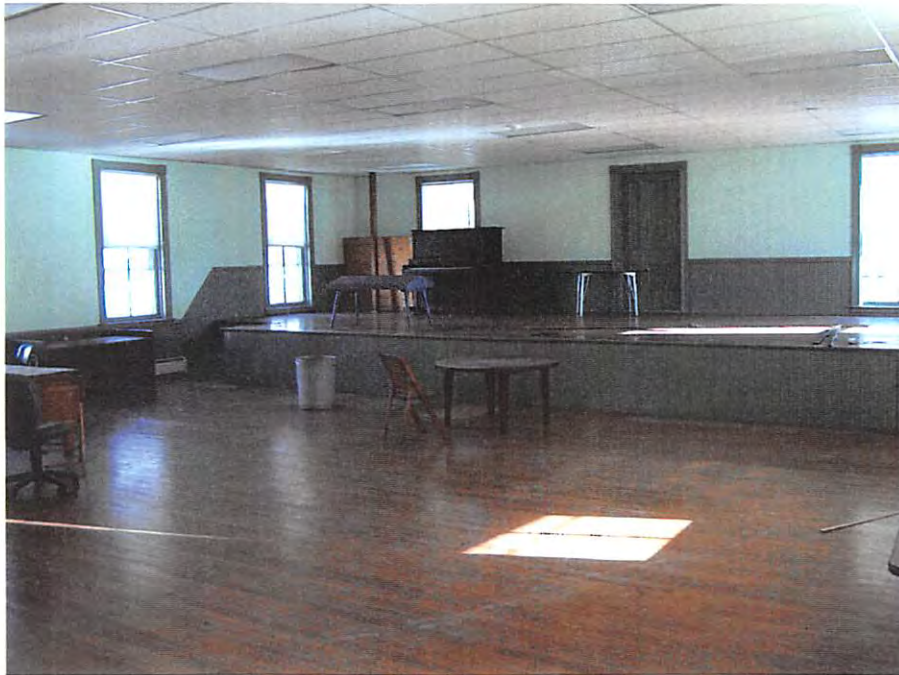
SECOND FLOOR MEETING ROOM / STAGE

- Previous Installed Suspended Ceiling / Lighting
- Low Window Sill Height at Stage

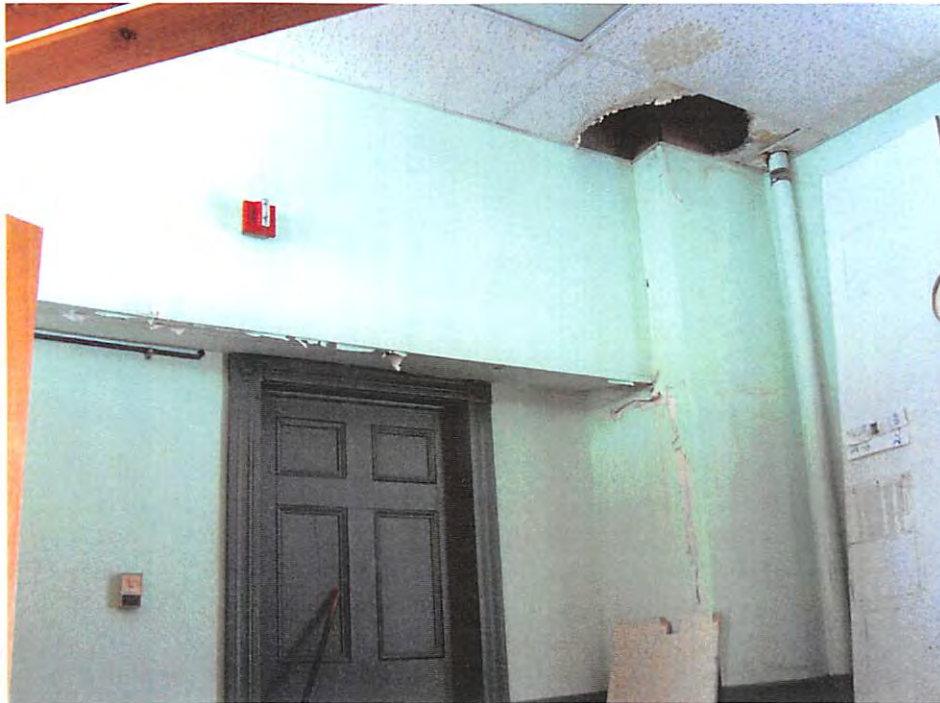
SECOND FLOOR MEETING ROOM

- Previous Water Damage Near Chimney

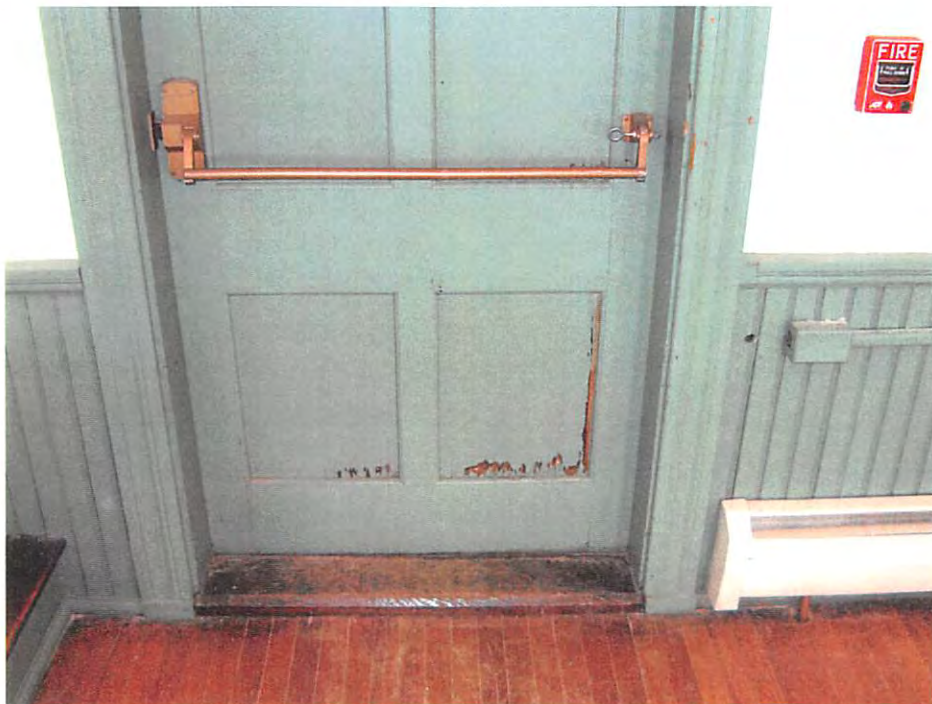
SECOND FLOOR FIRE ESCAPE EXIT DOOR

- Moisture Damage at Lower Door
- Wood Wainscoting
- Previously Installed Hydronic Baseboard

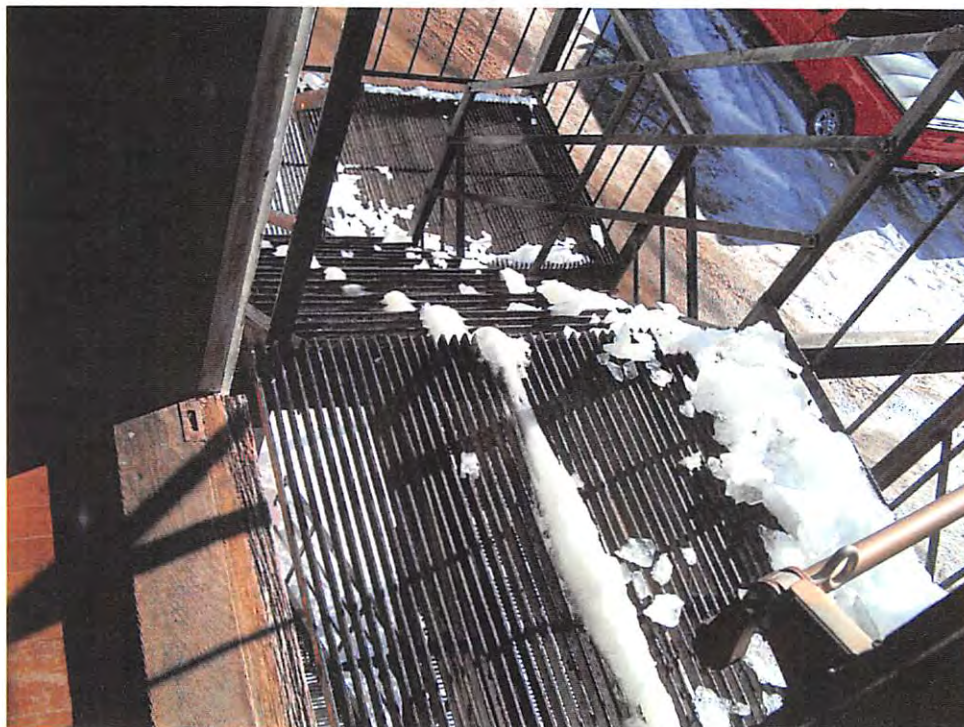
SECOND FLOOR FIRE ESCAPE

- Snow and Ice Falls from Roof Obstructing Exit
- Wood Will Partially Rotted

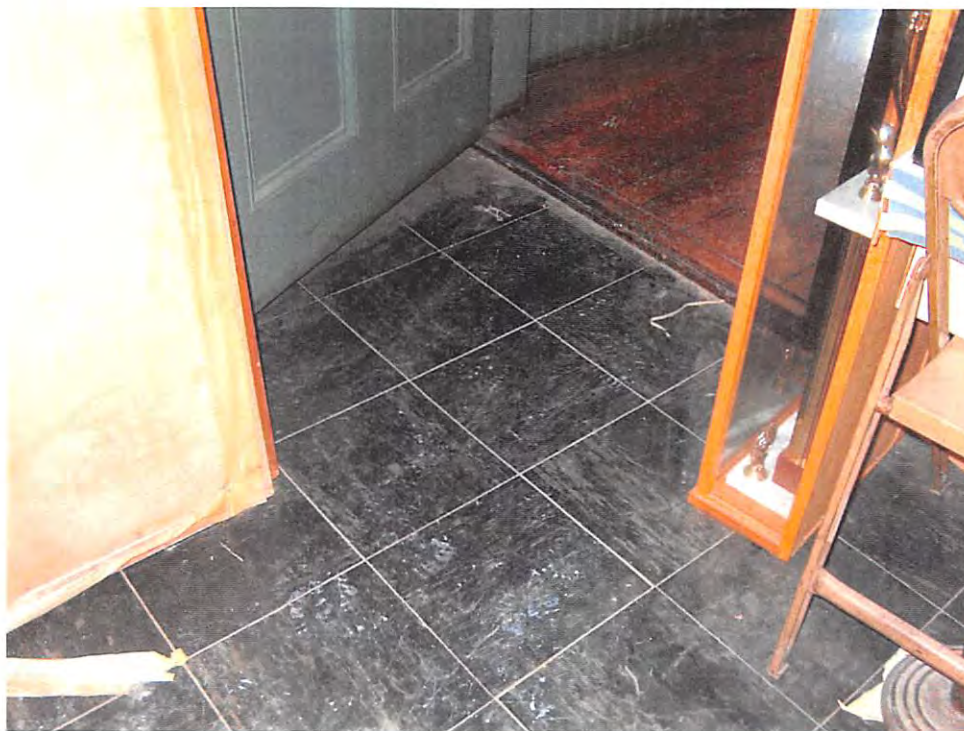
SECOND FLOOR OFFICE

- Probable Vinyl Asbestos Floor Tile

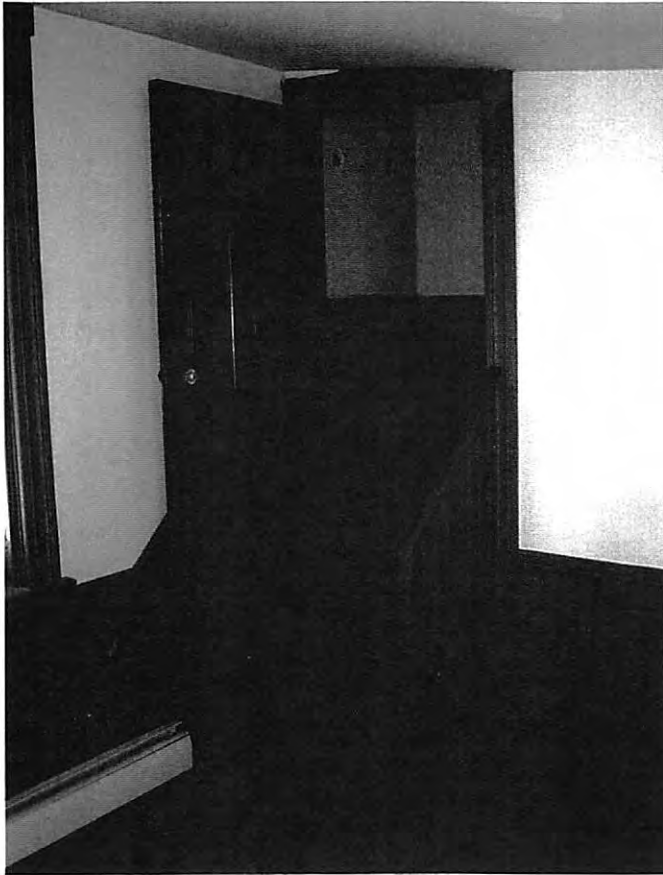
SECOND FLOOR BALCONY STAIR

- Cracked Plaster Ceiling in Lobby Area
- Exterior wall Cored Openings for Previous Blown-In Insulation
