STERLING 1835 TOWN HALL

**ARCHITECTURAL / STRUCTURAL ASSESSMENT
and
FEASIBILITY STUDY FOR UNIVERSAL ACCESSIBILITY
of the
STERLING 1835 TOWN HALL BUILDING**

JULY 8, 2005

PHASE I: ARCHITECTURAL CONSERVATION ASSESSMENT

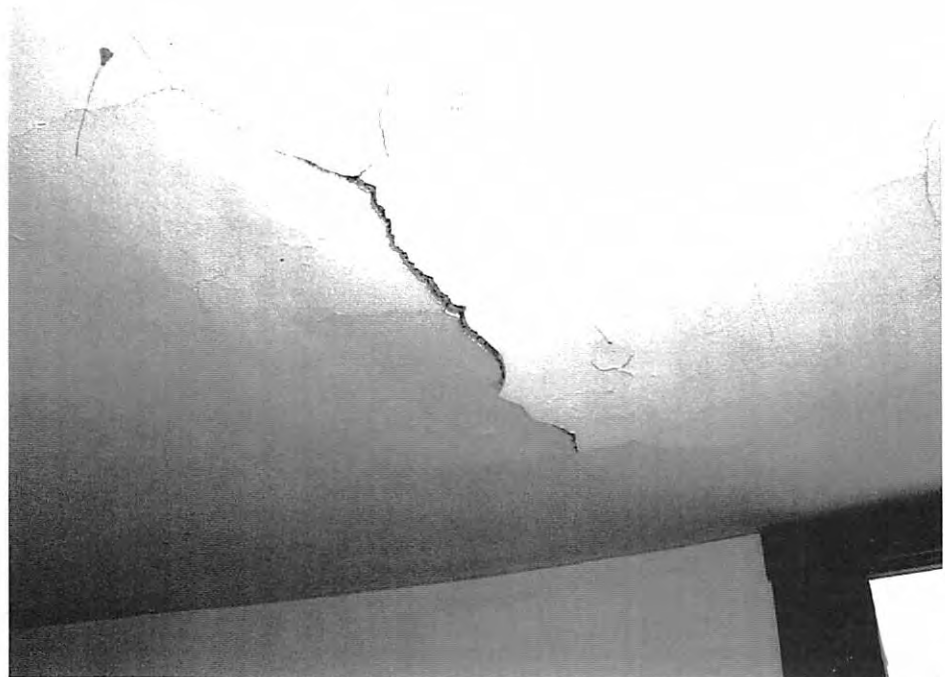
SECOND FLOOR LOBBY CEILING

- Cracked Plaster

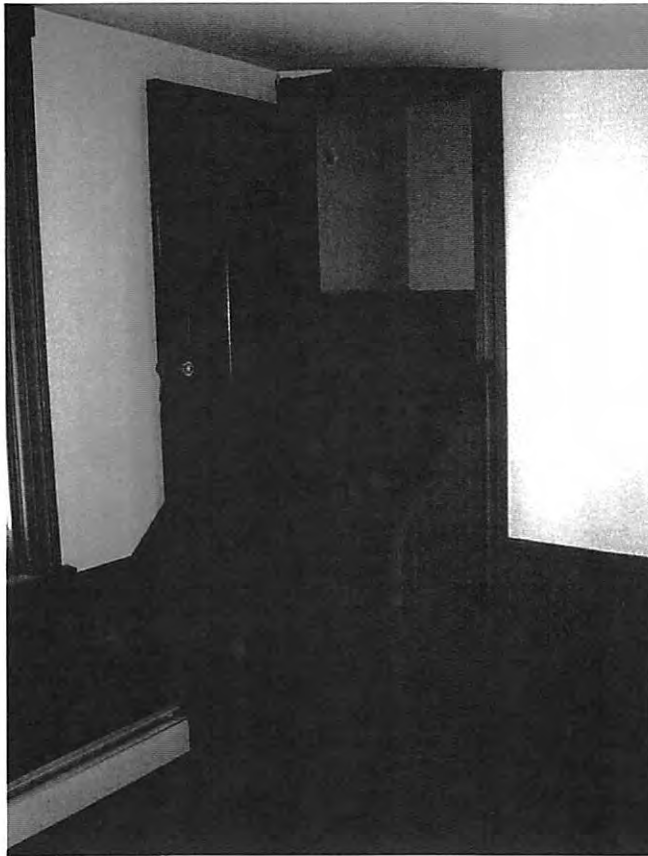
SECOND FLOOR BALCONY STAIR

- Cracked Plaster Ceiling in Lobby Area
- Exterior Wall Cored Openings for Previous Blown-in Insulation

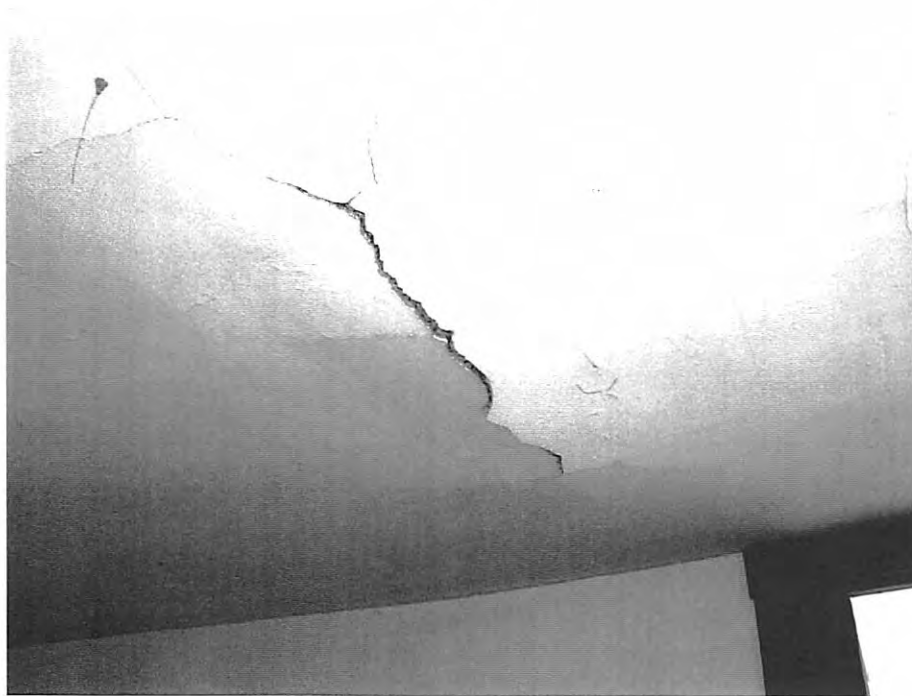
SECOND FLOOR LOBBY CEILING
Cracked Plaster

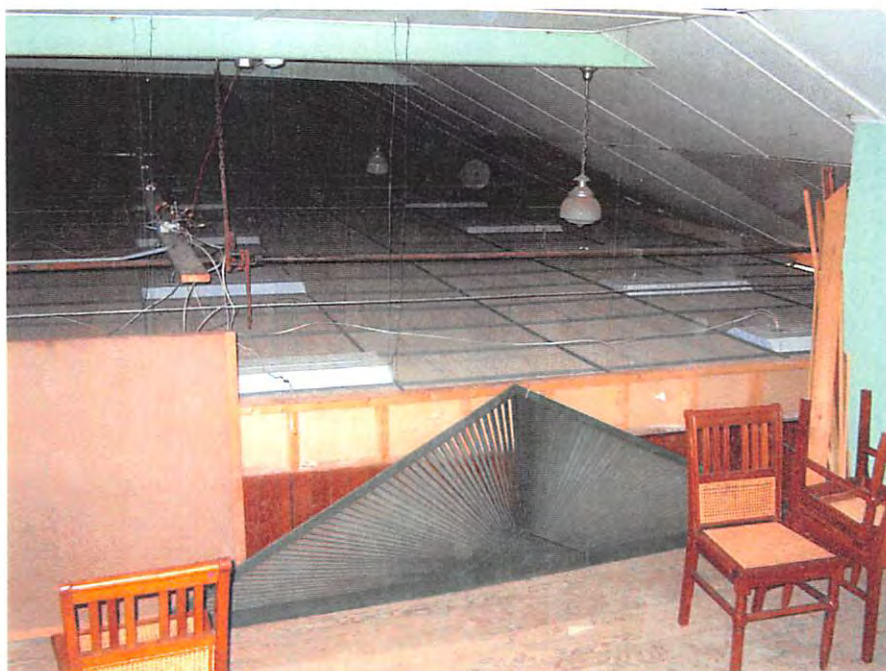
BALCONY

- Original Ceiling Above Suspended Ceiling
 - Original Type Light Fixtures
- Timber Truss Tie Rod and Cable Repairs

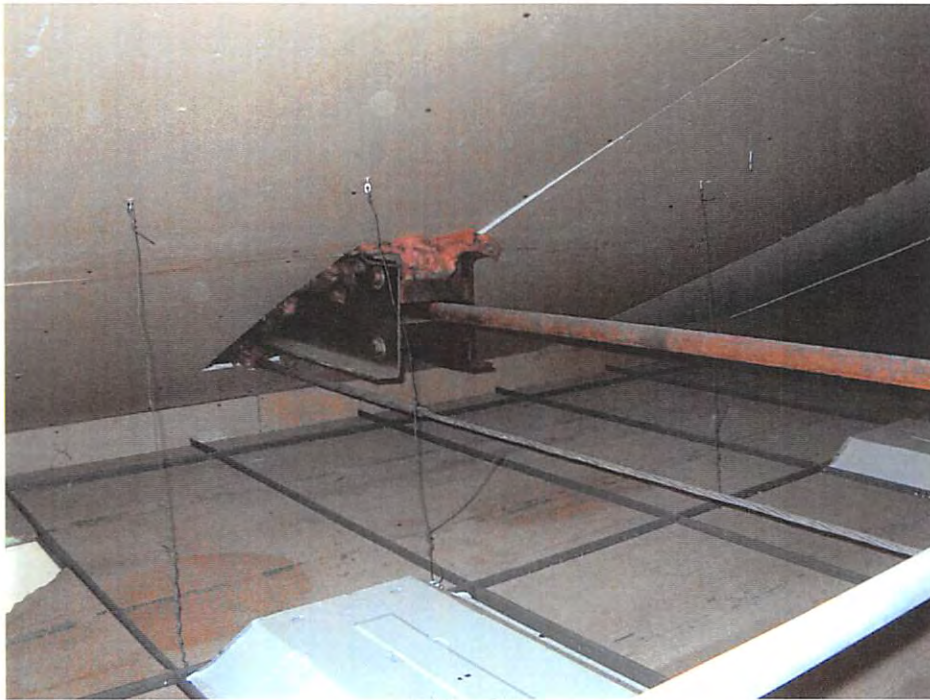
BALCONY

- Truss Tie Rod Repair
- Gypsum Board Repair of Original Wood Board / Batten Ceiling

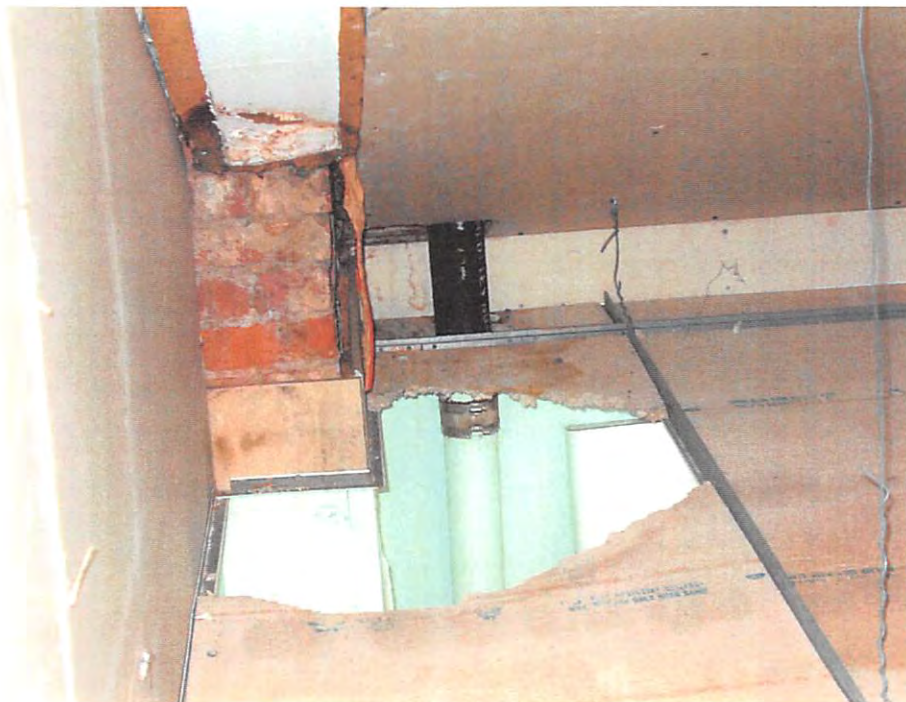
BALCONY

- Previous Roof Leak / Damage Near Chimney
