INTERIM REPORT
HORIZONTAL TIE REPLACEMENT
STERLING TOWN HALL
STERLING, MASSACHUSETTS

Prepared by

Harvey & Tracy Associates, Inc.
143 Dewey Street
Worcester, MA 01610

August 1987

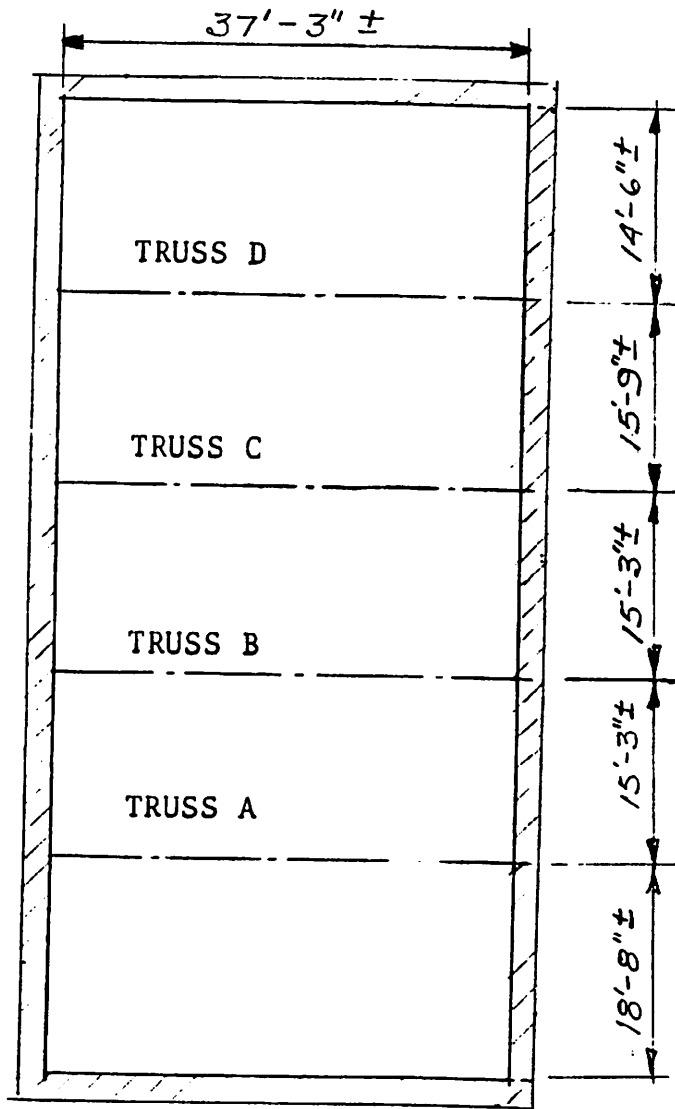
TRUSS LAYOUT PLAN

Several months ago a failure occurred in one of the ties (A)* in the original building. When the failure occurred the eave line on the two opposite sides of the building spread somewhat at this location. Although the only information concerning the failure as related to this office is verbal, it appears that the failure occurred in the connection of the yoke device to the rod at one of the two ends.

This rod assembly was then replaced with a cable type of assembly while still utilizing the existing yokes at the ends. Sometime later a similar type of failure occurred at the second tie (B)* within the original portion of the building. This one was then repaired in a similar fashion and it was then the intent of the Town to replace the ties (C and D)* which were in the newer portion of the building. After tie (C) had been replaced Harvey & Tracy Associates, Inc. was contacted to review the repairs that were being and had been undertaken and to comment on their appropriateness.

The yoke type devices at the end of the ties (A and B)* in the original part of the building had undergone some distortion as might be expected as their configuration introduced forces and stresses that were not designed for. This distortion in turn caused distress in the wood members to which they are attached.

There does not appear to be any distress in the remaining tie (D)* in the building addition. A visual review in the attic (limited because of low head room) indicated that there were cracks in some of the wood framing components of the roof.

The pieces of the original tie rod assemblies (A and B)* which had failed were discarded when the replacement ties were installed. Therefore, it is impossible to determine precisely what the mode of failure was. Because the two failures occurred at different times it is also impossible to ascertain what type of loading the building may have been subjected to at the time those failures did take place.

The replacement tie rod assemblies installed to date (A, B, and C)* do not appear to be structurally adequate for code mandated loads and in the case of ties A and B particularly because these incorporate the yoke devices described previously.

The one remaining tie rod assembly (D)* in the building addition does not at this time evidence any visible signs of distress.

New tie rod assemblies should be designed and installed to replace all of the existing tie assemblies including the ones recently installed.
