**FEASIBILITY STUDY FOR THE ADAPTIVE REUSE OF THE
STERLING TOWN HALL
STERLING, MASSACHUSETTS**

FOR THE STERLING BUILDING NEEDS COMMITTEE

**Prepared by
Suzanne O. Carlson, Architect
94 Cross Point Road Edgecomb, Maine**

January 15, 1998

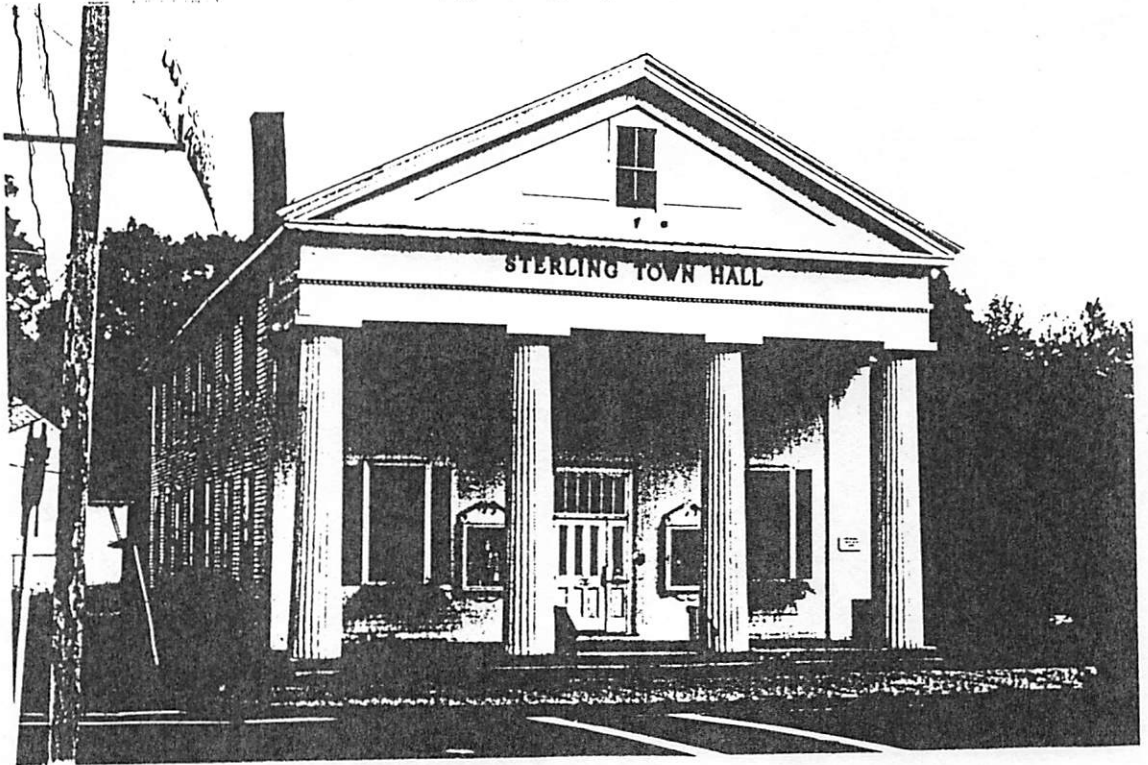
WEST ELEVATION

The large overhanging pediment appears to be structurally sound with gable and soffit woodwork in excellent condition. The four large Doric columns are in excellent condition. The venting system seems to be working well and there is no indication of deterioration in any of the elements. The boarding is also in good condition. Part of the granite platform has been replaced with concrete, but the overall effect of the granite steps and base has been retained.

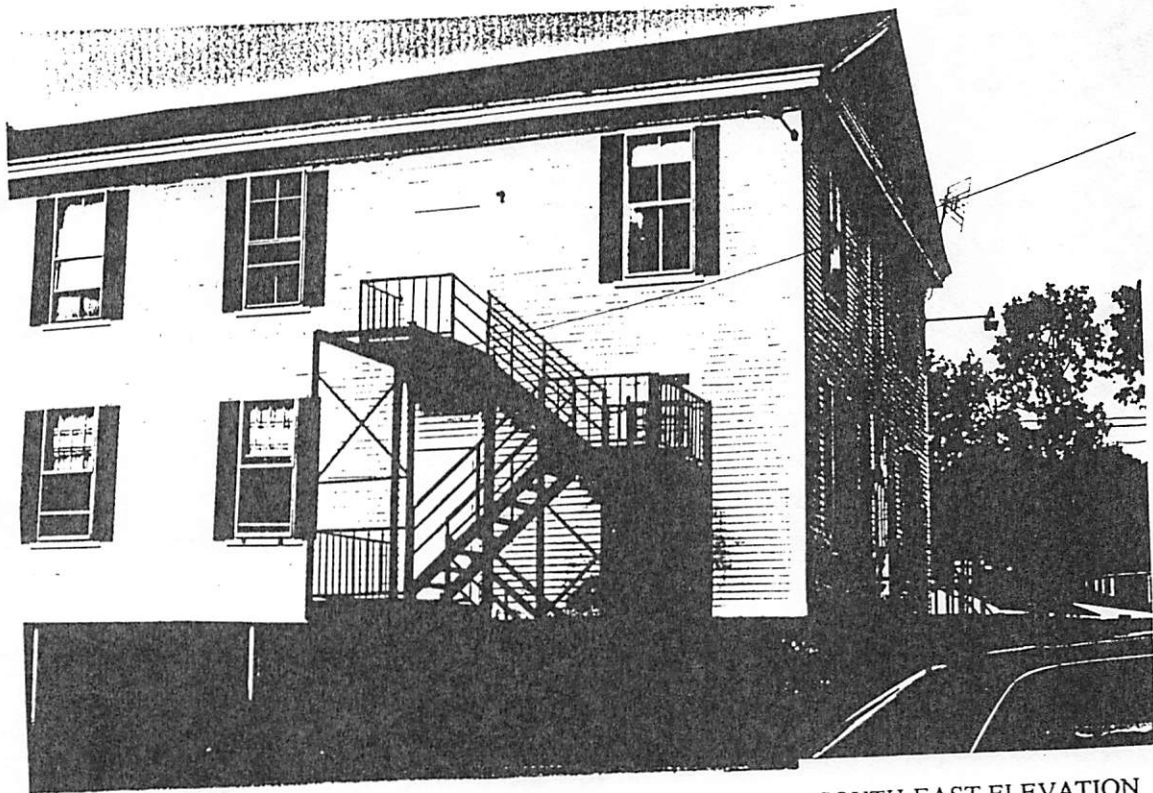
SOUTH ELEVATION

The symmetry of the side wall fenestration is broken by a door and steel fire escape leading from the second floor to grade at basement level. Brick basement wall is in bad condition and needs repair. Windows and doors at basement are in poor condition. The railing design at west end door is not appropriate to the period. All wood needs painting.

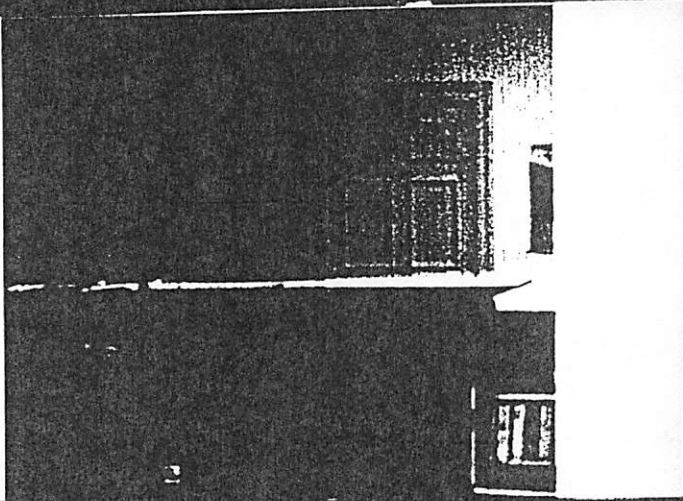
FIRST FLOOR INTERIOR

The first floor underwent major renovations in 1979, adding handicapped toilets, a janitors closet, and new concrete-filled, steel pan stairs to the second floor and basement. The original ceilings were removed and a new suspended acoustical tile ceiling installed throughout. New lighting was incorporated into the ceiling system. New wood panel doors were incorporated added as needed. Wood paneling and standing trim is original and in good condition. The floors are currently carpeted, presumably covering a hard wood floor.

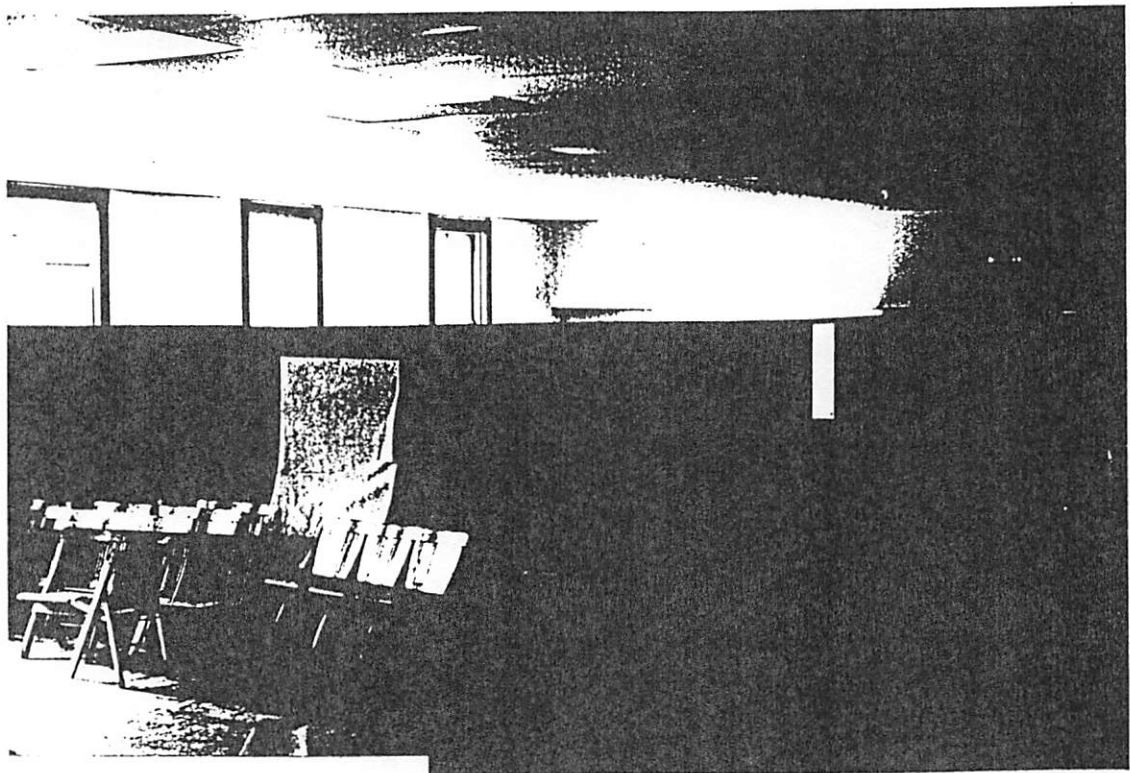
SECOND FLOOR INTERIOR

The second floor: Other than the suspended acoustical tile ceiling the finishes on the second represent the 1890s renovation, with the stage apron and narrow vertical beaded wainscoting still in place. Hardwood floors are in good condition but are need refinishing.
