Sterling 1835 Town Hall

Progress Report October 17, 2018

1835 Town Hall Committee

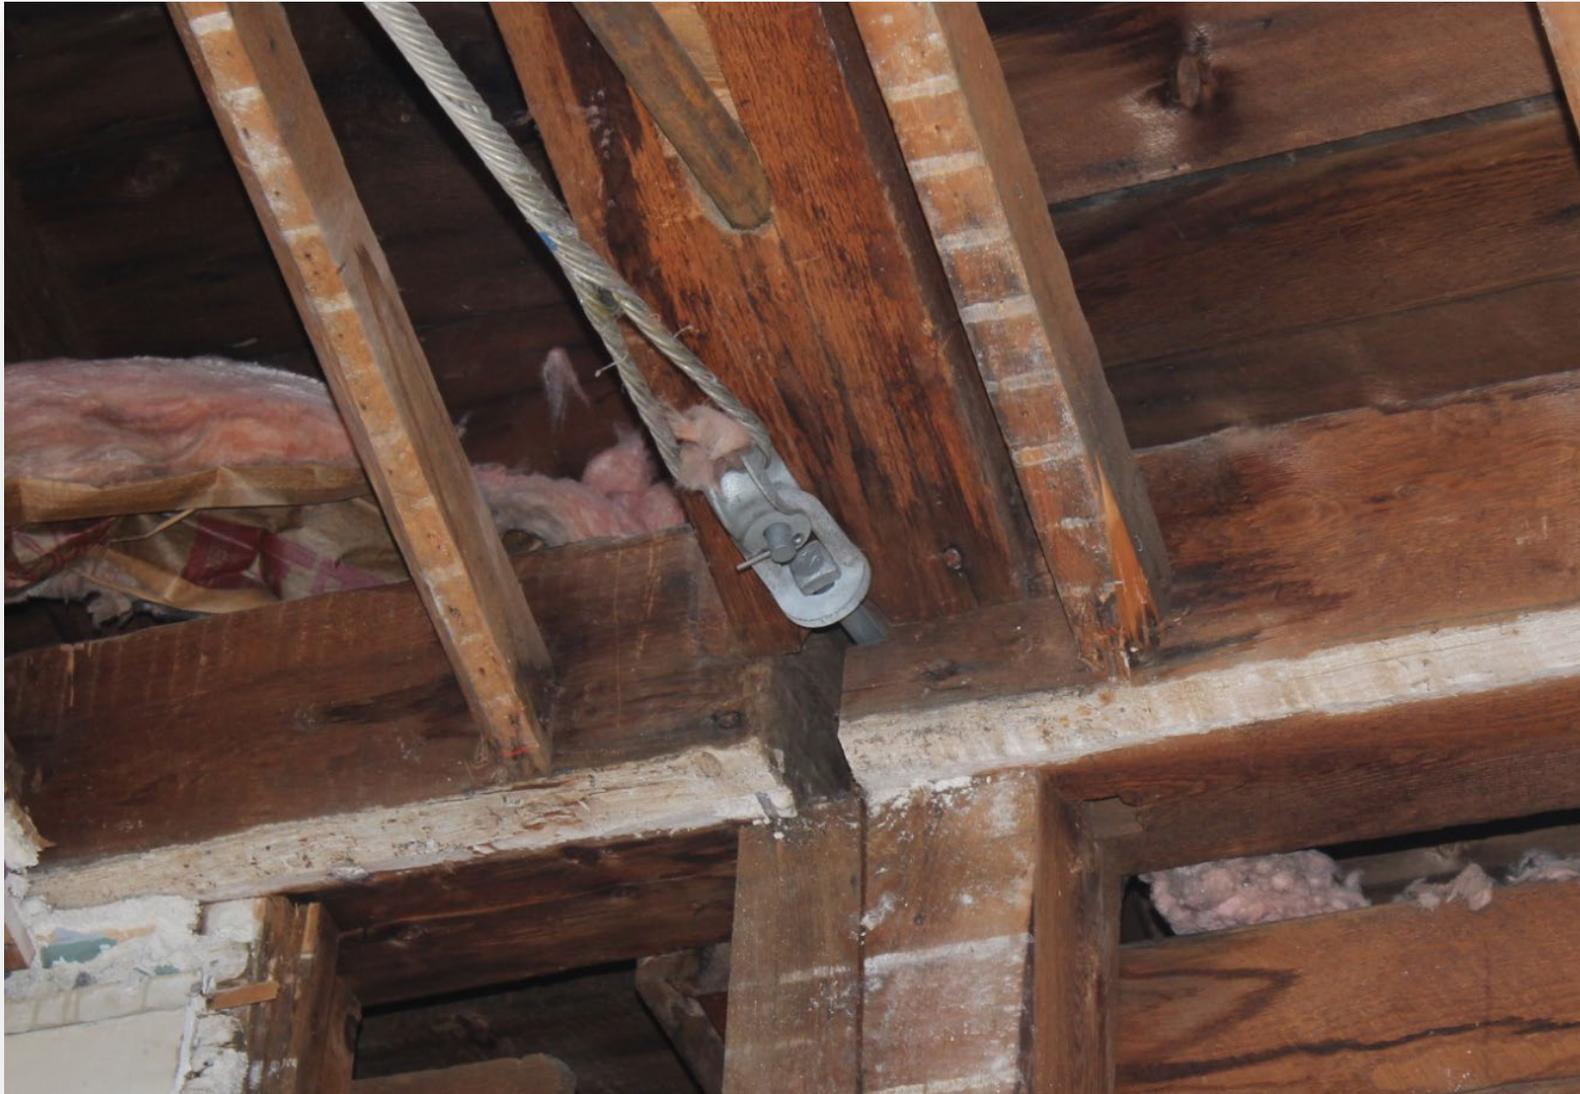
Structure Bay #3 – Before
Junction Timber Frame with Rod and Cable

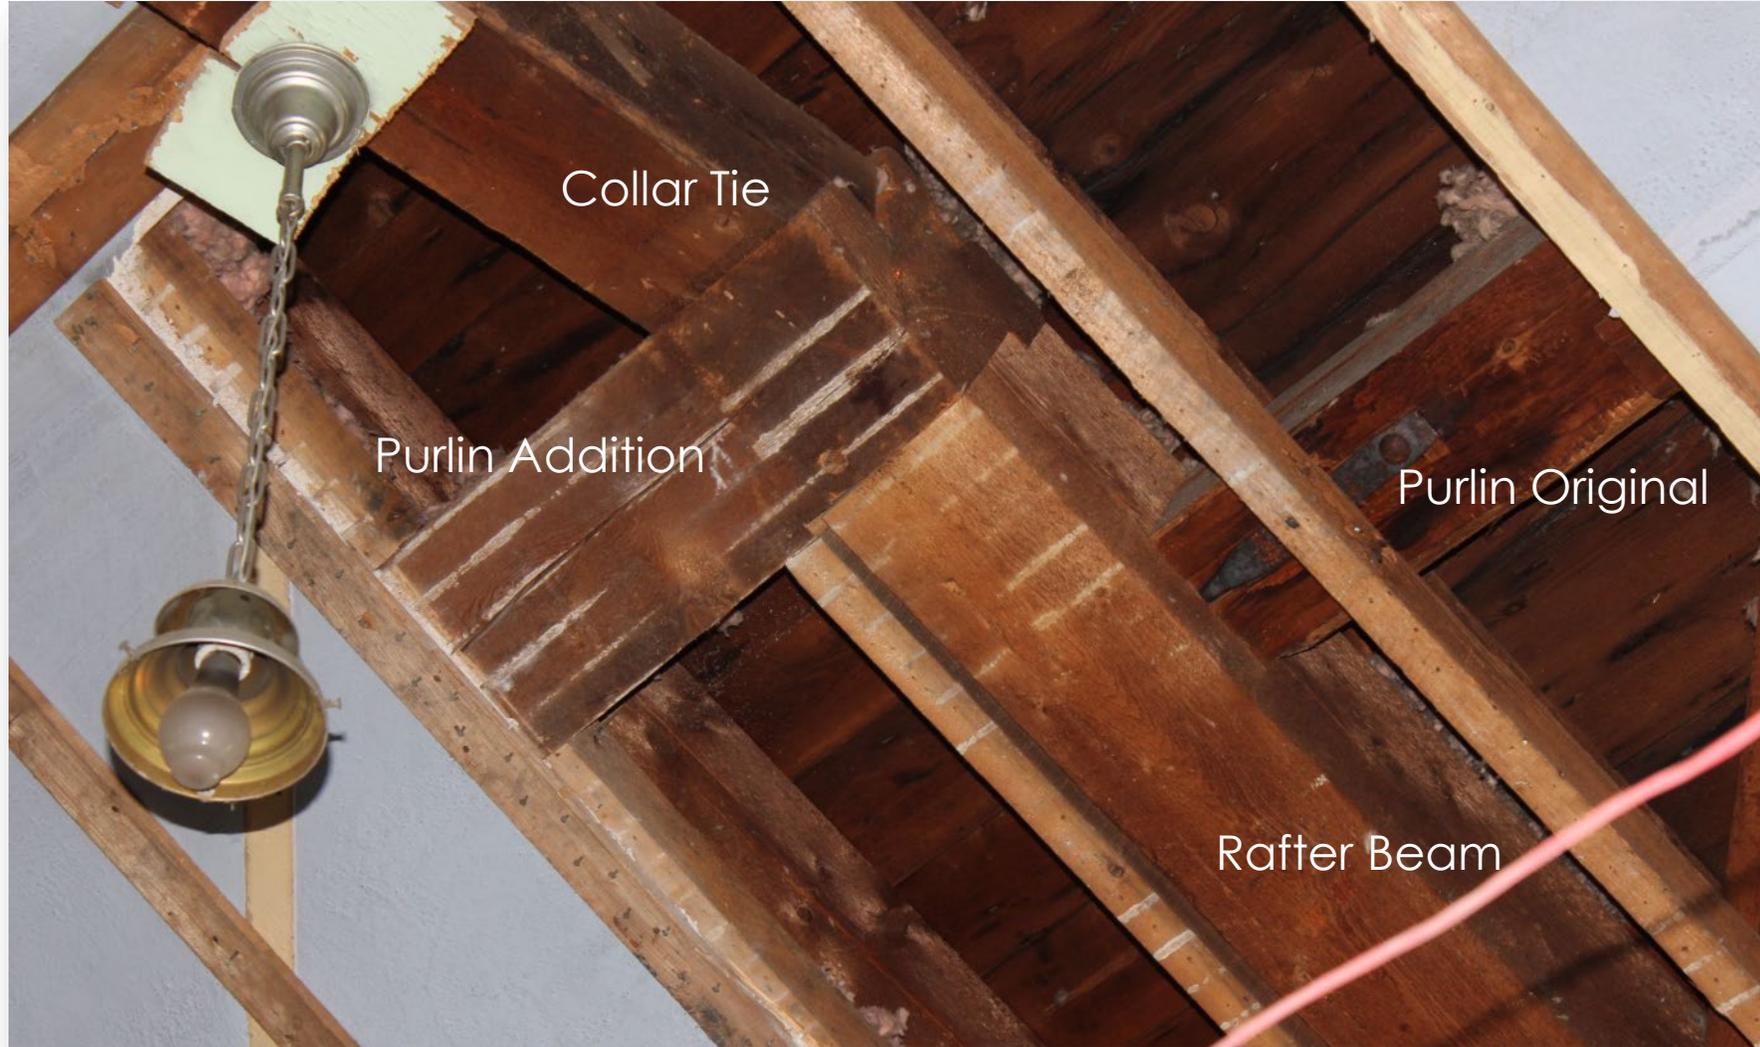
Structure- Before
Junction Timber Purlin and Rafter Beam

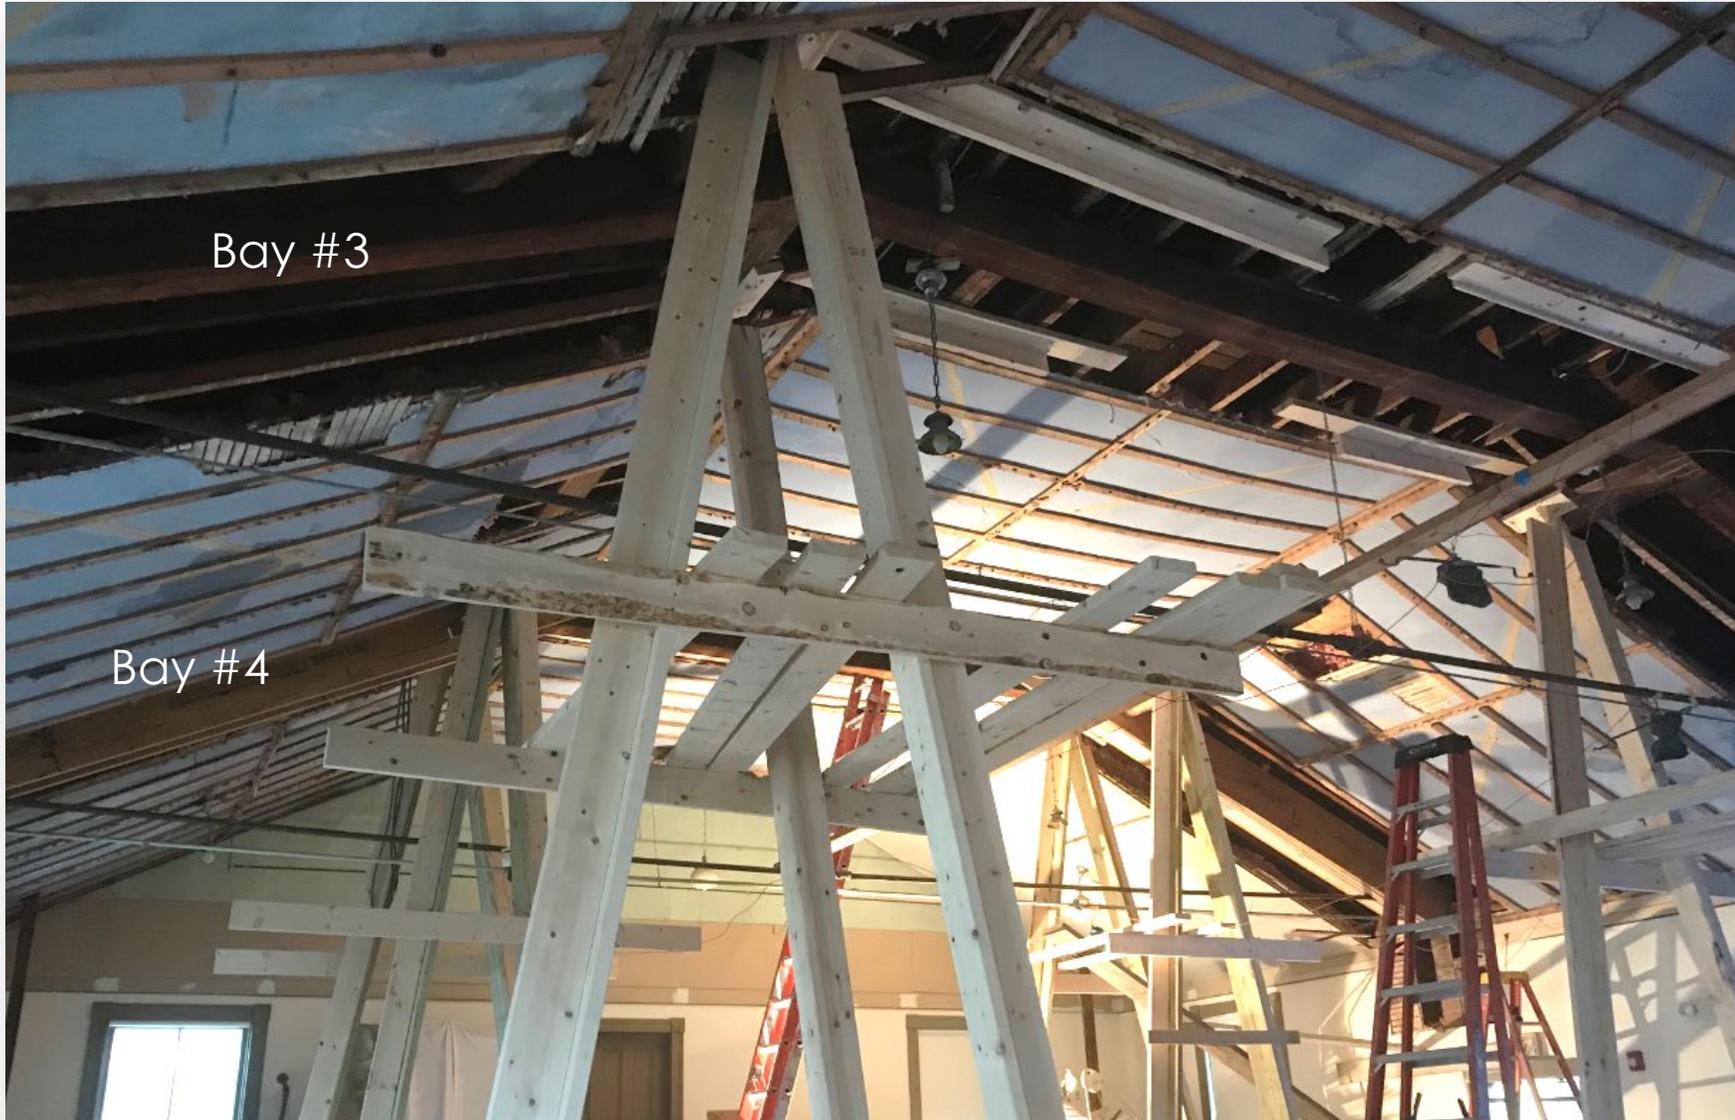
Structure - Current
Temporary Supporting Structure

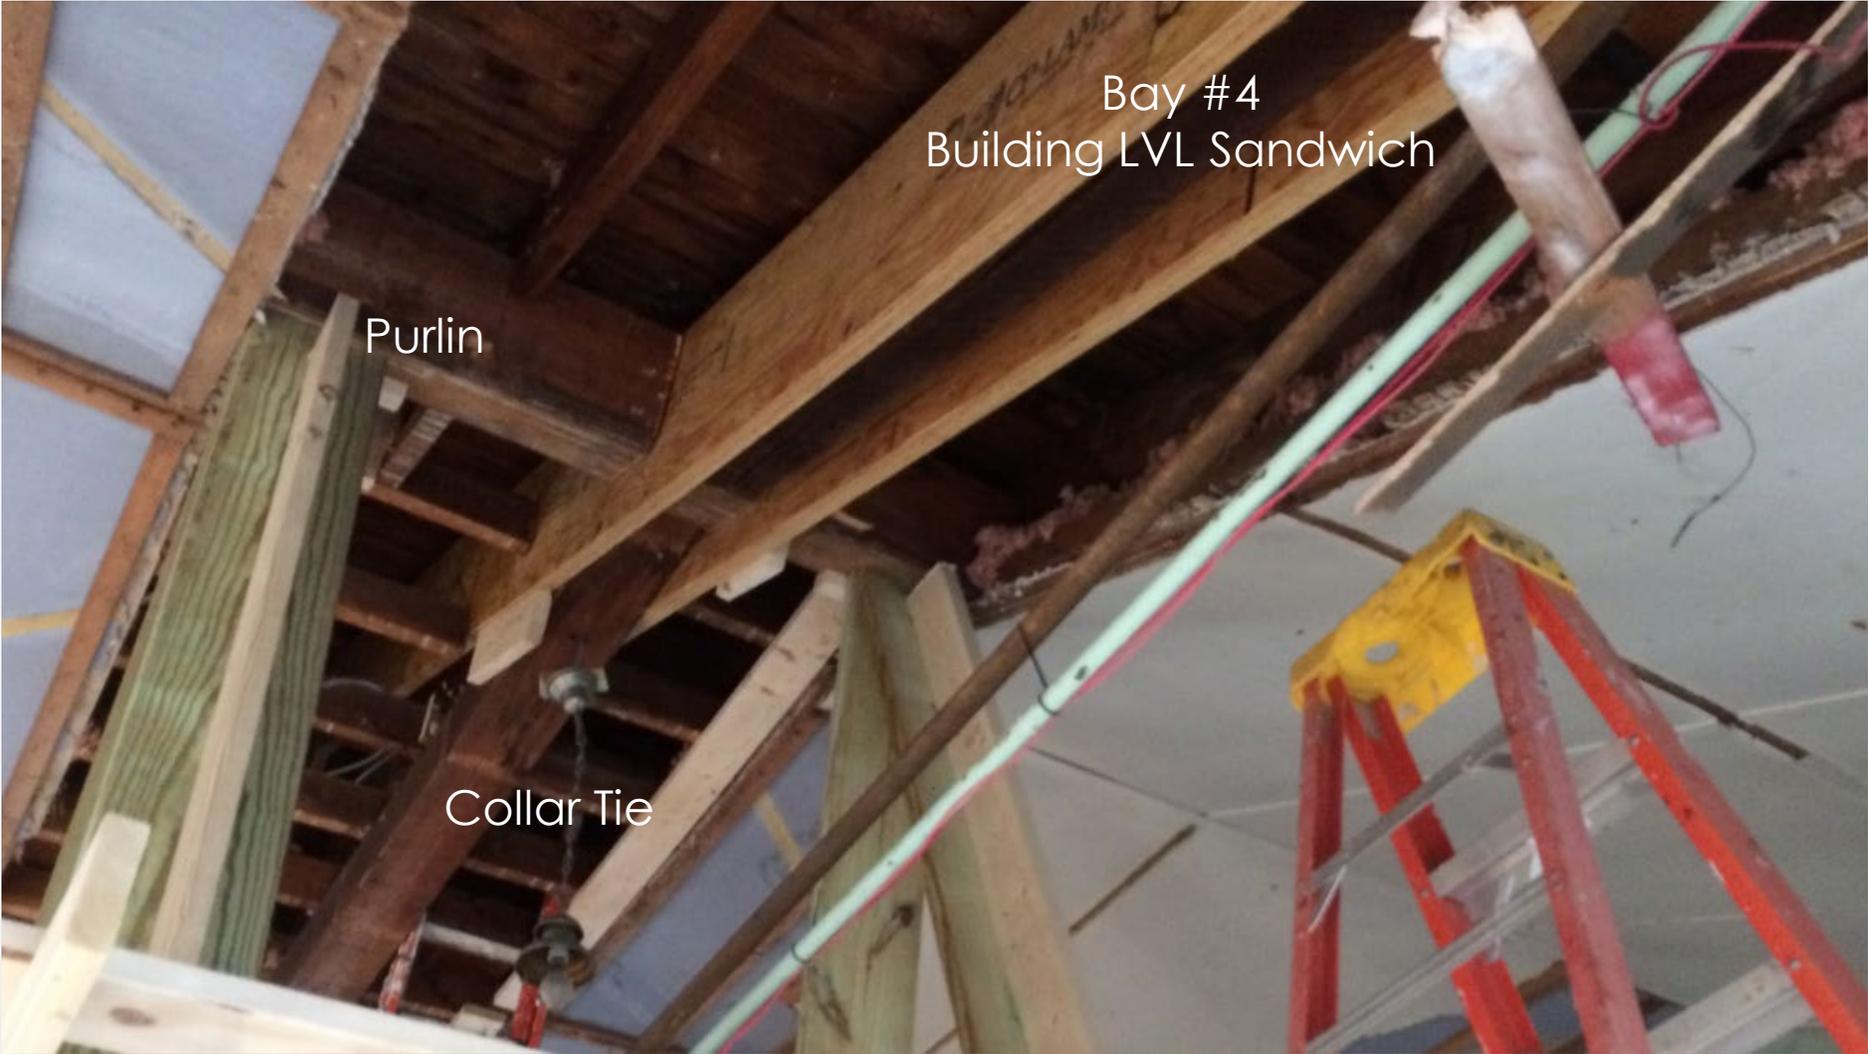
Structure - Current
LVL Sandwich Beam

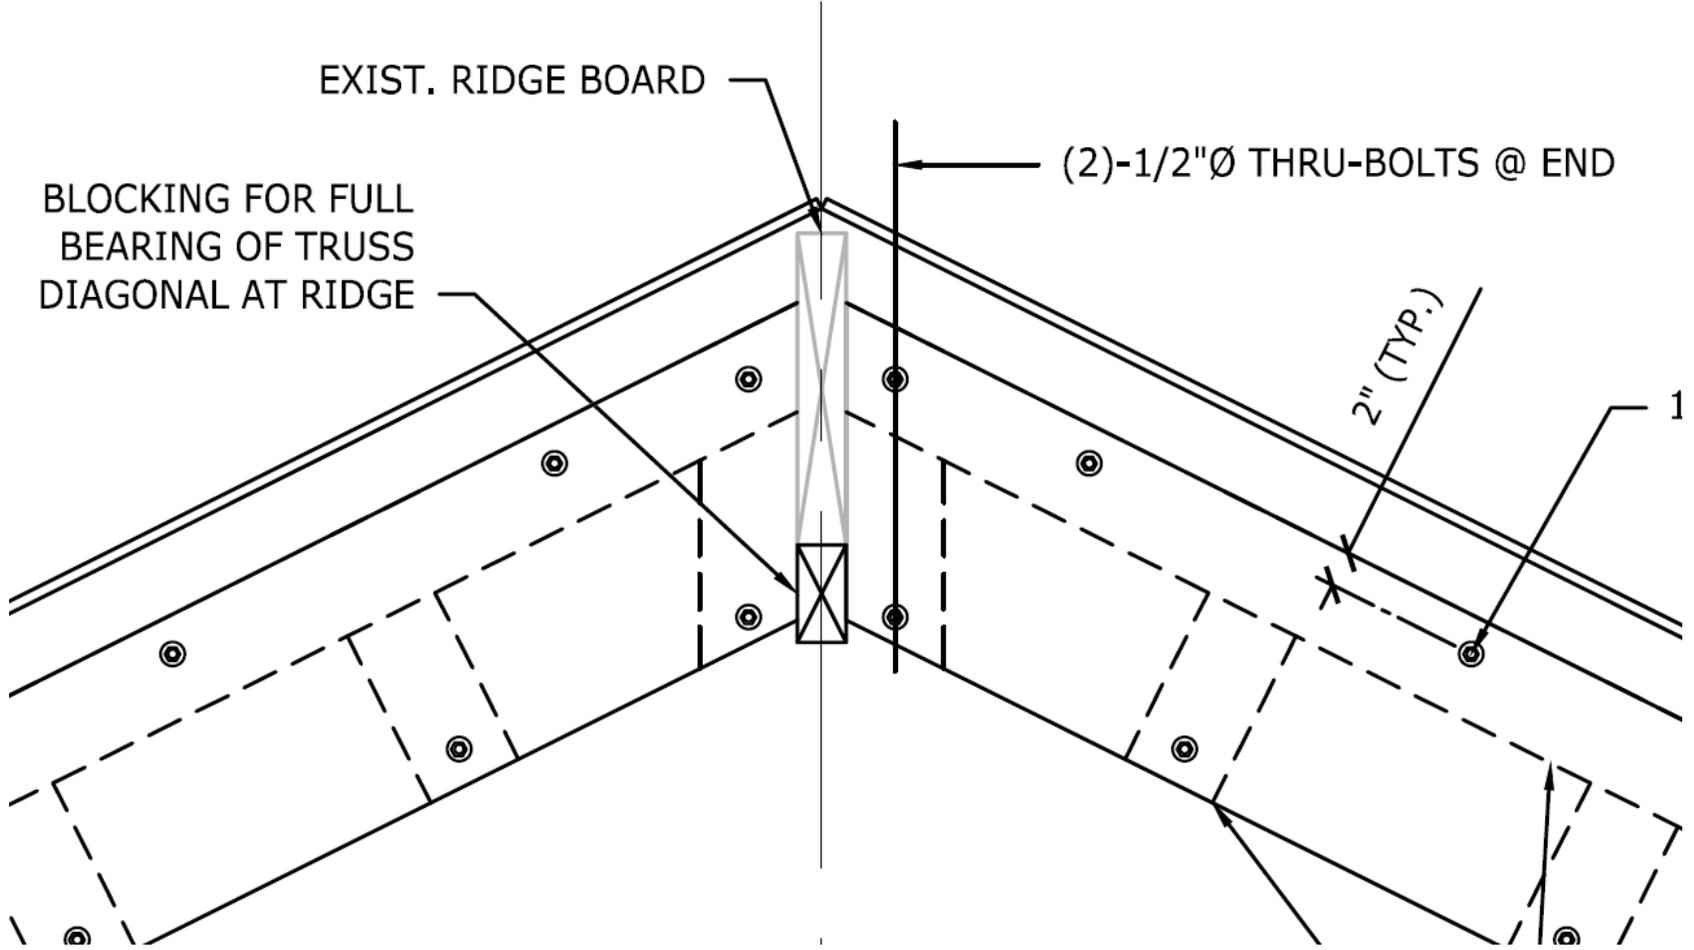
Structure - Current

LVL Sandwich Beam at Ridge

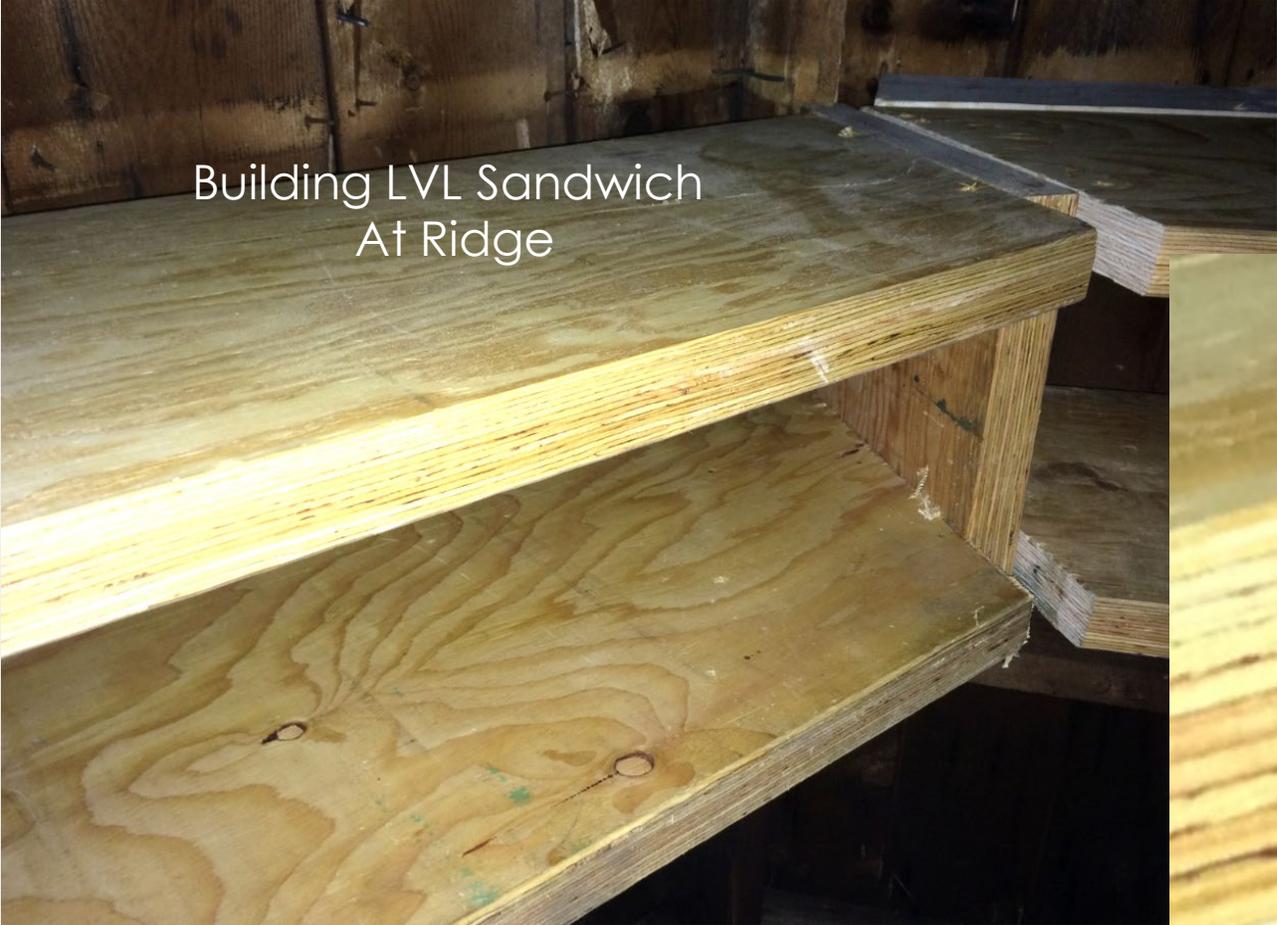
Structure - Current
LVL Sandwich Beam

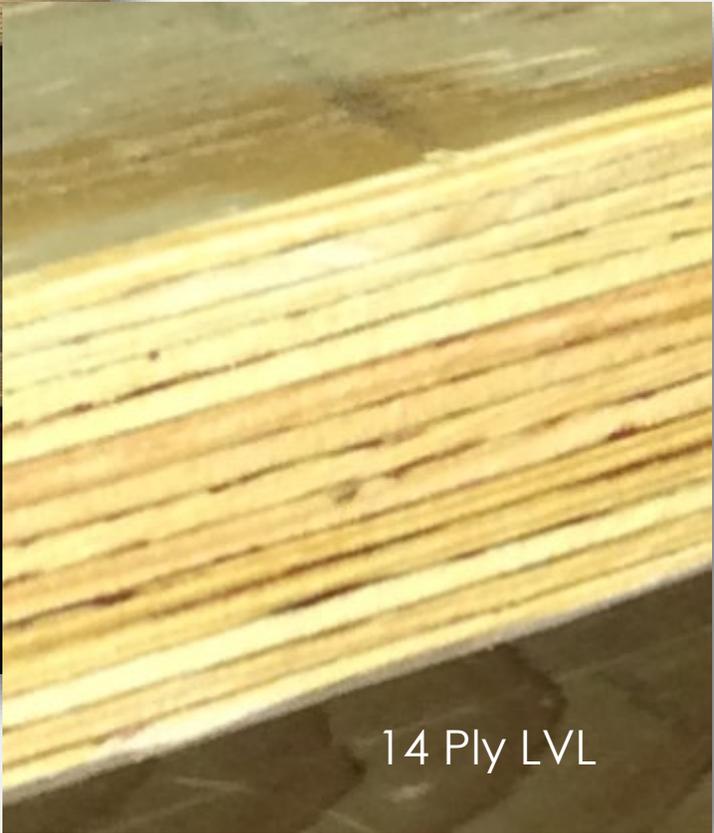
Building LVL Sandwich
At Ridge

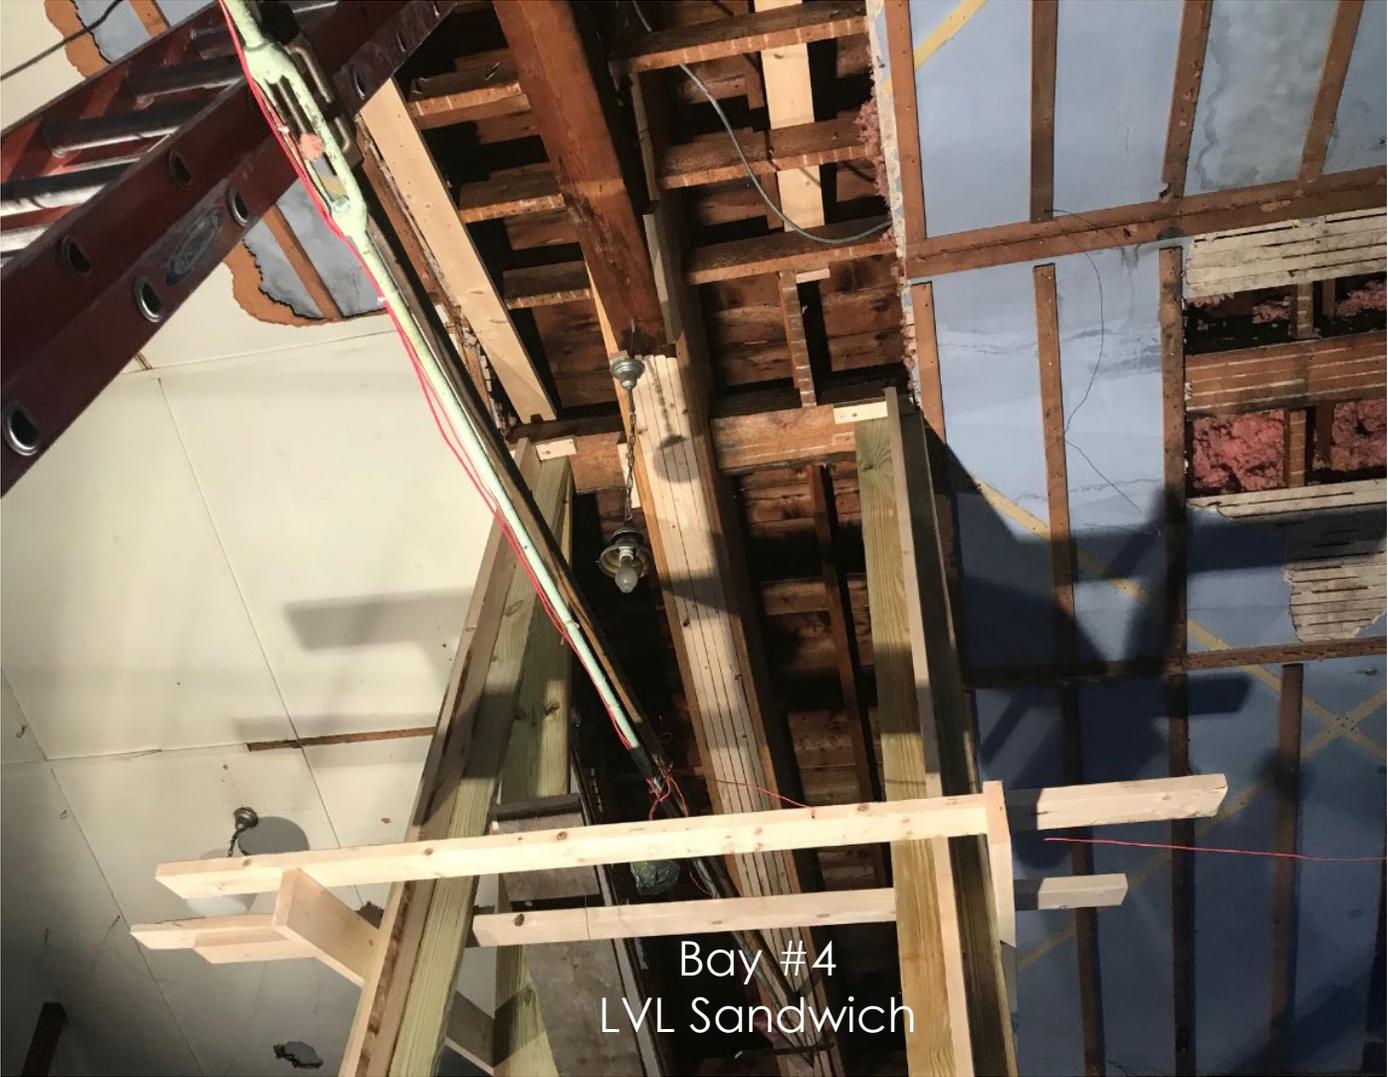
Structure - Current
LVL Sandwich Beam

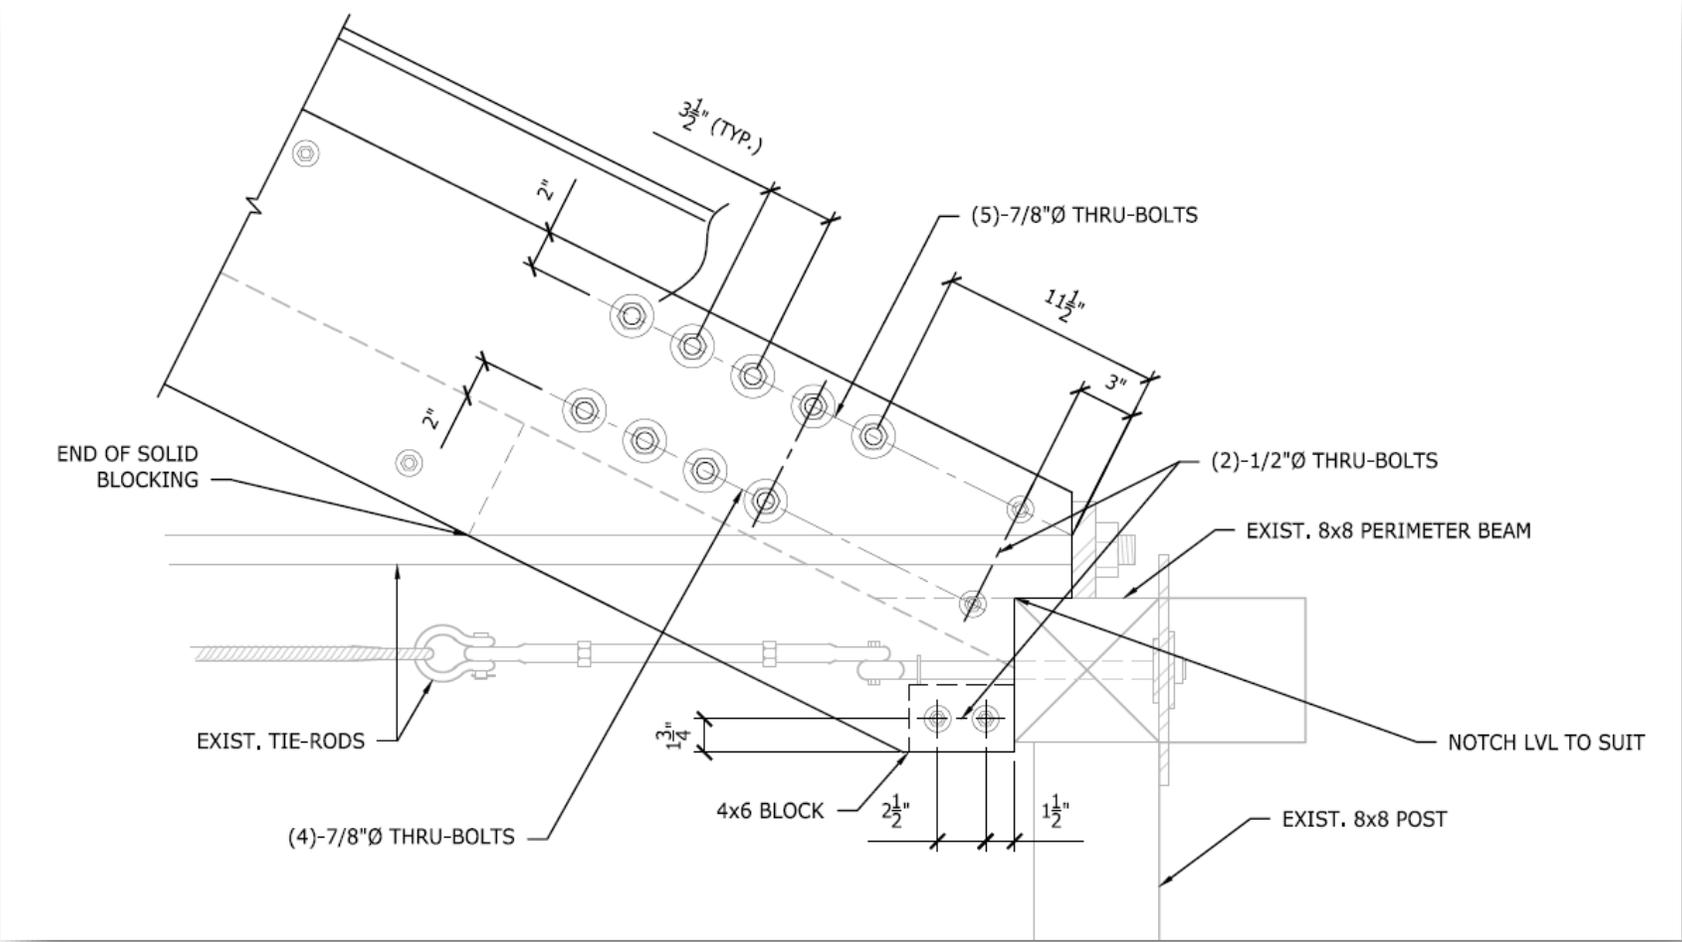
Structure - Current

LVL Sandwich Beam

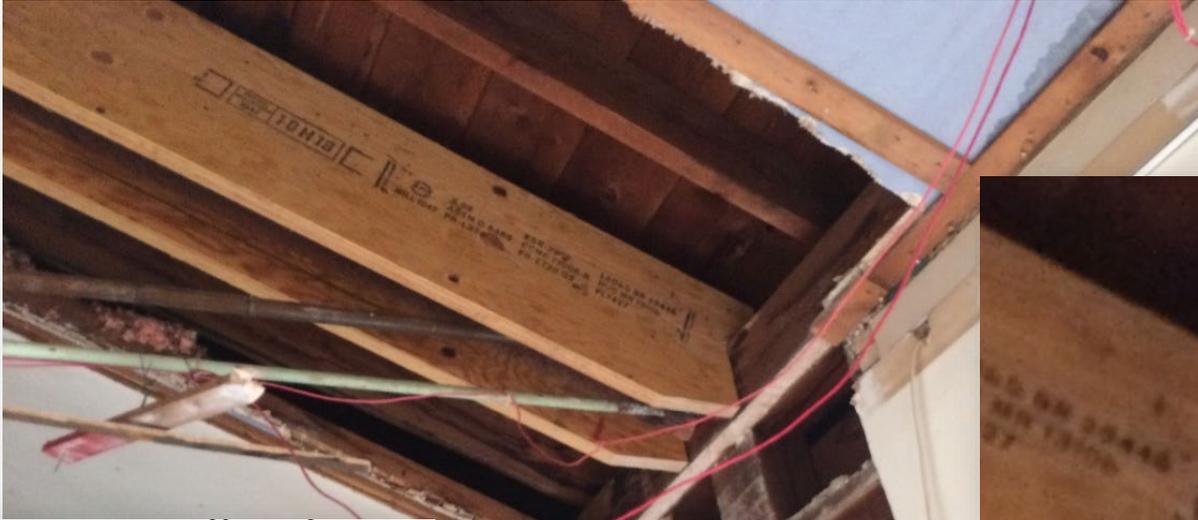
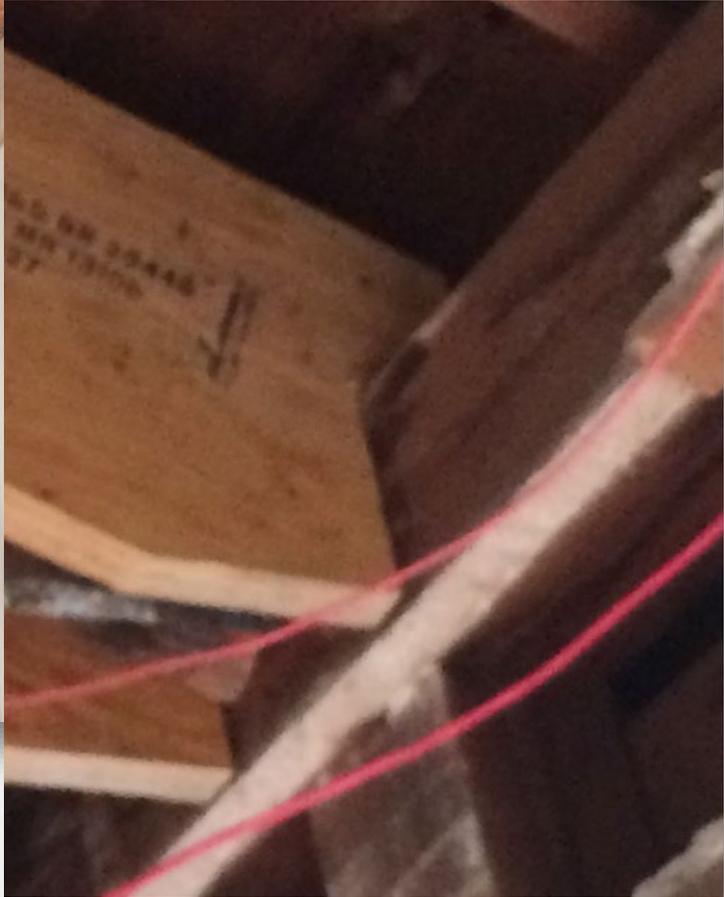
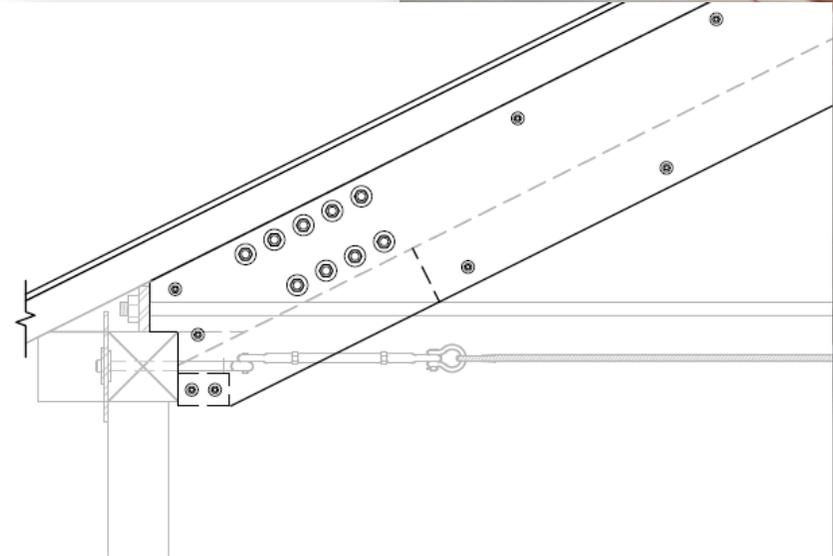
Structure - Current

LVL Sandwich Beam

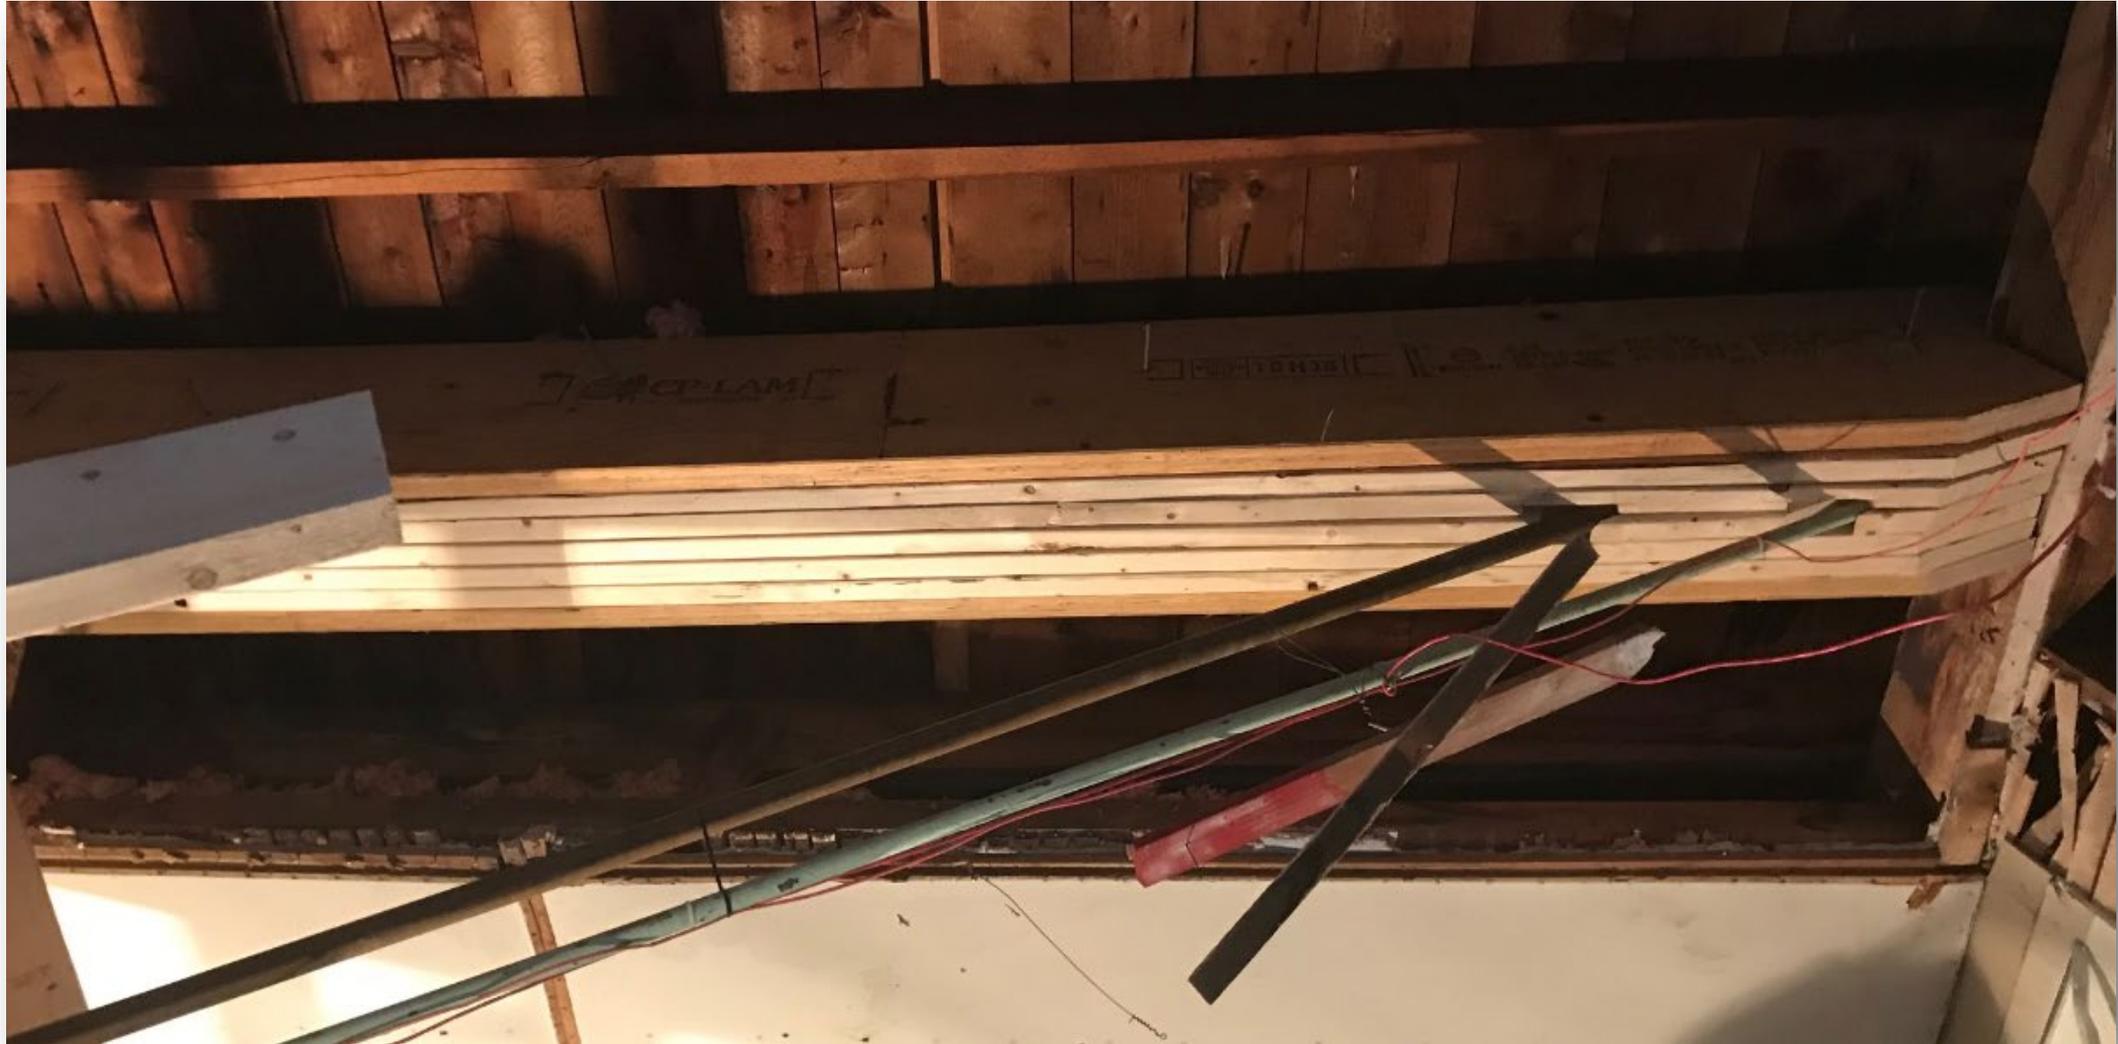
Structure - Current

LVL Sandwich Beam
