## STRUCTURAL SURVEY & RECOMMENDATIONS

Reference: Sterling Town Hall  
Sterling, Massachusetts

Re: Limited Hazardous Building Materials Inspection  
1835 Town Hall, Sterling, Massachusetts  
Fuss & O'Neill EnviroScience, LLC No. 20111236.A1E

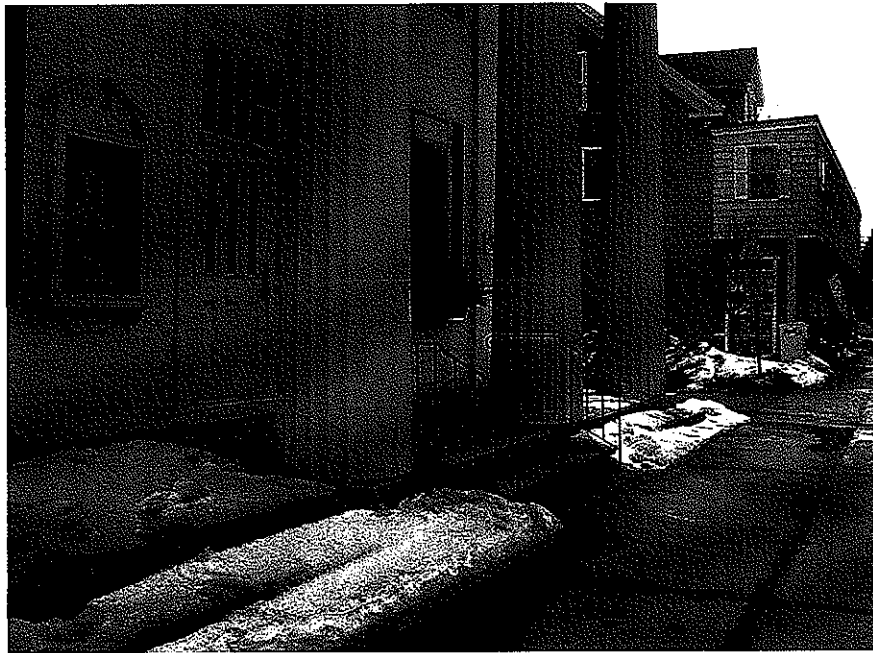
**MAIN ENTRANCE PORTICO**

- Recess Granite Below Columns

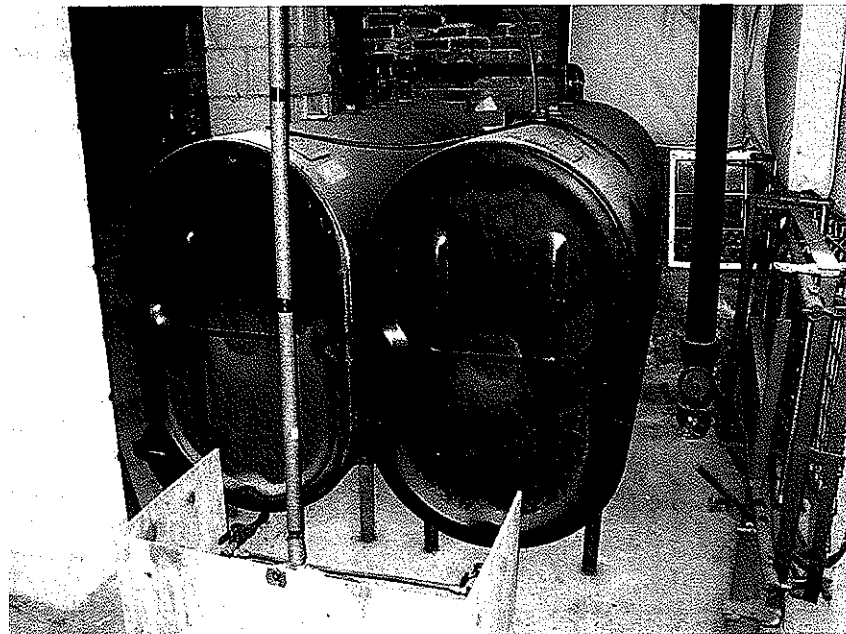
**BASEMENT FUEL OIL TANKS**

- Plywood Protection Skirt at Exposed Piping and Valves
- Existing Sewer Entrance
- Newer CMU Structural Piers (Left)
- Mattress to Block Basement Window Opening (Upper Right)

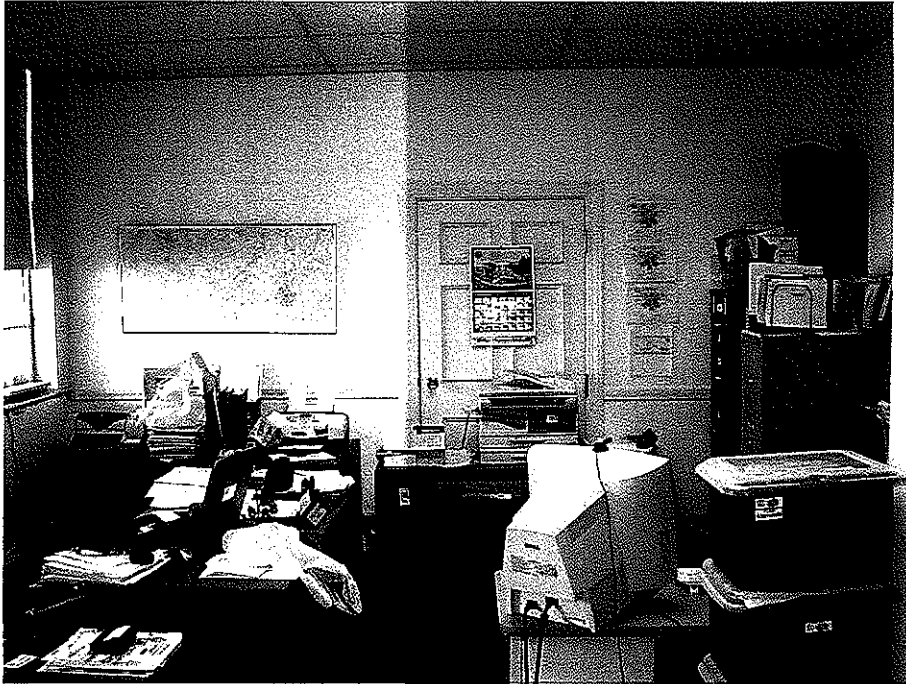
**FIRST FLOOR OFFICE**

- Previous Newer Finishes Include Gypsum Wallboard, Suspended Ceiling, Lighting, Chairrail, Door, Carpeting

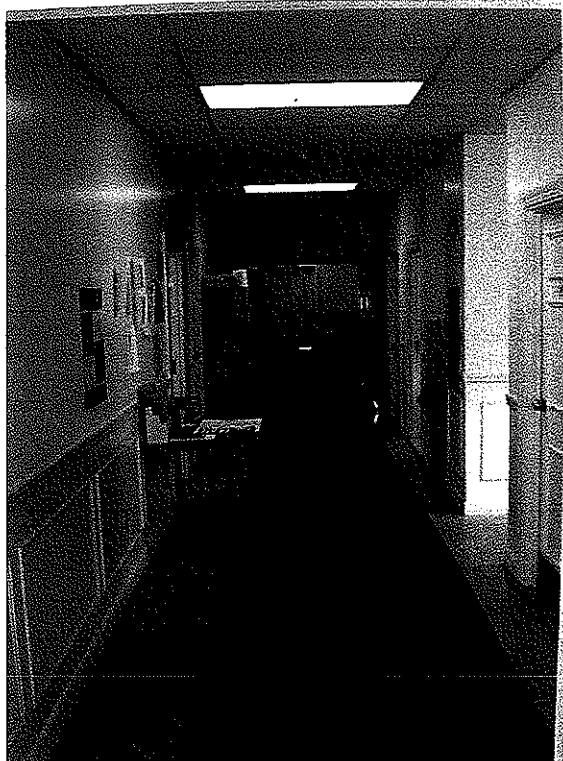
**FIRST FLOOR CORRIDOR**

- Previous New Finishes Include Gypsum Wallboard, Suspended Ceiling Lighting, Wainscoting, Doors, Vinyl Tile Flooring

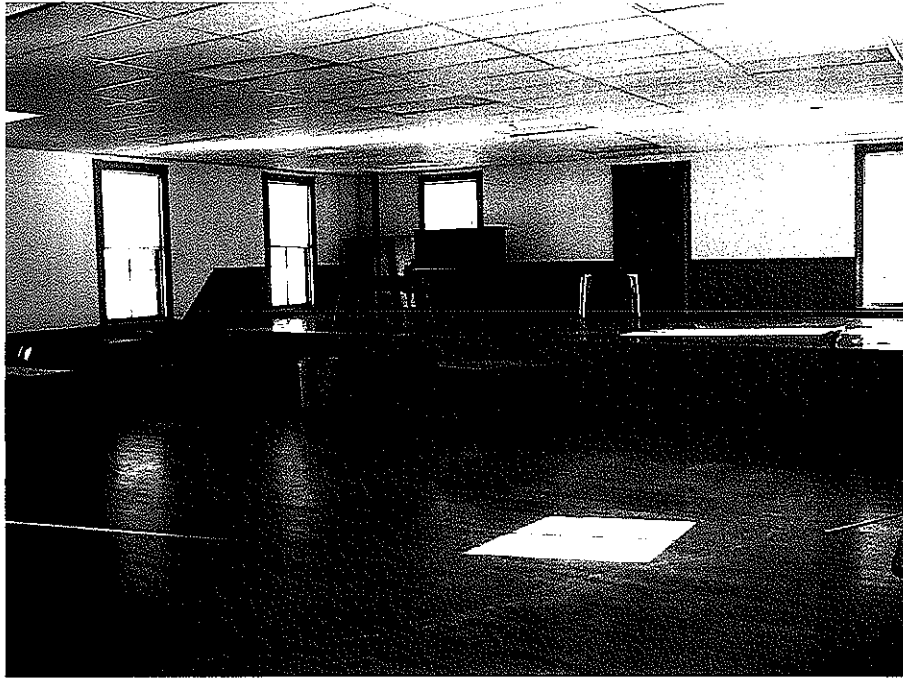
**SECOND FLOOR MEETING ROOM / STAGE**

- Previous Installed Suspended Ceiling / Lighting
- Low Window Sill Height at Stage

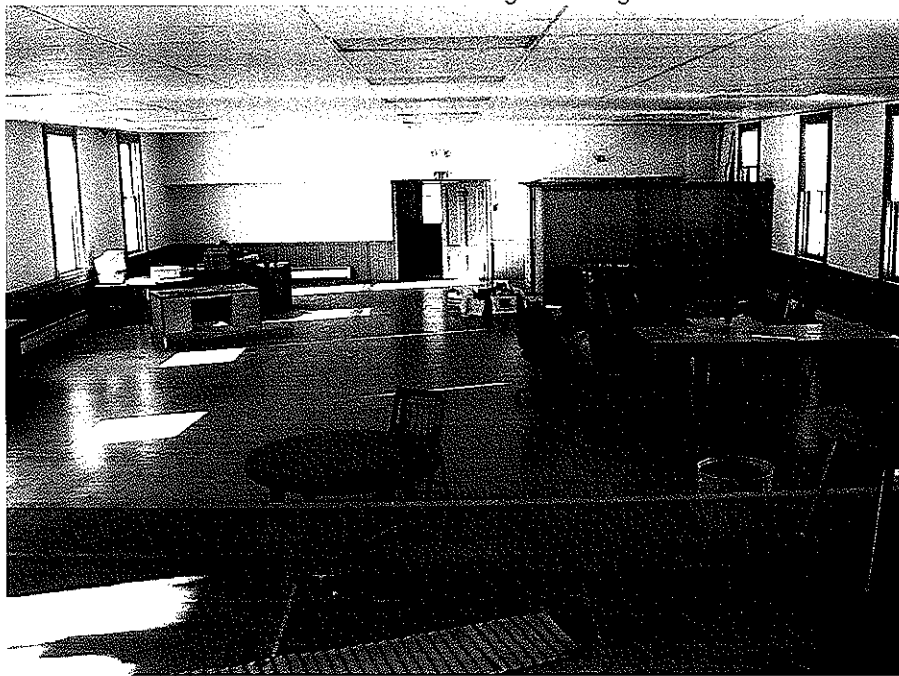
**SECOND FLOOR MEETING ROOM / STAGE**

- Previous Installed Suspended Ceiling / Lighting
- Temporary Wood Partitioning
- Previously Installed Perimeter Hydronic Baseboard

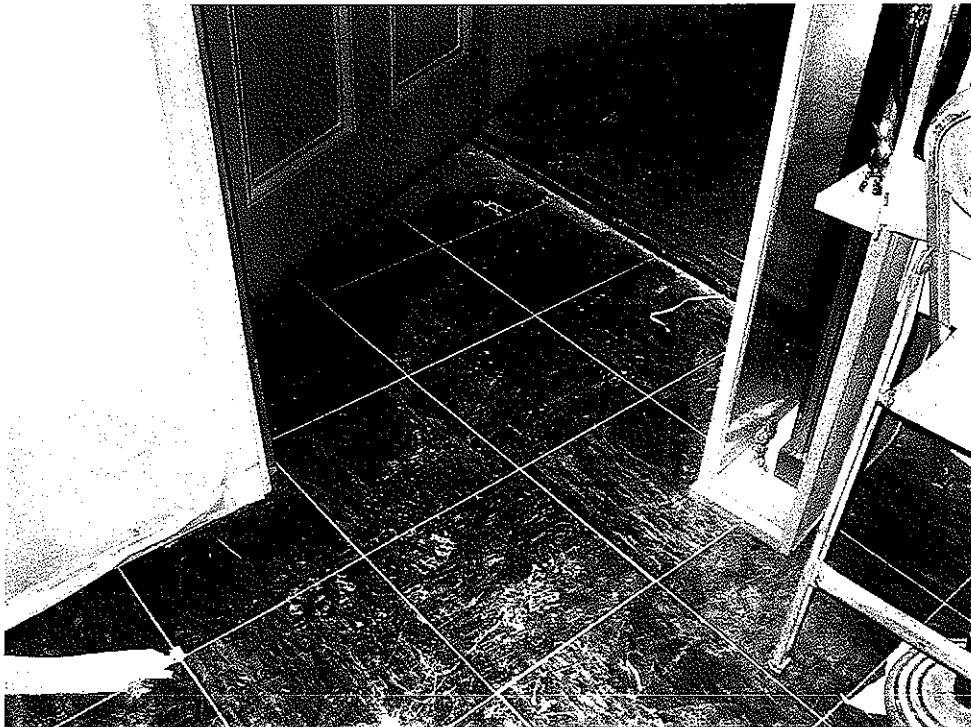
**SECOND FLOOR OFFICE**

- Probable Vinyl Asbestos Floor Tile
