**FEASIBILITY STUDY FOR THE ADAPTIVE REUSE OF THE
- STERLING TOWN HALL
STERLING, MASSACHUSETTS**

FOR THE STERLING BUILDING NEEDS COMMITTEE

**Prepared by
Suzanne O. Carlson, Architect
94 Cross Point Road Edgecomb, Maine**

January 15, 1998

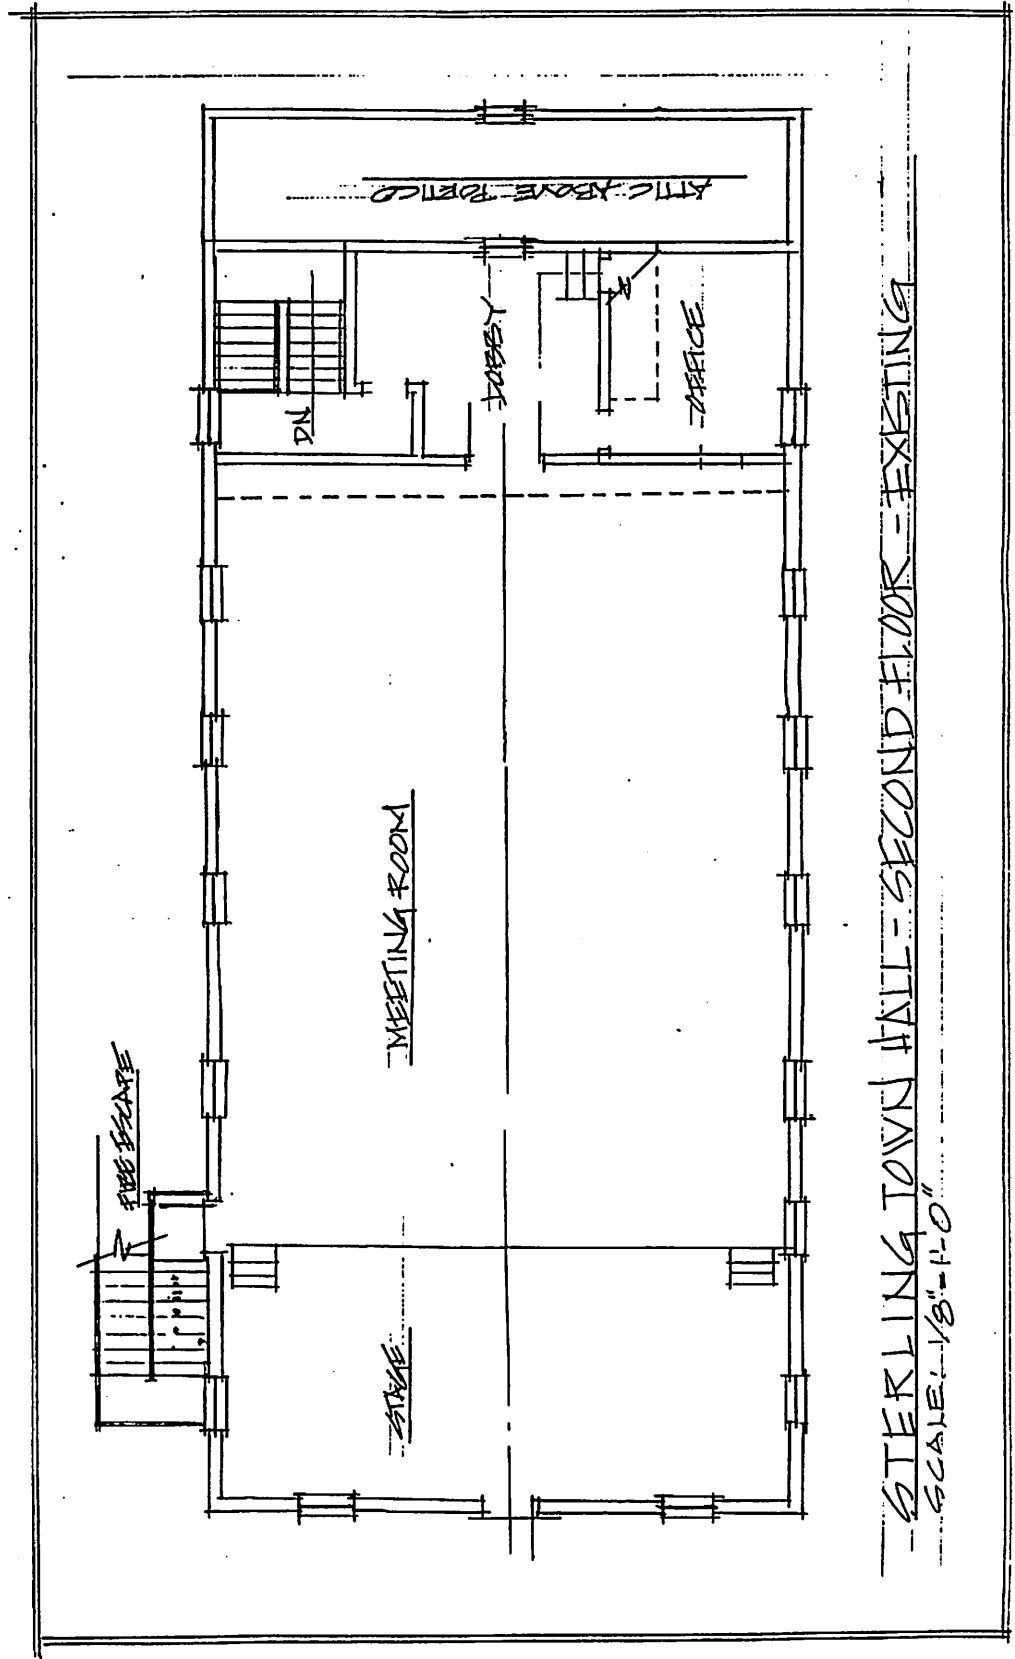
STERLING TOWN HALL - SECOND FLOOR - EXISTING
SCALE: 1/8" = 1'-0"

The second floor: Other than the suspended acoustical tile ceiling the finishes on the second represent the 1890s renovation, with the stage apron and narrow vertical beaded wainscoting still in place. Hardwood floors are in good condition but are need refinishing.

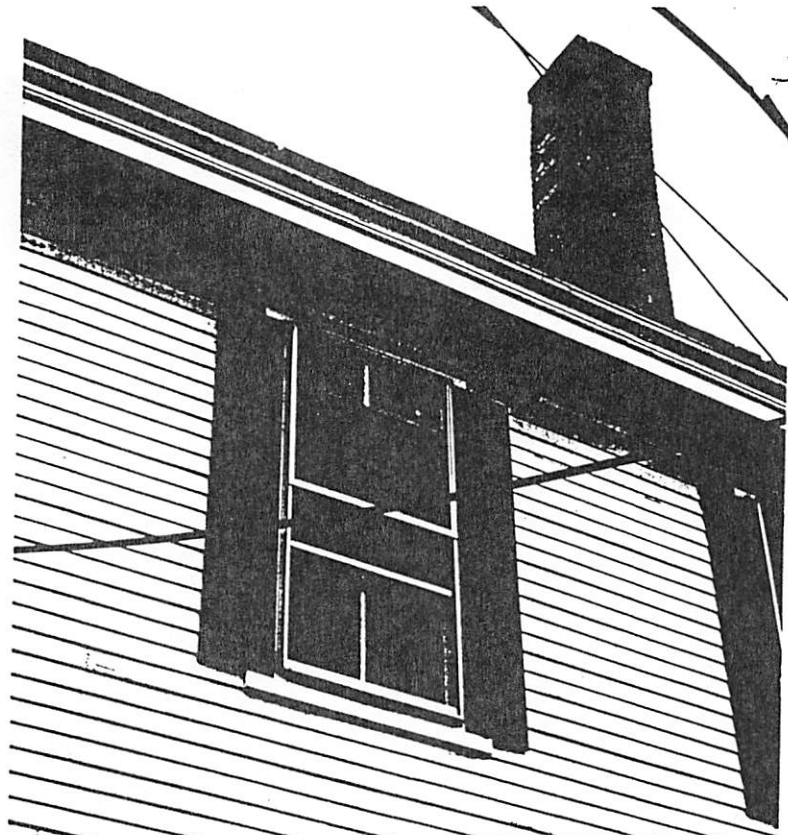
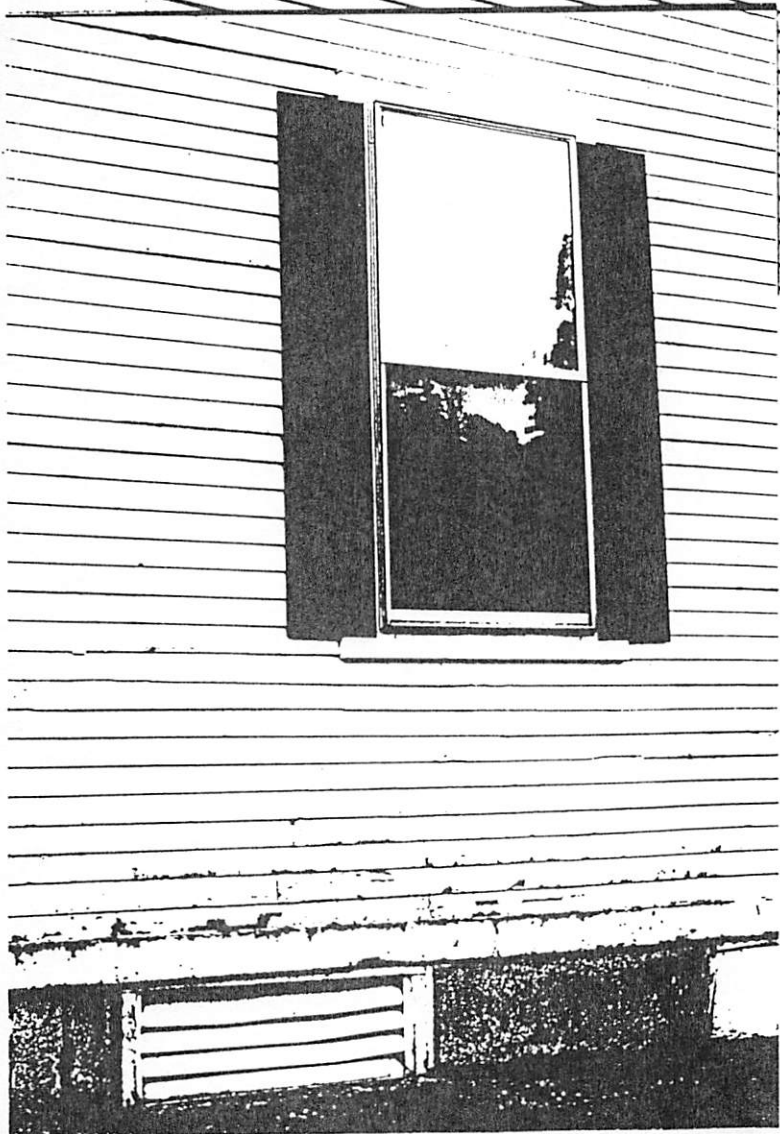
WINDOW DETAILS
NORTH ELEVATION

The symmetry of the side wall fenestration is broken by a door and steel fire escape leading from the second floor to grade at basement level. Brick basement wall is in bad condition and needs repair. Windows and doors at basement are in poor condition. The railing design at west end door is not appropriate to the period. All wood needs painting.

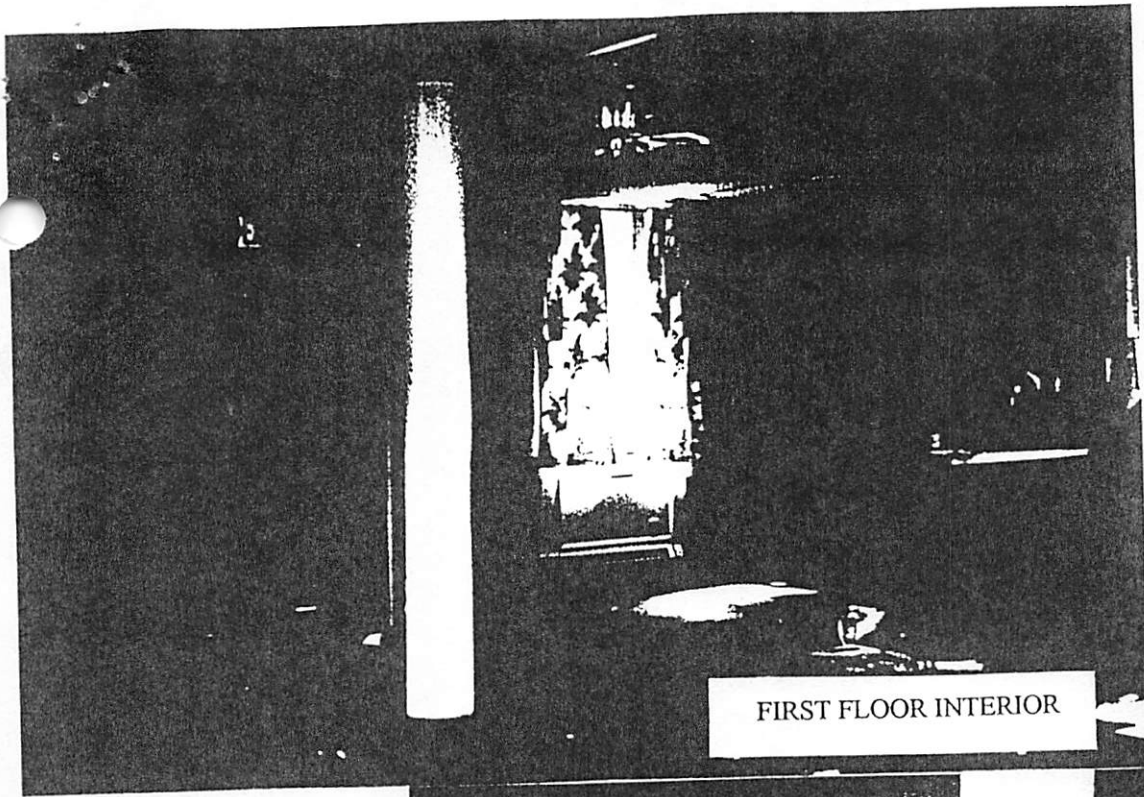
FIRST FLOOR INTERIOR

The first floor underwent major renovations in 1979, adding handicapped toilets, a janitors closet, and new concrete-filled, steel pan stairs to the second floor and basement. The original ceilings were removed and a new suspended acoustical tile ceiling installed throughout. New lighting was incorporated into the ceiling system. New wood panel doors were incorporated added as needed. Wood paneling and standing trim is original and in good condition. The floors are currently carpeted, presumably covering a hard wood floor.
