STERLING 1835 TOWN HALL

**ARCHITECTURAL / STRUCTURAL ASSESSMENT
and
FEASIBILITY STUDY FOR UNIVERSAL ACCESSIBILITY
of the
STERLING 1835 TOWN HALL BUILDING**

JULY 8, 2005

PHASE I: ARCHITECTURAL CONSERVATION ASSESSMENT

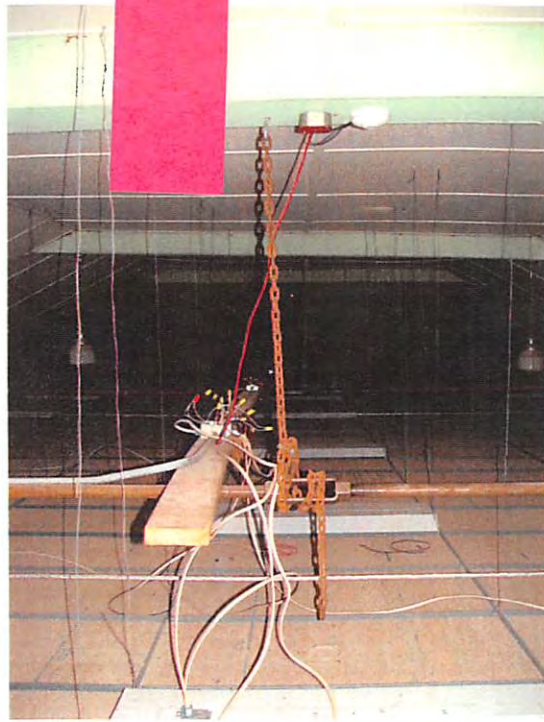
Tie Rod with Lower Cable

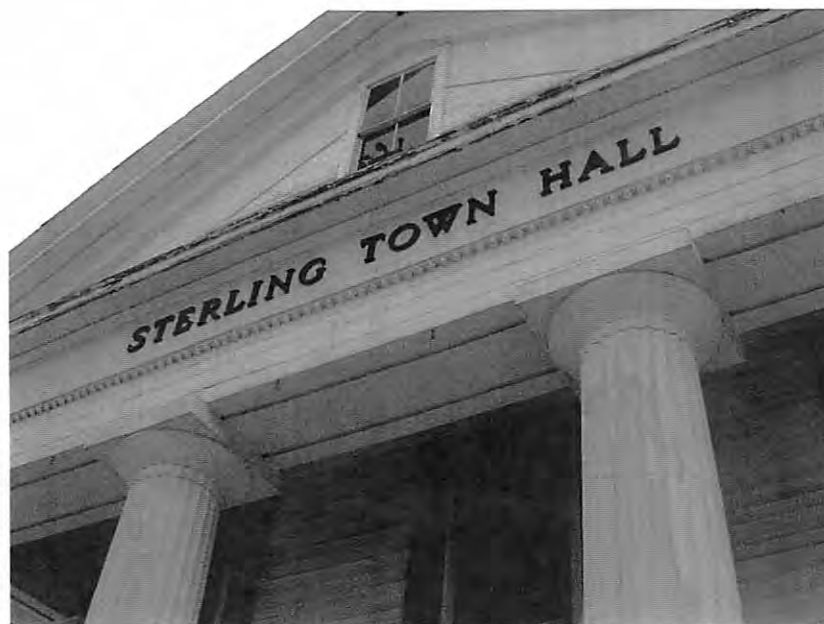
MAIN ENTRANCE PORTICO

- Base of wood columns at portico are loose and subframe appears to have deteriorated due to previous moisture damage. Wood is particularly vulnerable when in contact with stone or masonry. South facing column joints are widening. Snow is left in contact with wood columns accelerating column deterioration.

- Previous concrete portico slab installation appears to be trapping moisture at wood column base because slab was installed higher than column base stone.

- Failed sealant joint at concrete portico slab to wood base board. It appears concrete was poured adjacent to original wood base trim.
- Flush wood siding on front (West) elevation is cupping or ridging at joints due to swelling with moisture.

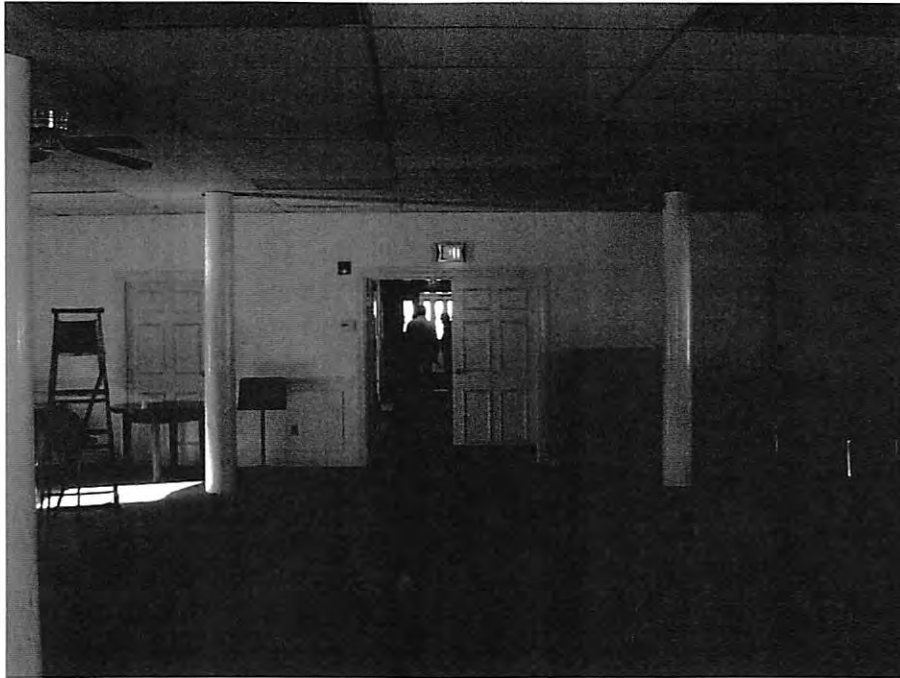
FIRST FLOOR MEETING ROOM

- Previous Installed Suspended Ceiling / Lighting
- Previous Installed Wood Wainscoting and Doors
- Original Wood Columns

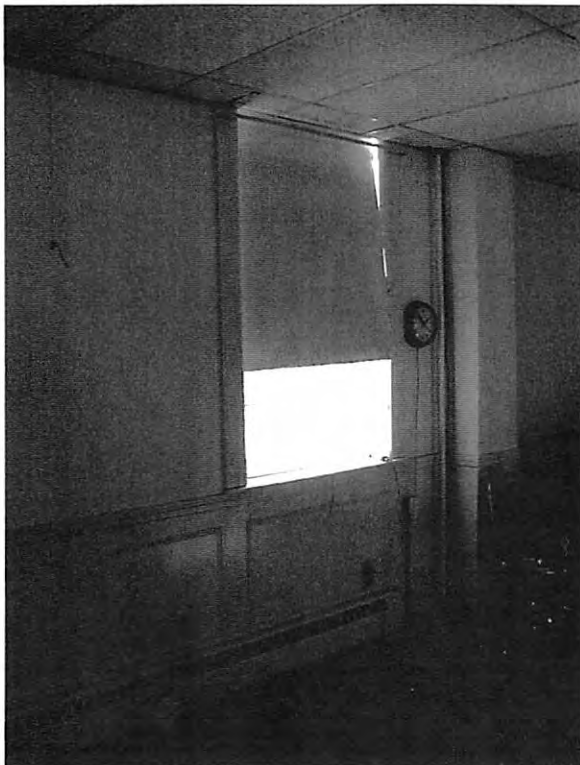
FIRST FLOOR MEETING ROOM

- Suspended Ceiling Bisects Glass Window

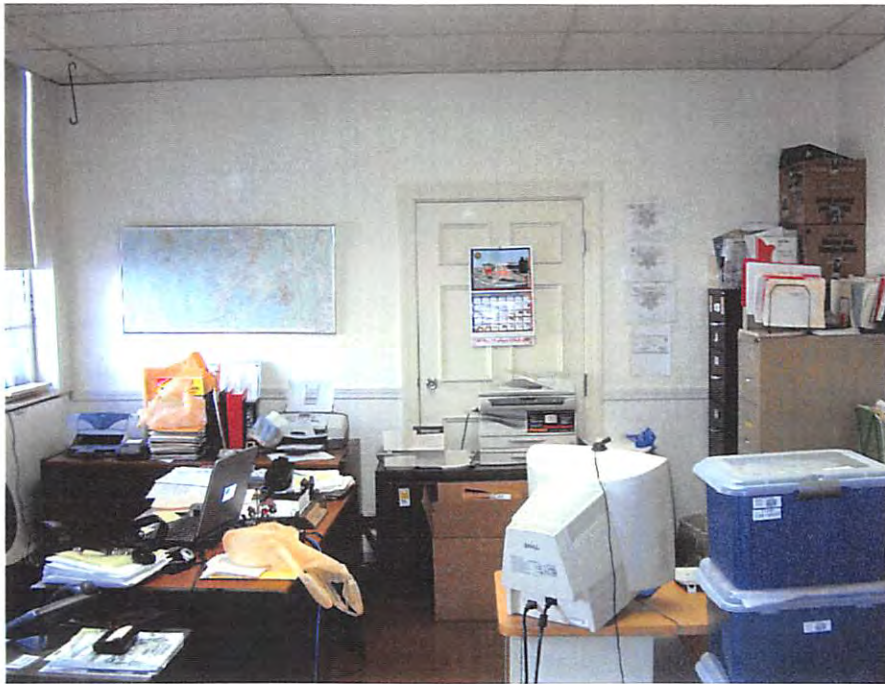
FIRST FLOOR OFFICE

- Previous Newer Finishes Include Gypsum Wallboard, Suspended Ceiling, Lighting, Chairrail, Door, Carpeting

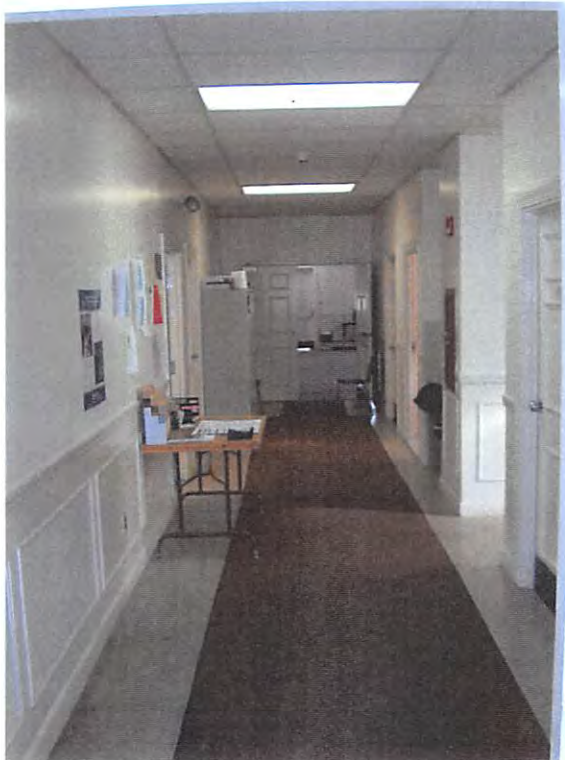
FIRST FLOOR CORRIDOR

- Previous New Finishes Include Gypsum Wallboard, Suspended Ceiling Lighting, Wainscoting, Doors, Vinyl Tile Flooring

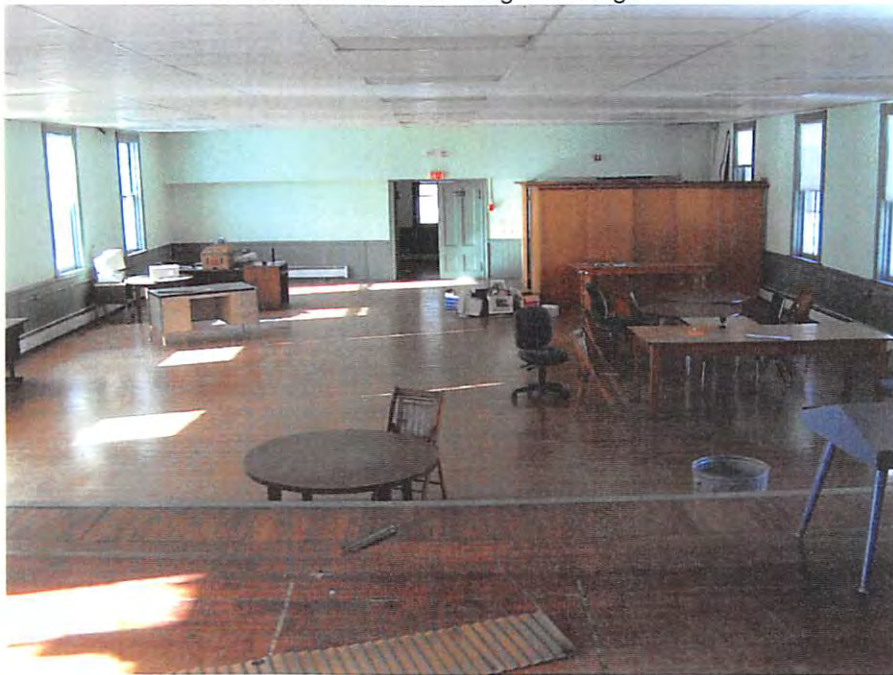
SECOND FLOOR MEETING ROOM / STAGE

- Previous Installed Suspended Ceiling / Lighting
- Temporary Wood Partitioning
- Previously Installed Perimeter Hydronic Baseboard

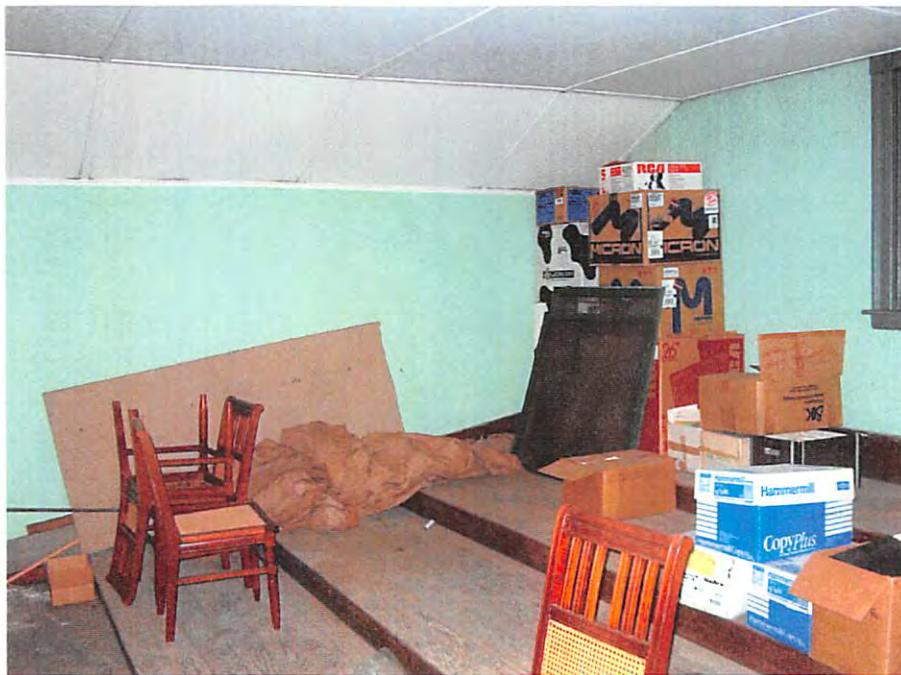
BALCONY

- Board and Batten Ceiling
- Original Stepped / Tiered Floor
