INTERIM REPORT
HORIZONTAL TIE REPLACEMENT
STERLING TOWN HALL
STERLING, MASSACHUSETTS

Prepared by

Harvey & Tracy Associates, Inc.
143 Dewey Street
Worcester, MA 01610

August 1987

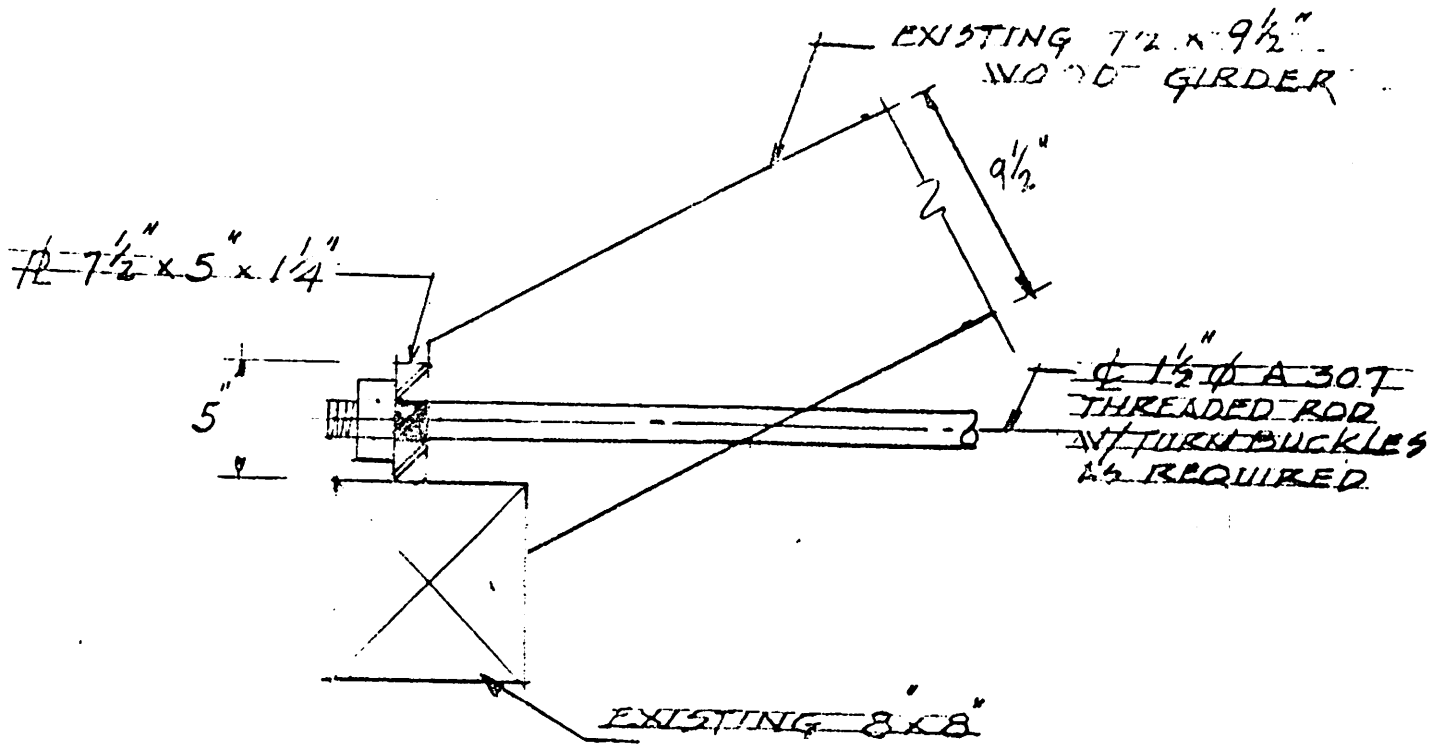
TRUSS LAYOUT PLAN

The yoke type devices at the end of the ties (A and B)* in the original part of the building had undergone some distortion as might be expected as their configuration introduced forces and stresses that were not designed for. This distortion in turn caused distress in the wood members to which they are attached.

There does not appear to be any distress in the remaining tie (D)* in the building addition. A visual review in the attic (limited because of low head room) indicated that there were cracks in some of the wood framing components of the roof.

The replacement tie rod assemblies installed to date (A, B, and C)* do not appear to be structurally adequate for code mandated loads and in the case of ties A and B particularly because these incorporate the yoke devices described previously.

New tie rod assemblies should be designed and installed to replace all of the existing tie assemblies including the ones recently installed.
