**FEASIBILITY STUDY FOR THE ADAPTIVE REUSE OF THE
STERLING TOWN HALL
STERLING, MASSACHUSETTS**

FOR THE STERLING BUILDING NEEDS COMMITTEE

**Prepared by
Suzanne O. Carlson, Architect
94 Cross Point Road Edgecomb, Maine**

January 15, 1998

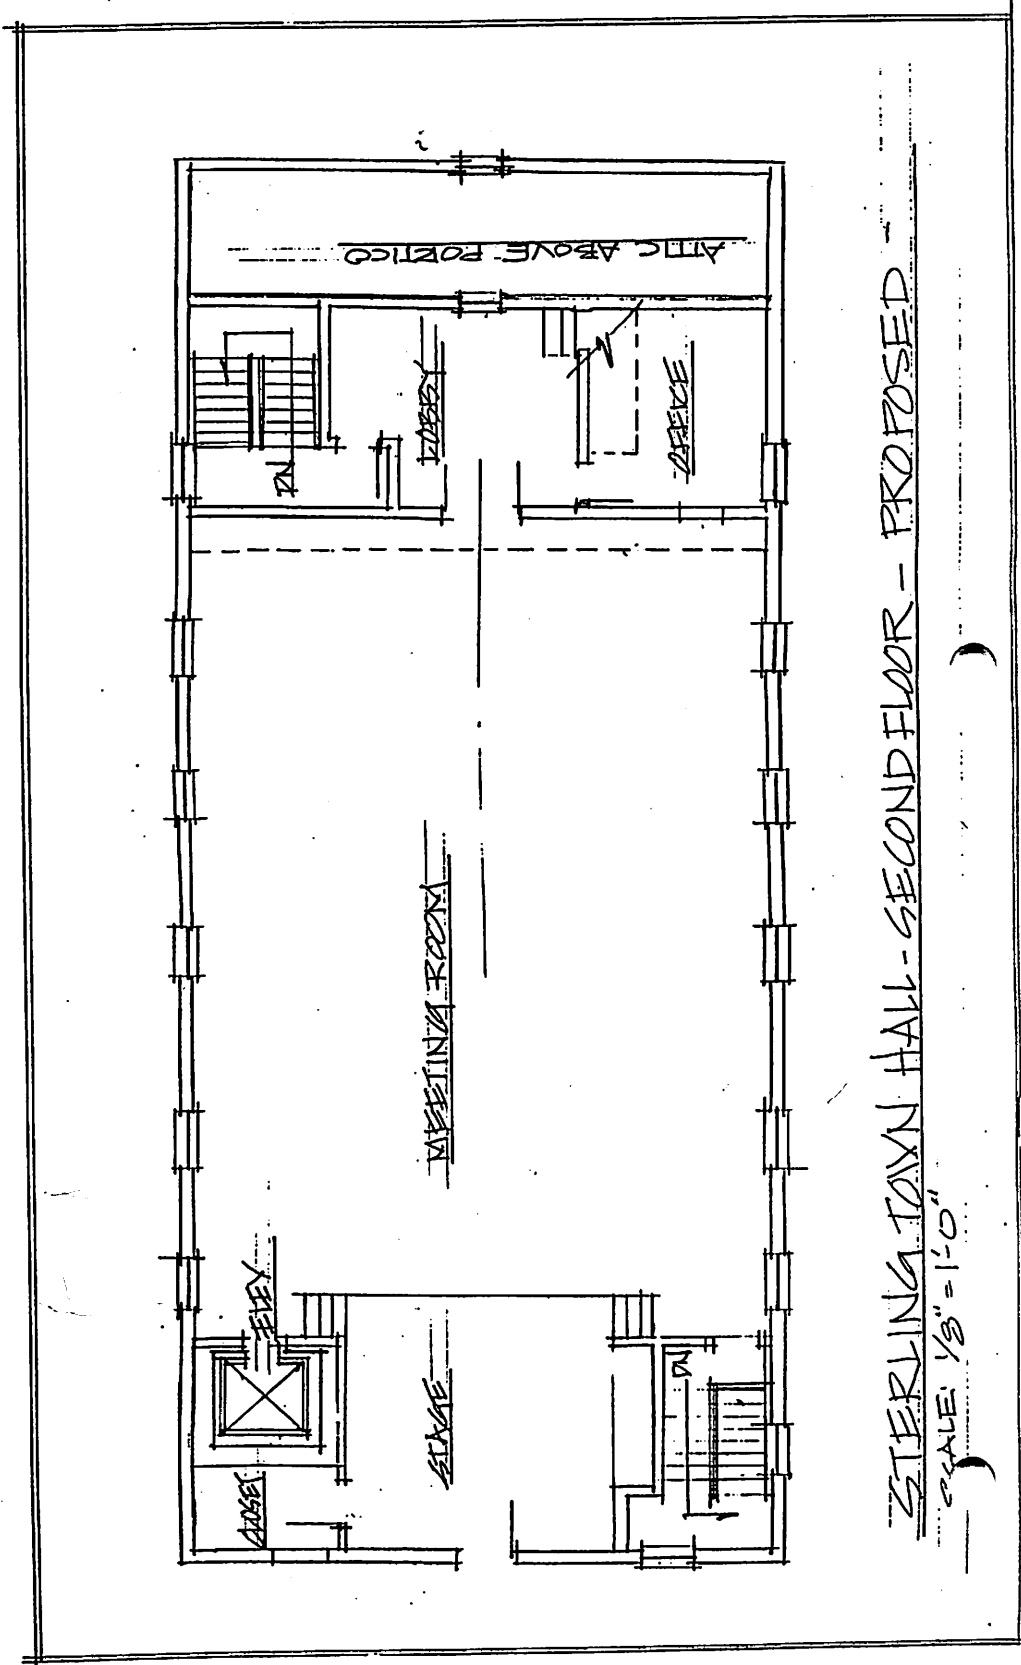
STERLING TOWN HALL - SECOND FLOOR - PROPOSED

Approx. Area of 2nd
Floor where Floor
Trappings Modifications
Have Not Been Made

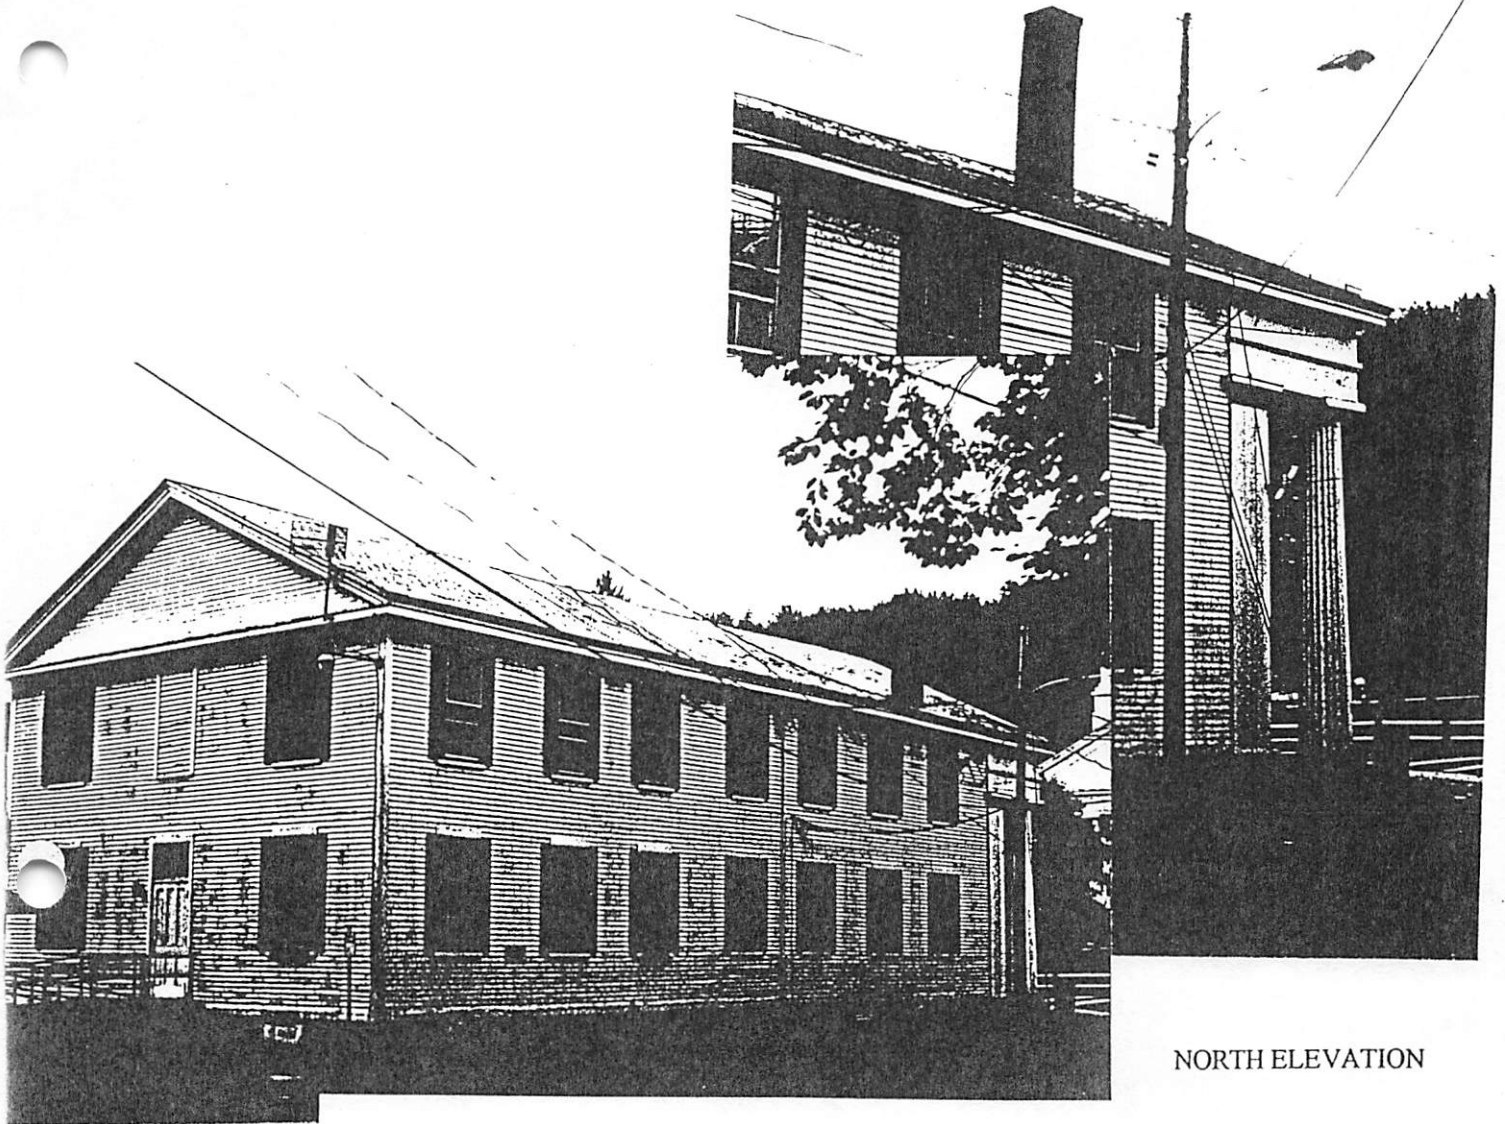
NORTH ELEVATION

The symmetry of the side wall fenestration is broken by a door and steel fire escape leading from the second floor to grade at basement level. Brick basement wall is in bad condition and needs repair. Windows and doors at basement are in poor condition. The railing design at west end door is not appropriate to the period. All wood needs painting.
