Sterling 1835 Town Hall Long-Term Plan

March 2016

Prepared 2016 by Robert McKay Jones

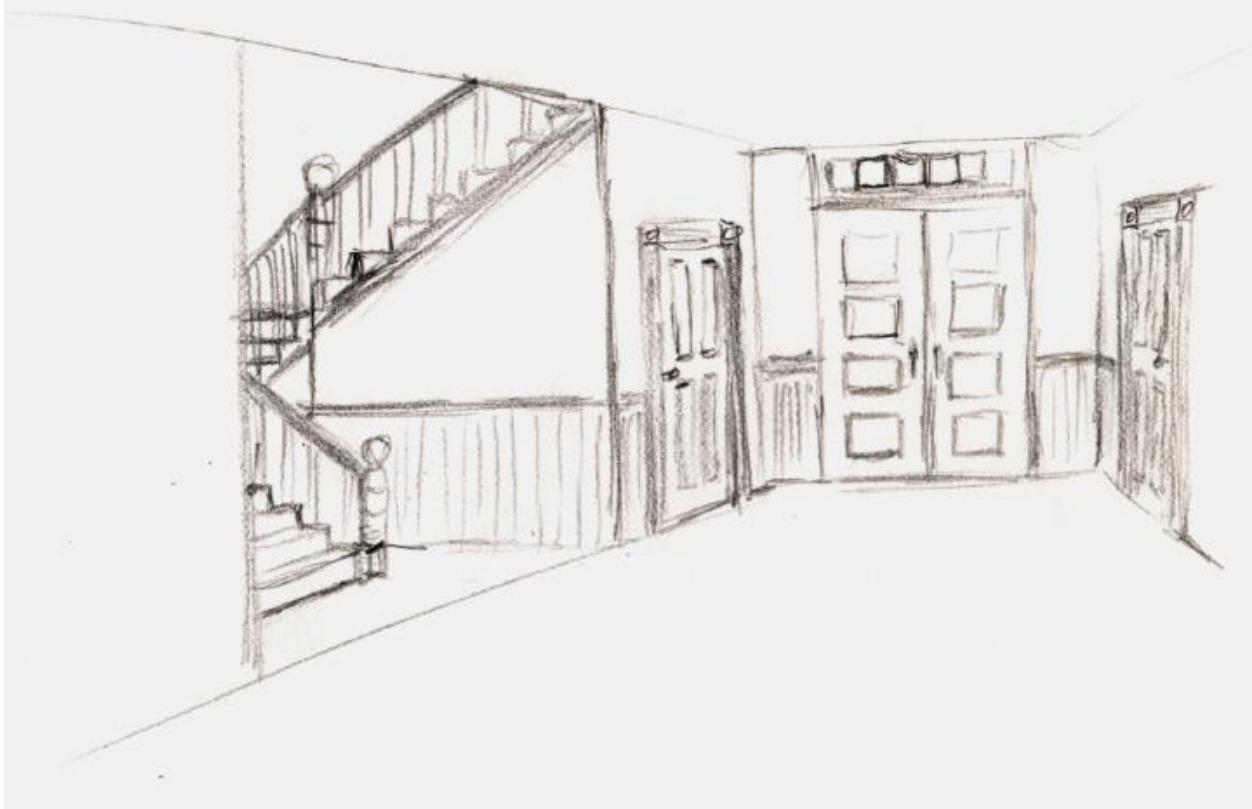
Drawing of original staircase (credit: Vern Gaw)

The downstairs would also be kept in a form similar to its present layout, with the large meeting room in the rear and two or three other meeting rooms toward the front. A small kitchen area is suggested. The stairs, installed in the mid-1970s, need attention, as they are deteriorating and provide poor access to the upstairs.

- Sister the joists as required with new framing.
- Remove dropped ceiling.
- Restore original staircase configuration and finishes.
- Replace restrooms with new, code complaint accessible facilities.
